CAA Safety Investigation Report

Departure from controlled flight

ZK-MBX RANS Aircraft S-19

CAA Final Report 17/3767

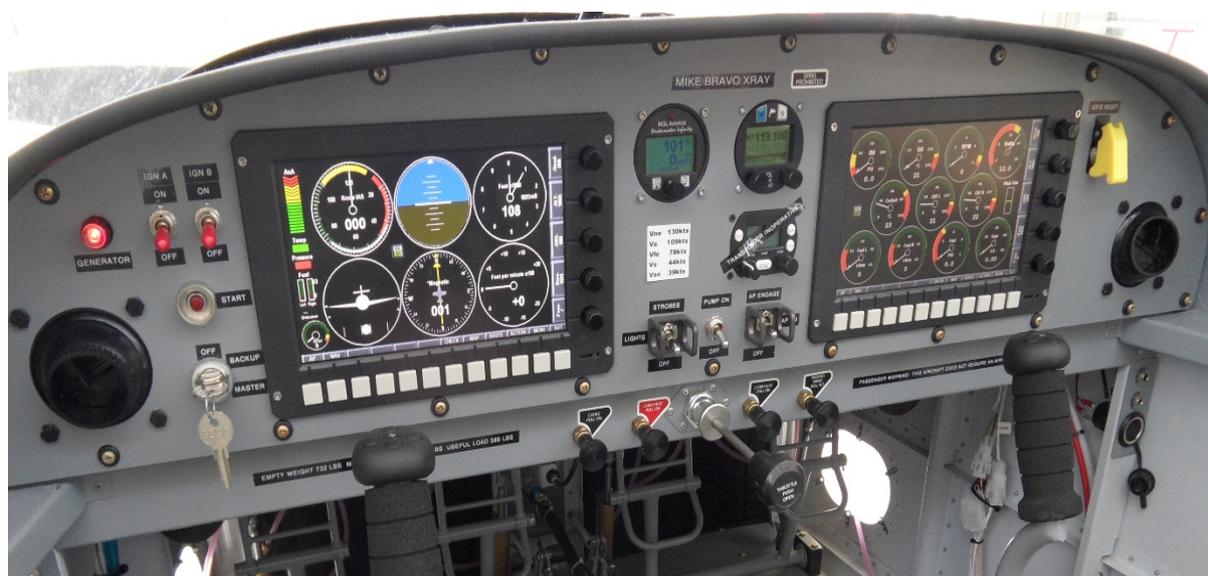
Figure 3: ZK-MBX Instrument Panel

The passenger normally flew an aircraft with conventional instruments. ZK-MBX was fitted with an EFIS which displayed the aircraft instruments on two glass screens (See Fig 3).

ZK-MBX had two dual control sticks which were located in front of both seats (See Fig 3). The flush fitted electric trim buttons are located on top of both control sticks. The forward button activated the nose down trim and rear button activated the nose up trim (See Fig 4). The PTT button is located on the front of the control stick.

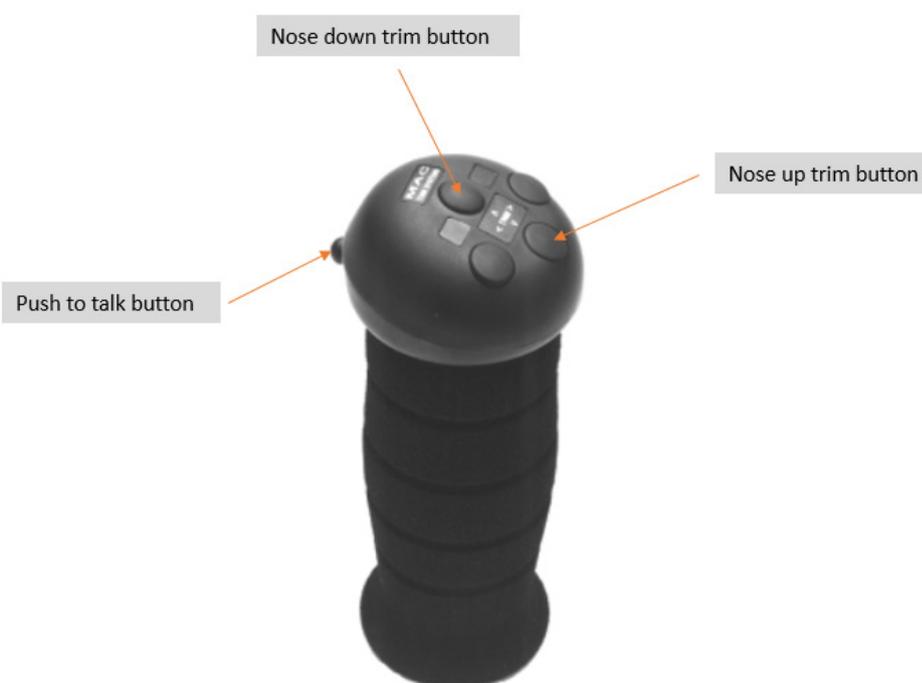
Figure 4: Ray Allen G205 Stick Grip, as installed on ZK-MBX (Manufacture).

The pitch trim servo was activated by physically pressing either the up or down electronic trim buttons, located on the top of both control stick grips. (See Fig 4). This sent an electrical signal via an electronic circuit breaker system to the pitch trim actuator.

During the safety investigation it was noted that the push button switches, by design, are sensitive and susceptible to inadvertent activation. They only required a light touch to activate the trim.

The design of the control stick, and associated trim buttons, offers no protection to inadvertent trim commands. The safety investigation has identified occurrences of inadvertent trim actuations. As such, the CAA has issued a Continuing Airworthiness Notice – 27-013 Control Sticks fitted with a G205 Stick Grip manufactured by The Ray Allen Company (See Appendix 1).

The sensitivity of the electric trim buttons may cause unintentional activation of the trim system has also been raised as a safety observation. This has been brought to the attention of the stick grip manufacturer, as a formal Safety Observation (CAA 20A177).

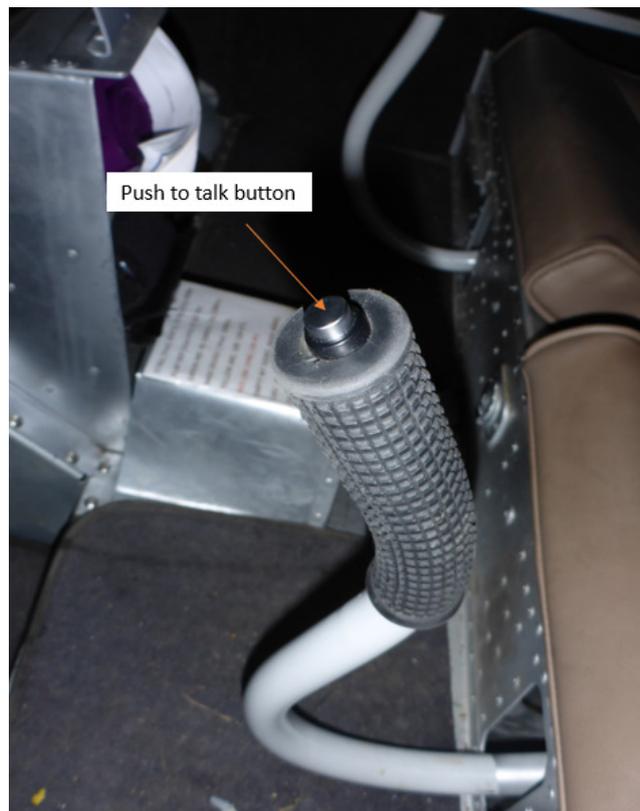
Figure 5: VANS RV-12 control stick with the push to talk button located on top.

The passenger had recent flying experience in the RANS S-6 and VANS RV-12 aircraft. Both of these aircraft are fitted with dual controls sticks and are located in front of both seats. The PTT buttons are located on the top of both control sticks (See Fig 5). The PTT buttons have a large stroke length which provides positive feedback when compared to the short stroke length of electric trim buttons, such as those on ZK-MBX’s control sticks.

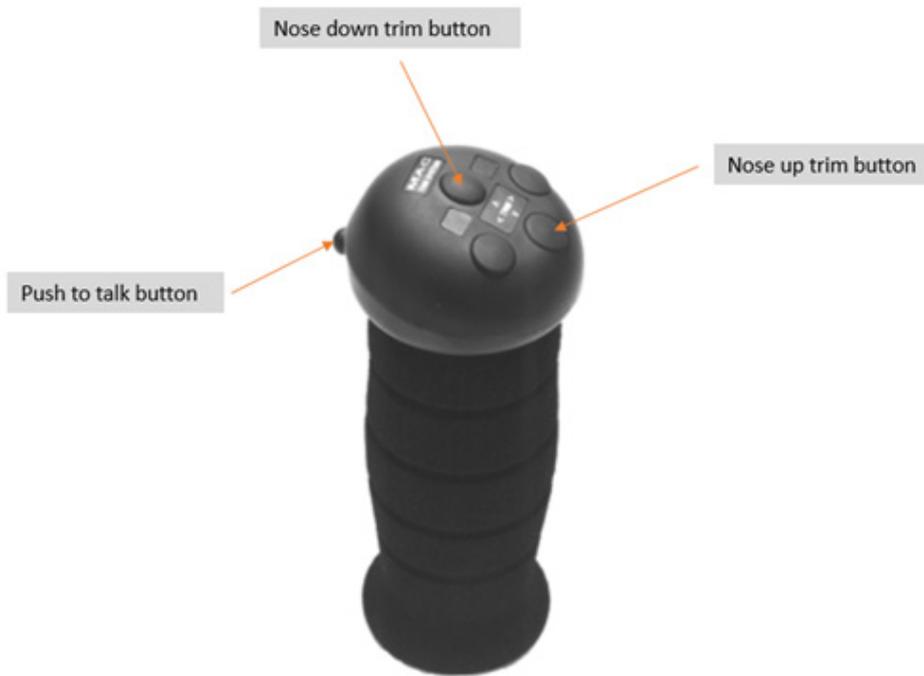
The Ray Allen Company, G205 Stick Grip

On Rans S-19 aircraft the dual control sticks are floor mounted in front of the seats. Both control sticks are fitted with flush mounted electric trim buttons on top of the stick grip. The forward button activates the nose down trim and the aft button activates the nose up trim. The Push-to-Talk (PTT) button is located on the forward side of the control stick grip. For further details, refer to the photograph below.

Due to the design/configuration of the horizontal stabiliser electric pitch trim buttons located on the top of the control stick grip, with no protection from inadvertent trim commands, unintentional activation of the horizontal stabiliser electric pitch trim is possible. The CAA has brought this to the attention of the stick grip manufacturer.

With unintentional activation of the horizontal stabiliser electric pitch trim system and the sensitivity/speed of the electric trim, the trim system is capable of quickly trimming the aircraft into a state of an out of trim condition, which will require a significant input force on the control stick to maintain aircraft control. The aircraft manufacturer is aware of the considerable control stick force on affected aircraft in an out of trim condition.

- The ergonomic layout of the electric trim push buttons located on top of the control stick grip on affected aircraft offer no protection against inadvertent trim activation.
- The trim push buttons are also quite sensitive and only require a light touch to activate the electric trim.
- Due to possible inadvertent activation and the speed of the electric trim system, the trim system is capable of quickly trimming the aircraft into a state of an out of trim condition.
- Control stick forces can be significant in an out of trim condition.
