CAA OCCURRENCE 21/3316

ROBINSON HELICOPTER COMPANY R44 RAVEN II

ZK-HVX

HEAVY LANDING FOLLOWING TOTAL ENGINE POWER LOSS

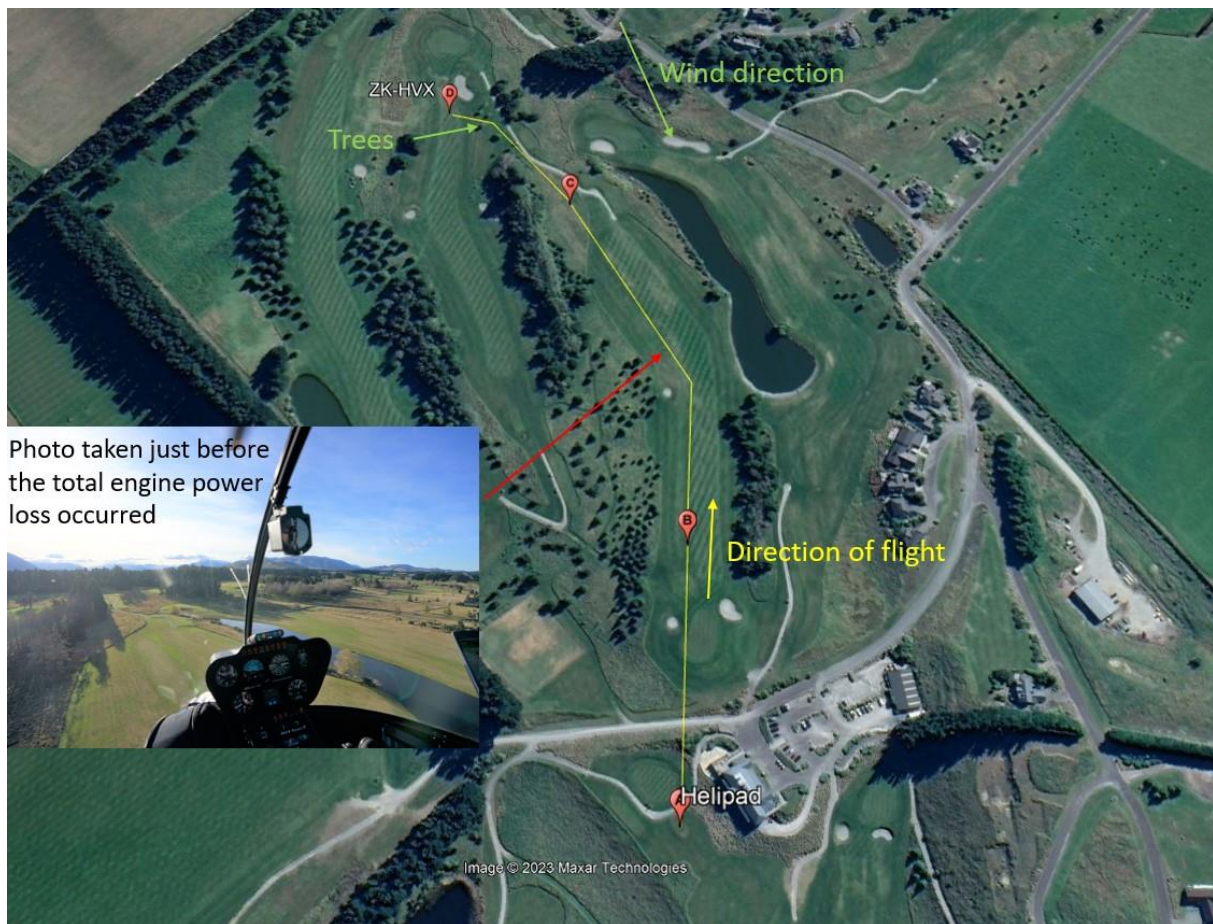
Figure 1: ZK-HVX accident flight path (Google Earth). Inset photo taken by the photographer

- 1.11.4 For clarity, the instrument indications which can be observed in the photo are:

Altitude	1700 feet amsl (150 feet AGL)
Airspeed	50 knots
Rate of climb	450 feet per minute
Engine RPM	102%
Rotor RPM	102%
Manifold Pressure	24 InHg

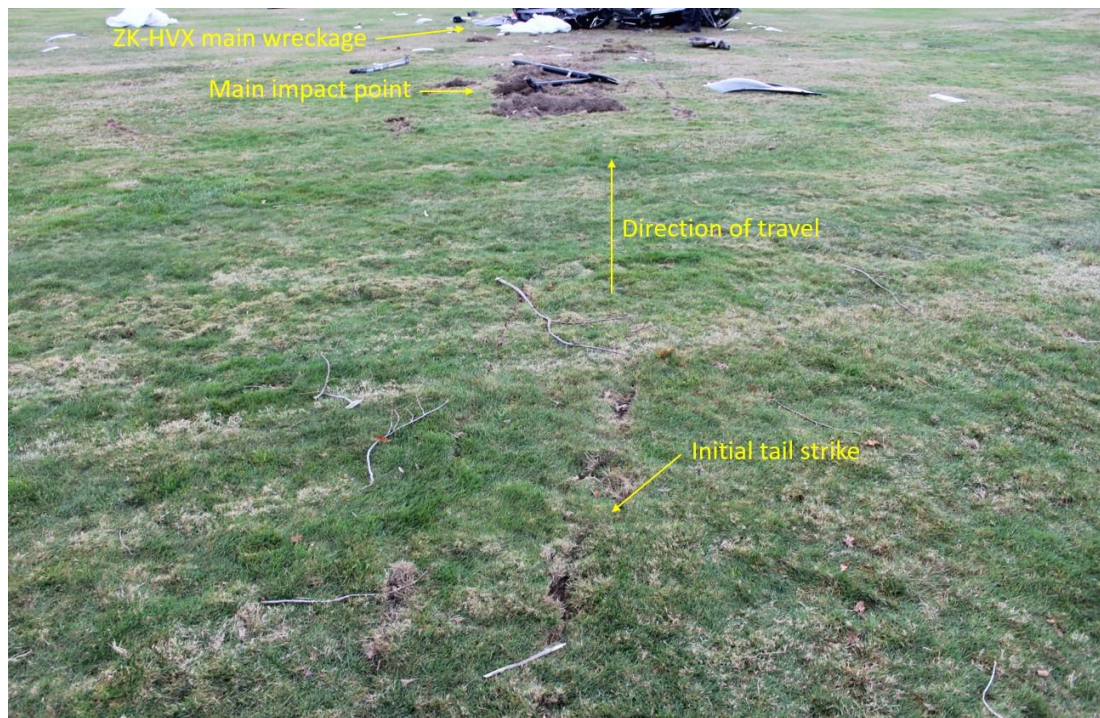
Figure 2: Ground scars (CAA photo)

- 1.12.1 The accident occurred on the golf course located at the Fable Terrace Downs High Country Resort, approximately 39 nautical miles west of Christchurch, New Zealand.
- 1.12.2 During the accident sequence, the aft tail boom initially struck the ground, followed by the landing gear, which then collapsed. The tail boom was severed by the main rotor. HVX then slid for five metres before coming to rest upright. Refer Figure 2.

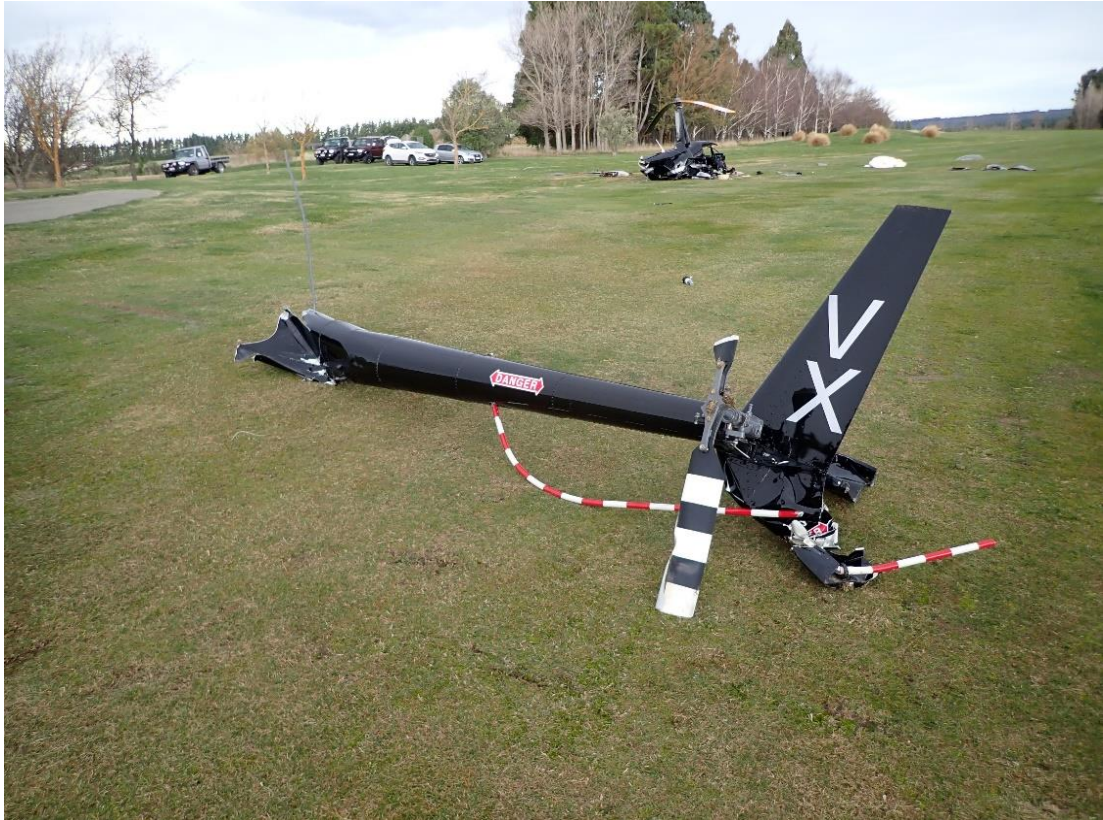
Figure 3: Tail boom (CAA photo)

- 1.12.3 The main rotor blades were intact, although they exhibited signs of damage from contact with the tail boom, and they had minor deformation which corresponded to the vertical deceleration during the ground impact. One pitch link had failed at the upper end, likely due to overload when the main rotor blade struck the tail boom.
- 1.12.4 The aft tail boom with the tail rotor attached was located 31 metres from the helicopter. Damage observed on the left side of the tail boom clearly indicates that it had been struck by the main rotor. Refer Figure 3. Witness marks observed on the tail rotor blades and sections of tail rotor drive shaft indicated that the tail rotor was being driven by the transmission when the tail rotor struck the ground.

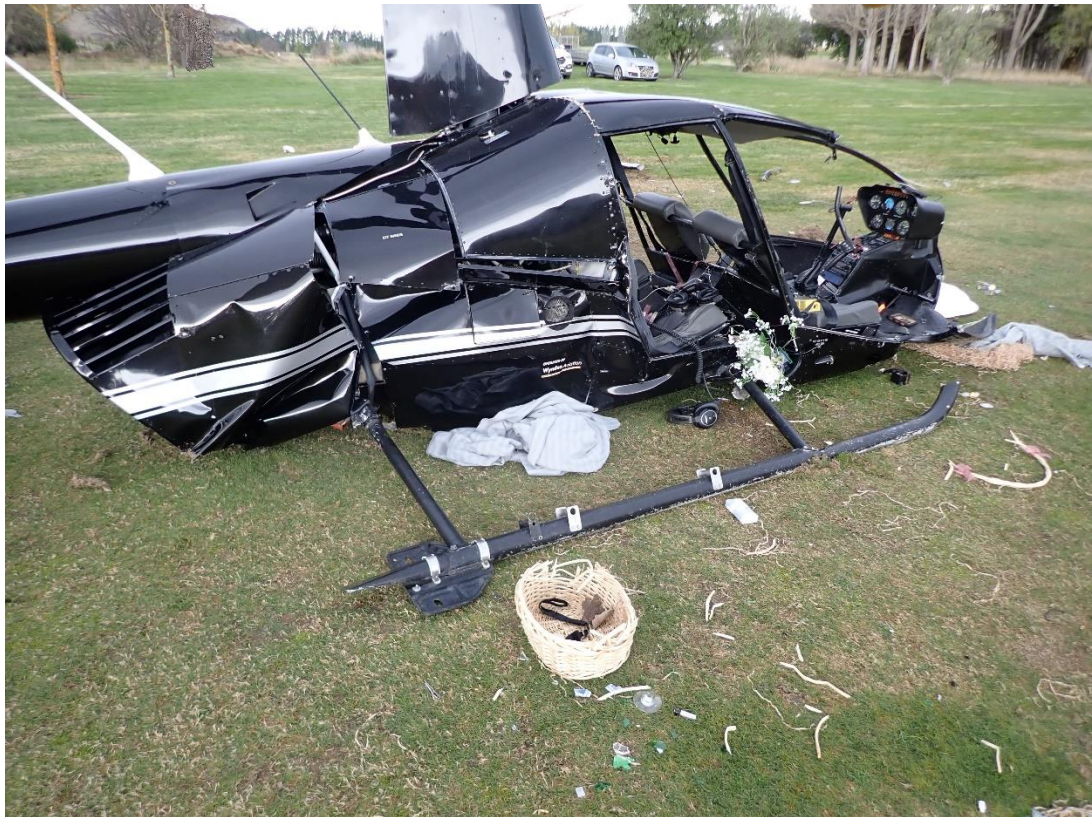
Figure 4: HVX Fuselage indicating damage (CAA photo)

- 1.12.5 The fuselage showed corresponding deformation from the ground impact. The Perspex® windscreens had shattered. The aluminium structure supporting the bladder fuel tanks showed deformation, although fuel leakage had not occurred. Fire and Emergency personnel had cut away sections of the door frames to enable extraction of the occupants. Refer Figure 4.

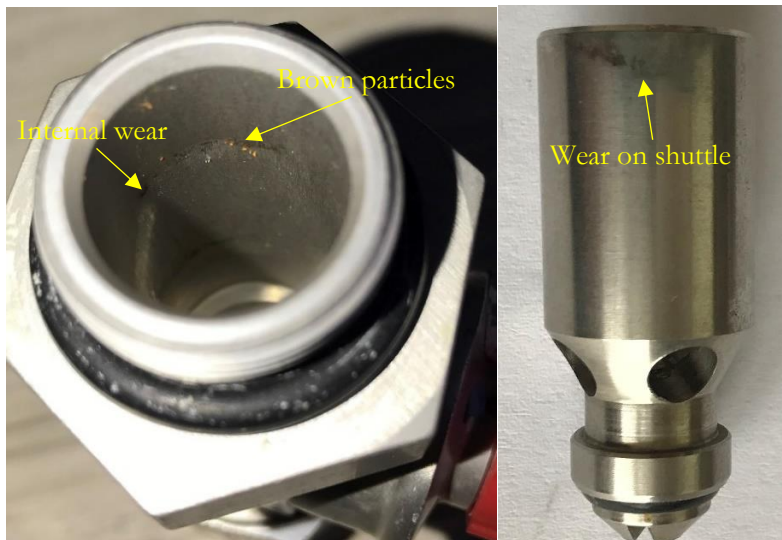
Figure 5: FPRV valve internal wear and suspect particles with FPRV shuttle shown alongside (CAA photo)

- 1.16.4 The FPRV, RHC part number D321-1 was removed for testing by the CAA. It was found that the FPRV was bypassing fuel at a lower pressure than the required specification.

- 1.16.6 CAA testing of the FPRV installed on HVX determined that the valve began to bypass fuel at 5 psi at a minimal rate, to a maximum flow of 40 USG/hr at 28 psi. The valve was then disassembled for inspection, wear marks were found in the bore of the valve and on the valve shuttle. Small flecks of brown particles were also found in the bore of the valve. These particles were too small for analysis, however, RHC determined that the brown particles were most likely to be fuel gum or residue.

- 3.11 The FPRV was found to be worn internally with small brown particles, possibly fuel gum in the internal bore of the valve. These particles and/or the internal wear in the valve, may have caused the valve to fail open in the maximum bypass flow position.

- 2.16 Following the identification of the FPRV which was not performing to specification, and information provided by industry in New Zealand of other similar valves, the CAA published Continuing Airworthiness Notice (CAN) 73-006 *Robinson R44 II helicopters – Fuel System Pressure Relief Valve (PRV)* on 18 August 2021. Refer Appendix 1. The CAN recommends that operators and maintainers of R44 II helicopters carry out the RHC check of the FPRV, as detailed in the RHC R44 II Maintenance Manual.

For that reason, CAA are advising operators and maintainers to replace these components at the manufacturers recommended replacement interval.

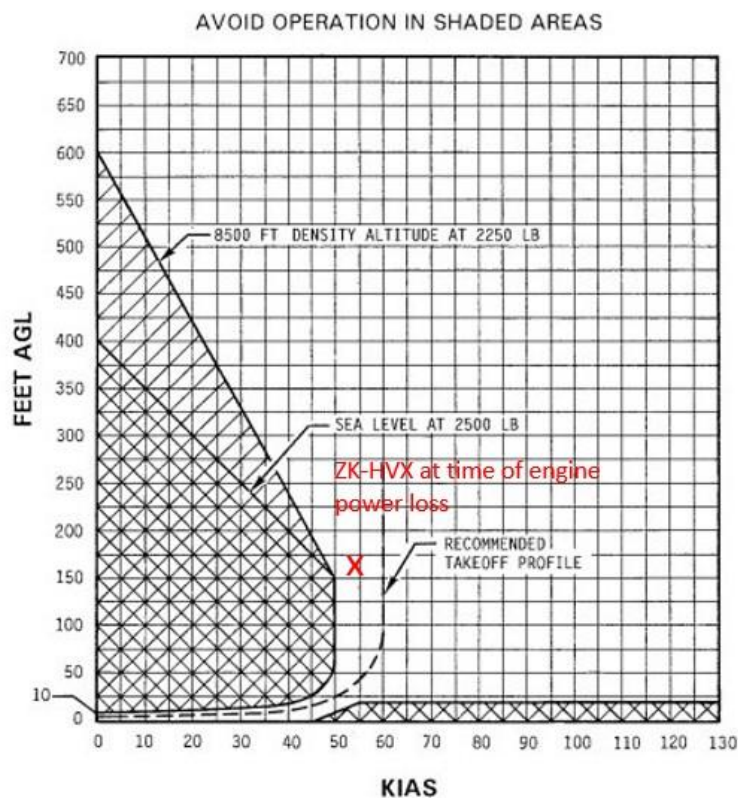
Figure 6: R44 II Height-velocity diagram

- 2.6 Despite having to turn out of wind to avoid ground obstacles after the engine failed, sufficient rotor RPM was retained to enable the pilot to flare HVX with a nose high attitude at the moment of ground contact.
- 2.7 At the time that the engine power was lost, HVX was approximately 160 feet AGL with an approximate forward airspeed of 50-55 knots. With reference to the R44 II Height-velocity diagram³, HVX was operating close to the edge of the 'avoid operation area' on the diagram. Refer Figure 5 below.

- 2.8 Given the ground obstacles, and the height and speed of HVX when the engine power loss occurred, the pilot would have been presented with a very challenging situation to be able to complete a successful landing, even with an immediate entry into the emergency autorotation.
- 2.9 It is also possible that the stand of tall trees upwind of the flight path created a wind shear effect or a localised downdraught. This could have affected the final stages of the emergency autorotation as HVX descended and rotor RPM reduced, with the pilot being unable to arrest the rate of descent before striking the ground.
