vector

AN OIL LEAK'S JOURNEY THROUGH SWISS CHEESE

Everyday items lost in the cockpit can jam essential controls. Two such incidents occurred in 2025.

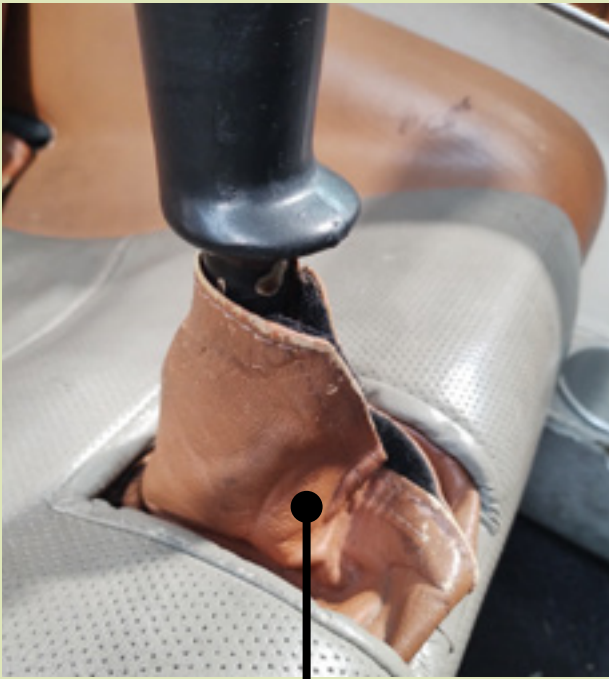
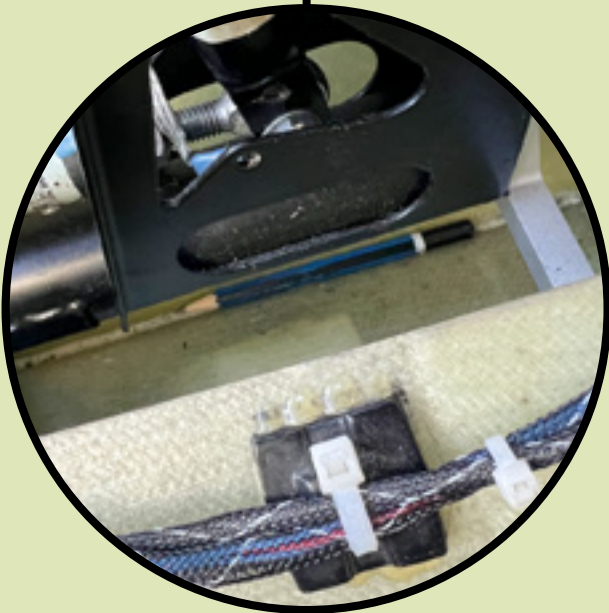
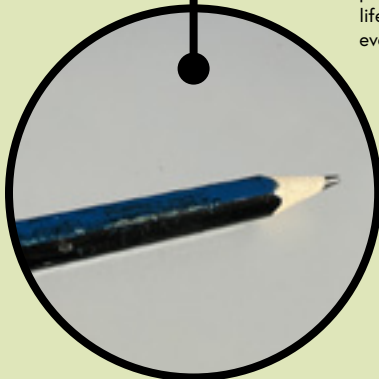
// This virtually unscathed pencil caused a life-threatening event.

“There was a comprehensive check of the aircraft in question. When the seats were removed, a pencil was found under the right-hand control stick mechanism.

“This pencil had indentations on it consistent with it being jammed in the control stick mechanism.

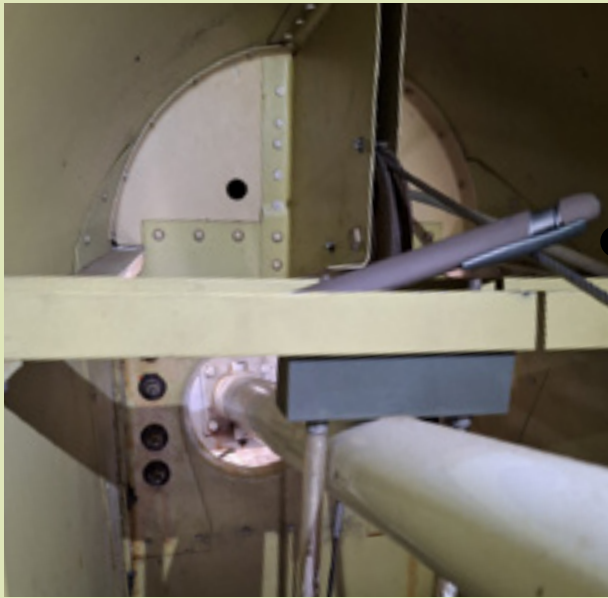
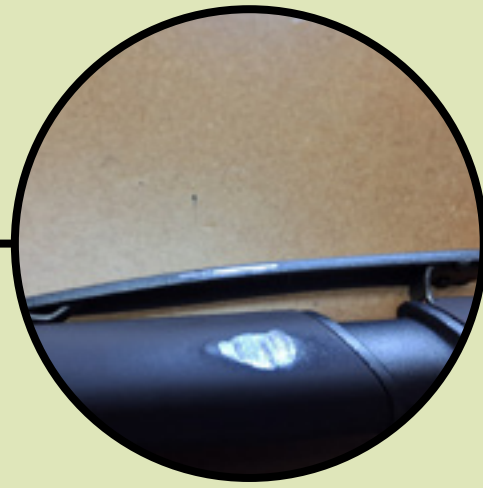
// This virtually unscathed pen could have caused havoc in the middle of an aerobatic spin.

"I didn't think they were going to find anything. When the engineers called me over and showed me the pen they'd recovered from the empennage, I thought it was a prank. It was the first of April.

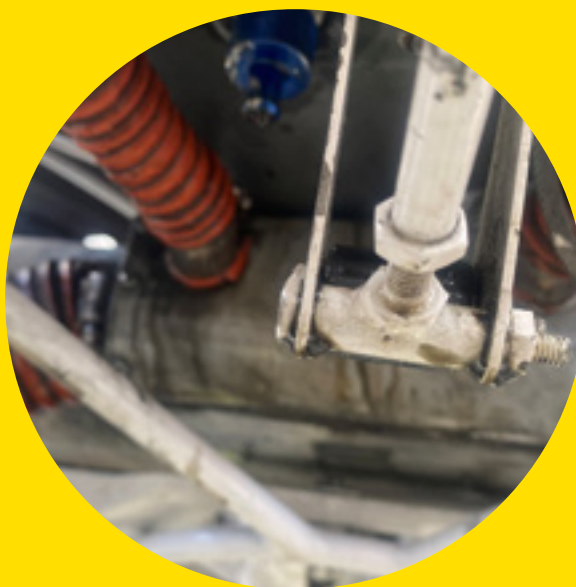
“The engine quit and I ditched on a stop bank. We’re okay, but the plane’s a bit munted.”

Jay – Director of Omake-based JEM Aviation – admits he was confused while driving out to the site of the damaged Piper Arrow, as a prop overspeed would normally be caused by a lack of oil.

His company had only just completed the aircraft’s 100-hour annual. A new oil cooler, oil hoses, and quick drain valve had been fitted.
