# VECTOR

*Pointing to Safer Aviation*

March / April 2002

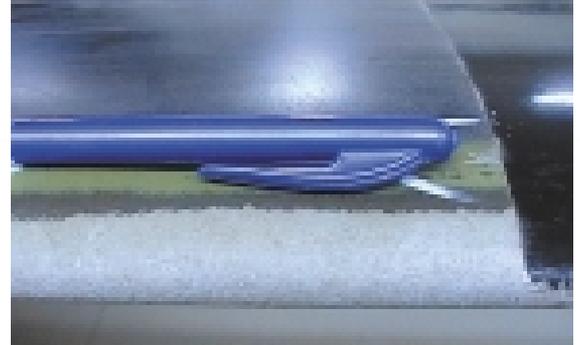
*An example of excessive corrosion of a blade that has done many hours of work. This blade will require refinishing with a good quality primer and top coat system and the application of a leading-edge abrasion strip.*

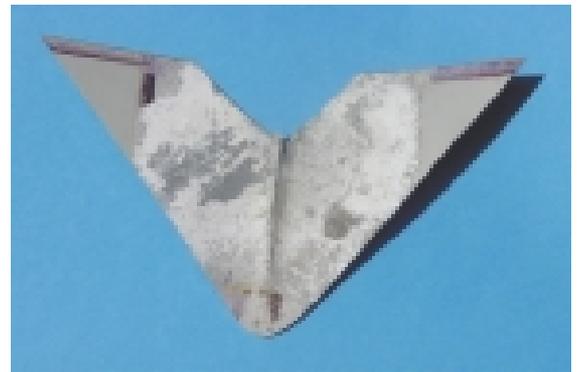
A number of blades, mostly off Schweizer 300 and Hughes 500 helicopters, have had to be scrapped due to severe corrosion caused in this manner. Had these blades been inspected more regularly and, at the first sign of corrosion, referred to a rotor blade repair facility, a repair probably would have prevented them from being scrapped so early in their useful life. In fact, around 80 percent of blades are scrapped due to corrosion before the end of their useful life. (A set of Hughes 500D and Schweizer 300 blades cost around \$117,500 and \$105,000 each respectively.)

*Severe internal rotor blade corrosion.*

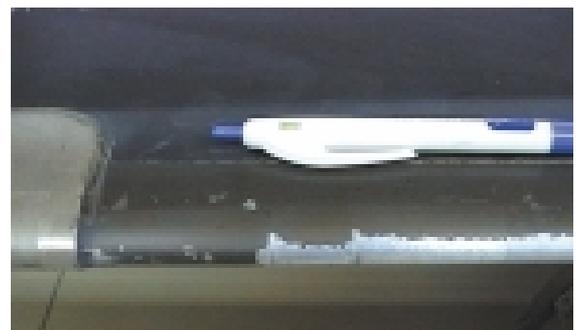
*An example of the 'notch effect' caused at the inboard end of a stainless steel leading-edge abrasion strip. Each time the abrasion strip is replaced, it should be started at a different place on the blade to preclude the leading edge eroding through.*

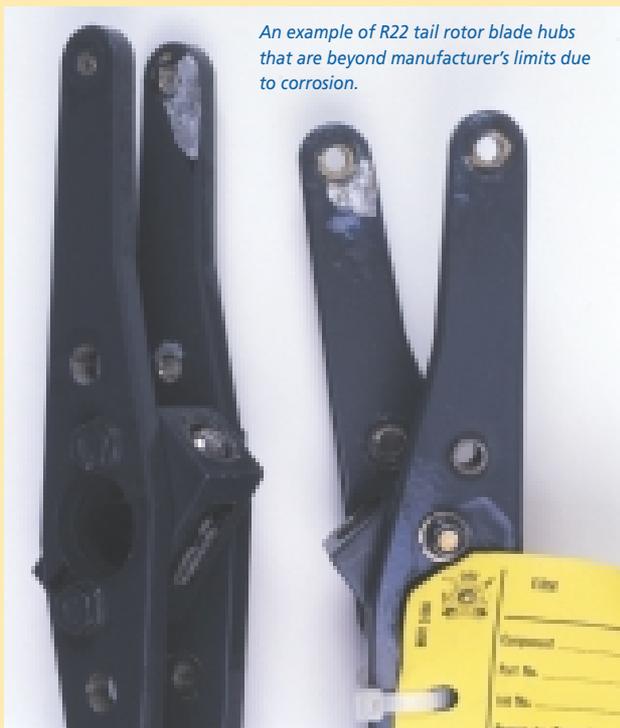
An example of R22 tail rotor blade hubs that are beyond manufacturer's limits due to corrosion.

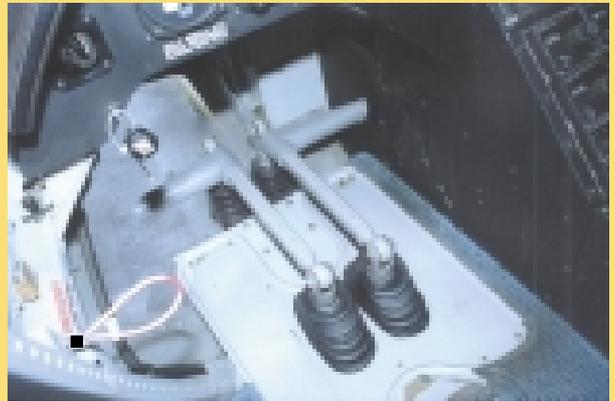
Two BK117 operators recently found that the installation of a dual-pedal cover (designed to protect the yaw pedals from inadvertent interference by a passenger's feet) can limit pedal travel if they are not installed in a particular way. Fortunately, the problem was discovered without any adverse consequences.

The covers are normally supplied with a placard in either English or Japanese, which reads "Caution: Make sure both pedals are fixed in the forward most position before the cover is installed". These particular helicopters had previously been registered and operated in Japan, and thus were fitted with the Japanese placard. There is unfortunately no reference in the helicopter Flight Manual to the installation of the pedal cover, meaning that more far-reaching enquiries had to be made in order to determine what the placard meant.

*The passenger-side yaw pedals of the BK117 involved in one of the incidents.*

The CAA was alerted to the problem, and a letter was sent to all BK117 operators advising them to ensure that all pedal covers carry the appropriate placard and that their pilots be made aware of the problem.

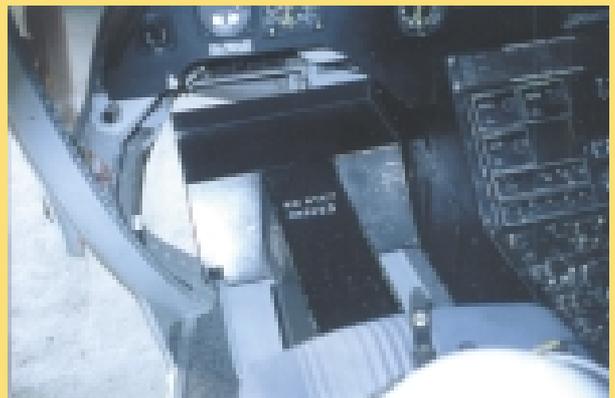
*The same yaw pedals with the dual-pedal cover installed.*
