VECTOR

**Secondary Damage
to Aircraft**

January / February 2005

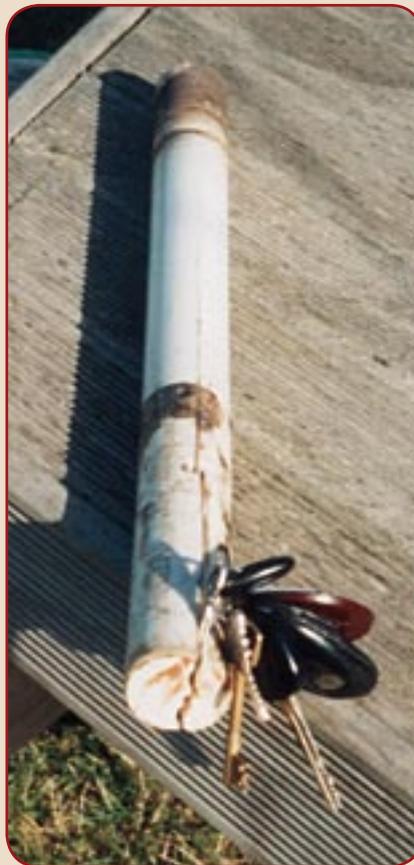
The story then came out about "maybe a heavy landing some time ago". The owner was persuaded to remove the landing gear attachment leg in question. This included the removal of a covering sleeve. Surprise, Surprise! The fibreglass leg had a very noticeable longitudinal crack in it which began under the sleeve. As can be seen from the photograph, a key could be inserted into the upper end of the crack, and it can also be seen that the crack, or material failure, is propagating down the leg.

The leg end with the crack failure was embedded into the fuselage and under a sleeve fairing. At the time of the inspection

The fibreglass landing gear leg with a very noticeable longitudinal crack in it which began under the sleeve. The crack was large enough that a key could be inserted into the upper end of the crack.

and removal, the propagating crack was just making itself visible on the exposed part of the leg.

The concern of the owner and the vigilance of an authorised inspector for the issuing of a microlight Annual Condition Inspection saved us from a nasty incident, or potentially fatal accident. Had part of the leg and wheel separated at a critical point in the takeoff or landing, the microlight is likely to have ‘wrapped itself into a ball’. Had it become airborne after having lost a leg and wheel (assuming no other structural damage on departure) the pilot would have had the unenviable prospect of a two-point landing, with the same ‘flip over and roll-up’ potential. The undercarriage legs on the microlight were replaced with ‘heavy-duty’ legs.

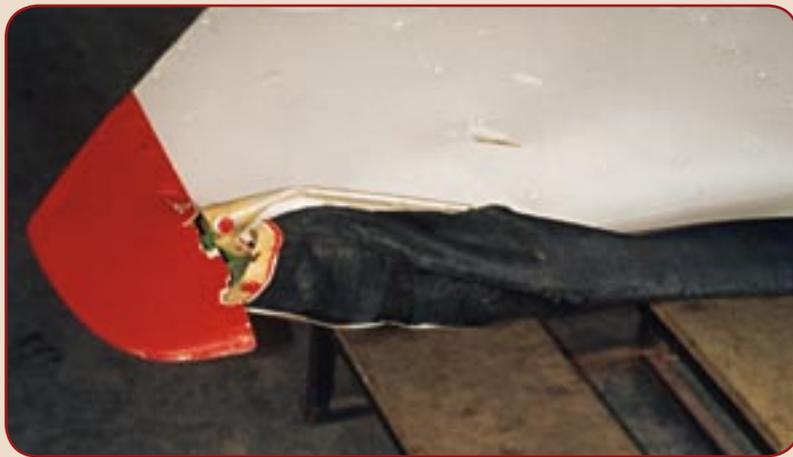
Damaged tailplane from the agricultural aircraft.

The aircraft in question had been well away from its base and owner/operator. In the course of the operations by another pilot, the tailplane had obviously struck something with considerable force. The leading edge had been torn, deformed, and bent back to the spar element in the tailplane. It could not be ascertained conclusively what the tailplane had struck to cause the damage.

The damage to the tailplane was first noticed during refuelling, and in the daily flight record was noted as “stone damage”. The pilot and loader driver present tested the integrity of the structure by pulling it backwards and forwards and up and down. The structure appeared to be ‘firm’. As the wind had risen, preventing further agricultural operations that day, the aircraft was flown to an aerodrome. At this aerodrome persons with engineering backgrounds undertook an external visual inspection of the aircraft. However, no panels or fairings were removed to aid an internal inspection. From this external inspection, the aircraft was deemed ‘safe’ and the agricultural operations were continued over a number of days until the job was completed. On completion of the contracted work, the aircraft was then ferried some considerable distance back to its home base and landed on a

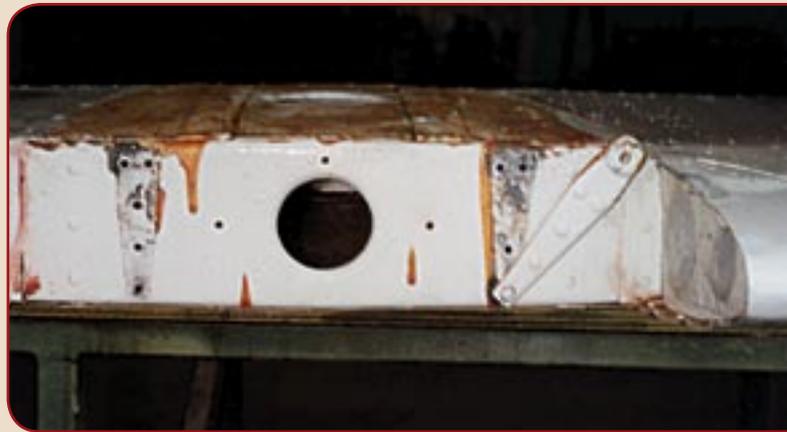
The engineer responsible for the aircraft immediately opened up and removed the tailplane structure. It was found that the starboard (right) mounting bracket of the tailplane had shorn off completely, and that the port mounting bracket was ‘holding on’ by one attachment rivet.

Further inspection on the tailplane revealed that the starboard mounting bracket (on the left in this photograph) had shorn off completely, and that the port mounting bracket was ‘holding on’ by one attachment rivet.

What was holding much of the structure together were the forward fairings between the tailplane and the fuselage and the associated Silafex. How long before the aircraft shed its tailplane, or had it move sufficiently to jam, or significantly disrupt the controls, we fortunately don’t know.

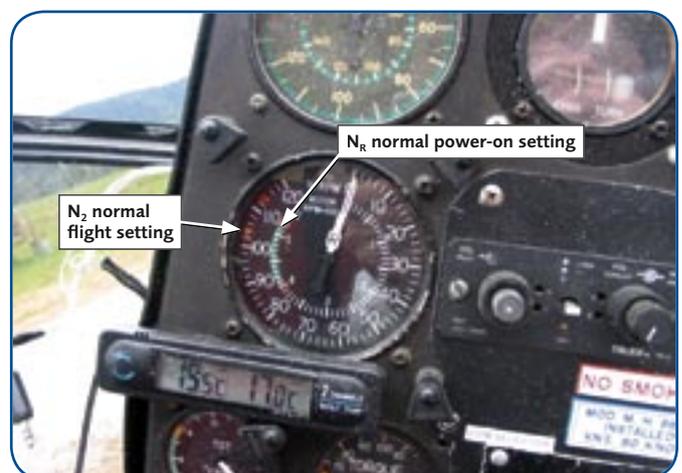
Dual engine power turbine speed (N_2) and main rotor speed (N_R) tachometer.

Investigation revealed that a power turbine governor (PTG) underspeed occurred, when electrical continuity to the governor (beep) switch was lost. Two of the three electrical wires to the PTG switch had become detached during the flight. One broken terminal was for the power supply, and the other was for the beep-up (increase N_2) connection. A panel nut securing the switch to the collective lever was found to be loose, allowing movement of the switch body. Consequently there would have been a constant flexing of the wires, which eventually caused them to break at the soldered connections. The breakage resulted in N_2 reducing to its minimum power setting of 97%.

To prevent a recurrence in other Hughes 369 helicopters, it is recommended that pilots report any switch that appears loose on its mounting (particularly the PTG beep switch) to their maintenance engineer for rectification. Maintenance engineers should check the PTG beep switch for security at the next scheduled inspection. Any switch found to be loose should be thoroughly investigated, to determine the condition of its electrical connections. Any defects found should be reported to the CAA via form CA005 and rectified before further flight.

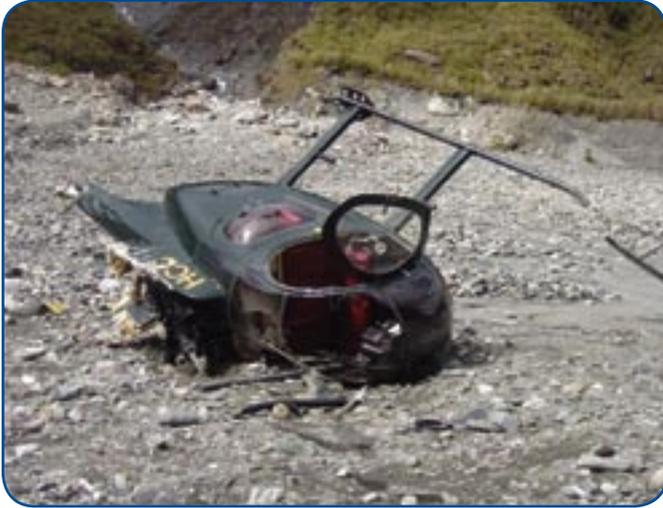
levelled and then sank quickly, striking a large rock with the heel of its right skid. The skid broke, and the helicopter rolled onto its right side, coming to rest with the engine still running. The pilot shut off the fuel to the engine, and then assisted the front passengers from the helicopter. The four passengers on board suffered only minor injuries, and the pilot was uninjured.

ZK-HCC after the accident at the base of the Fox Glacier
