vector

In this issue...

Life Lines	3
After the Quake	4
Don't Swing It!	7
Flying Safely this Summer	8
Handmade Parts – Genuine or Bogus?	11
Cracked Nuts	12
Online Occurrence Reporting	13
New Certification Procedures	14
Standard, but is it Safest?	15
Who's Where at Queenstown	18
What I learned about flying from this	20
New HSE Audit Material	22
Airspace Enquiries	22
Spur-winged Plovers Grounded!	22
Word for Word	23
Flight Testing in Aeroplanes	23
A Reminder from Personnel Licensing	24
Flight Plan Format Changes	24
Time to Order 2010 VNCs	24
The CAA is Moving	25
How to Get Aviation Publications	25
Planning an Aviation Event?	25
Aviation Safety Advisers	25
Accident Briefs	26
GA Defects	27
Summer Traffic Busy Spots	28

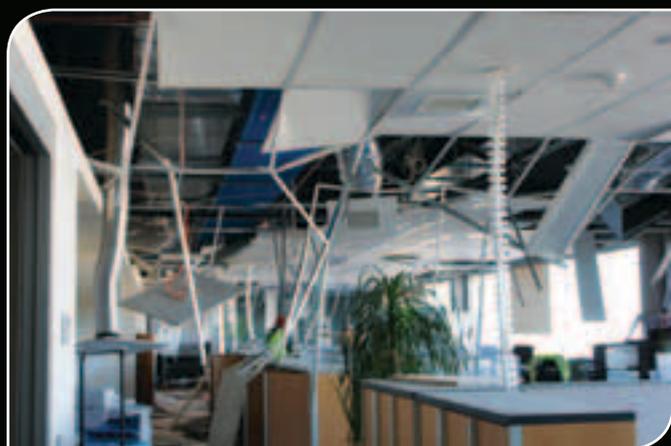
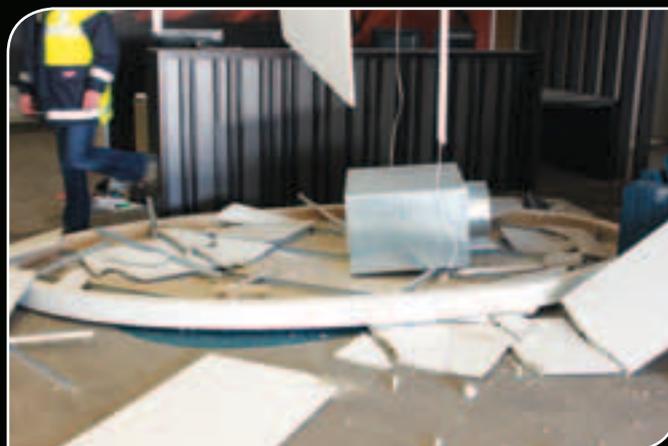
The CIAL corporate office on the fourth floor of the car park building suffered heavy damage. As a result the Emergency Operations Centre was not accessible.

Damage sustained by Christchurch International Airport Limited's offices.

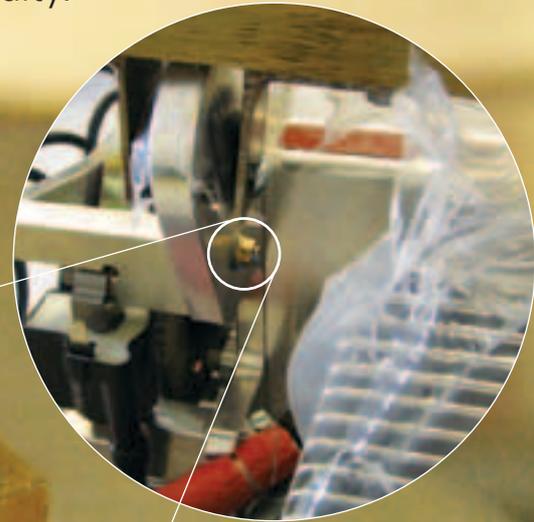
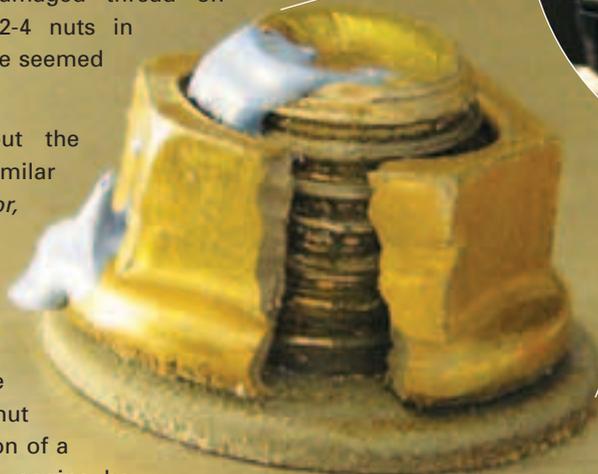
"The bolt easily rotated in my fingers – the MS21042-4 nut had fractured and a piece was actually missing entirely. I think this fracture was precipitated by a damaged thread on the bolt. The three other MS21042-4 nuts in corresponding locations on the engine seemed to be undamaged," says Brian.

The MS21042-4 nut is the cadmium-plated variety of the MS21042L4, which is the lubricated version of the same nut. The cracked MS21042-4 nut that Brian found could be an indication of a similar problem in Australia, as the engine he bought was manufactured in Australia and shipped to New Zealand early this year.

The broken MS21042-4 nut that Brian Anderson found on his brand new Jabiru engine.

Rex says it is important that all owners/operators check their aircraft thoroughly, especially all visible nuts, to see if any of them show signs of failure.

If any failed nuts are found, they should be replaced immediately. They should also be reported to the CAA on a CA005D form, available on the CAA web site, www.caa.govt.nz, "Forms".
