Continuing Airworthiness Notice – 27-013

Control Sticks fitted with a G205 Stick Grip manufactured by The Ray Allen Company

21 August 2019

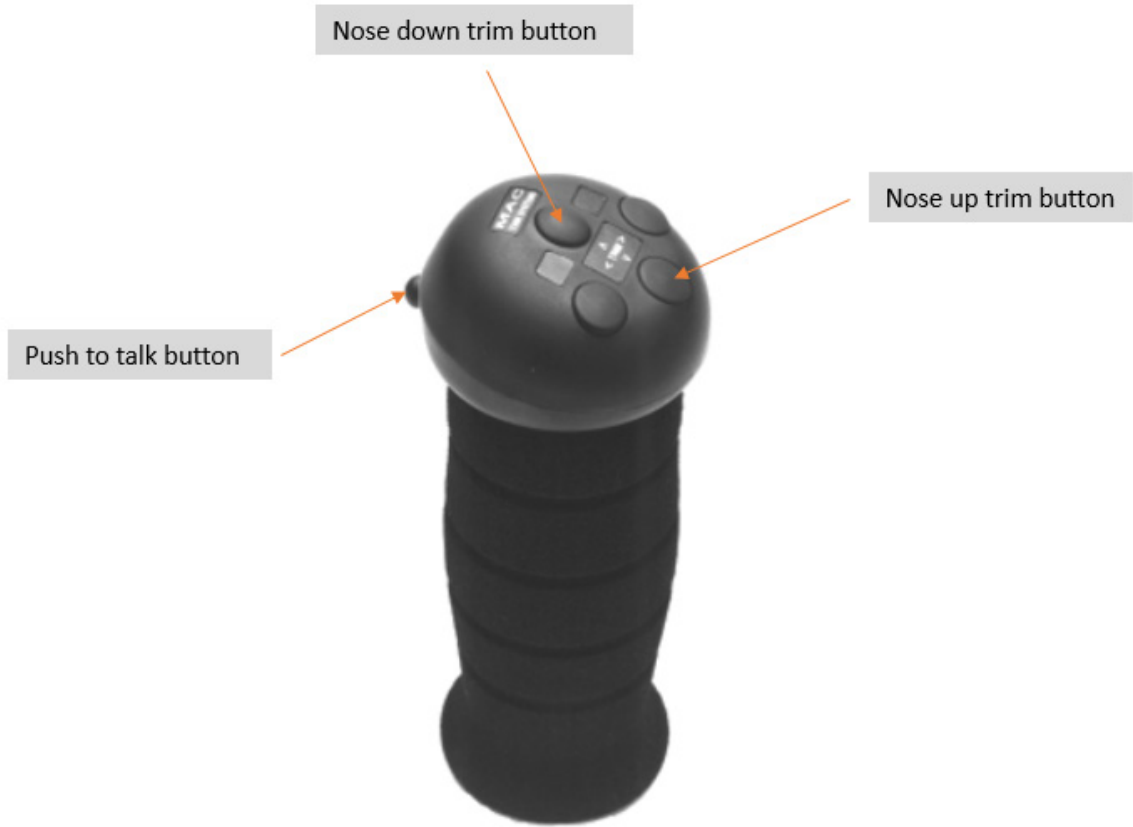
On Rans S-19 aircraft the dual control sticks are floor mounted in front of the seats. Both control sticks are fitted with flush mounted electric trim buttons on top of the stick grip. The forward button activates the nose down trim and the aft button activates the nose up trim. The Push-to-Talk (PTT) button is located on the forward side of the control stick grip. For further details, refer to the photograph below.

The Ray Allen Company, G205 Stick Grip

Due to the design/configuration of the horizontal stabiliser electric pitch trim buttons located on the top of the control stick grip, with no protection from inadvertent trim commands, unintentional activation of the horizontal stabiliser electric pitch trim is possible. The CAA has brought this to the attention of the stick grip manufacturer.

- The ergonomic layout of the electric trim push buttons located on top of the control stick grip on affected aircraft offer no protection against inadvertent trim activation.
- The trim push buttons are also quite sensitive and only require a light touch to activate the electric trim.
- Due to possible inadvertent activation and the speed of the electric trim system, the trim system is capable of quickly trimming the aircraft into a state of an out of trim condition.
- Control stick forces can be significant in an out of trim condition.
