Cessna 150, 152 and A152 Series - Elevator Bellcrank and Bracket Assembly

11 August 2020

This Continuing Airworthiness Notice (CAN) is revised to expand the applicability and bring attention to cracks found in the elevator bellcrank assembly brackets P/N 0411289-1 and P/N 0411290 on a second Cessna A152 aeroplane.

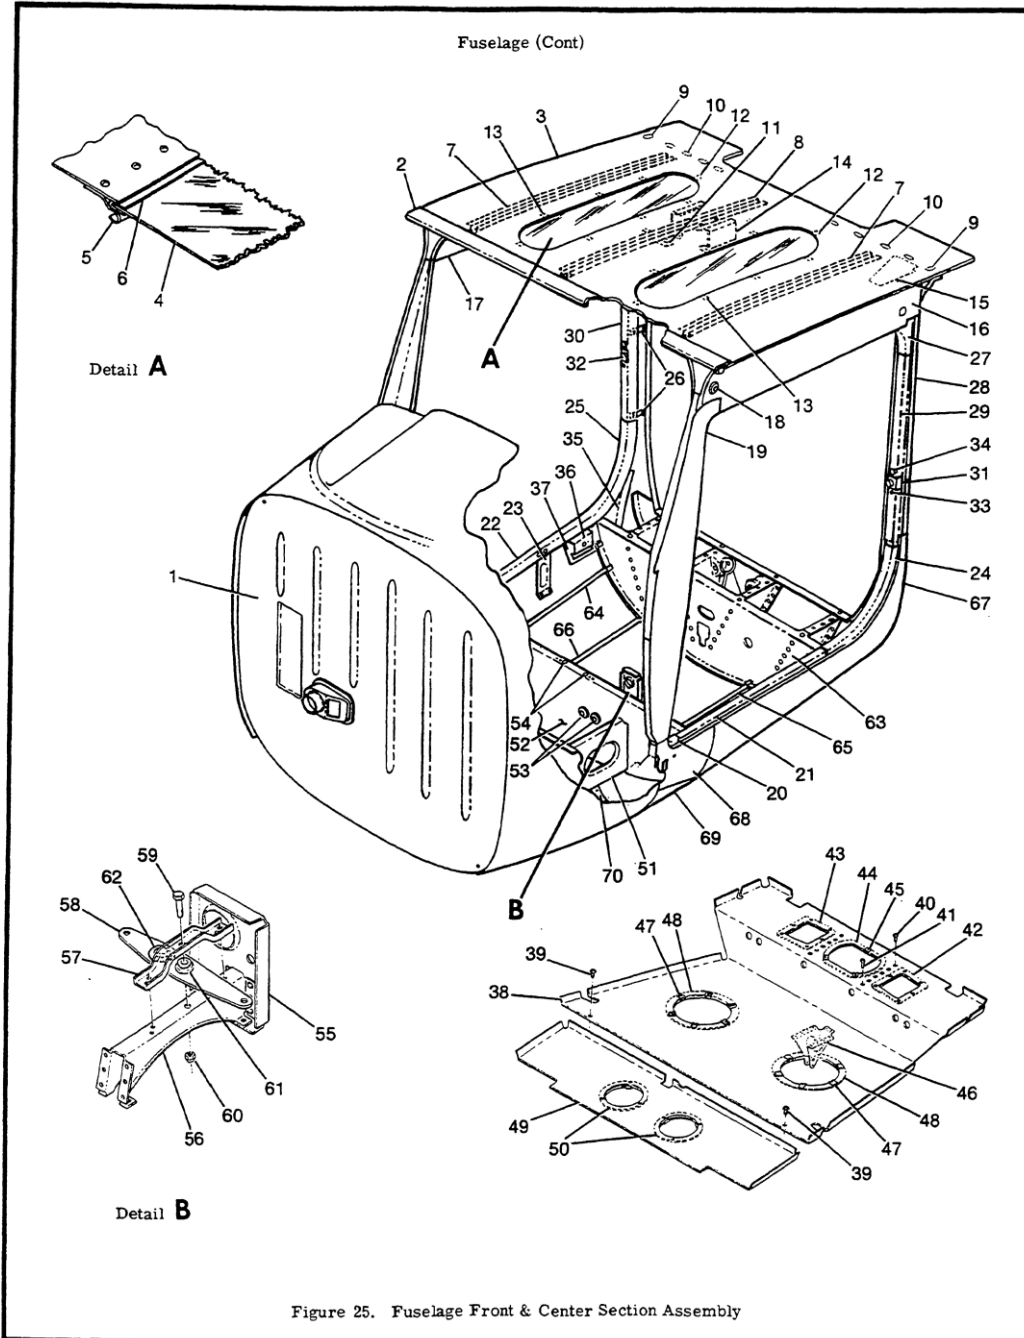
Figure 25 in the Cessna 152 and A152 Parts Catalogue.
For the location of the elevator bellcrank and bracket assembly refer to Detail B in the figure.

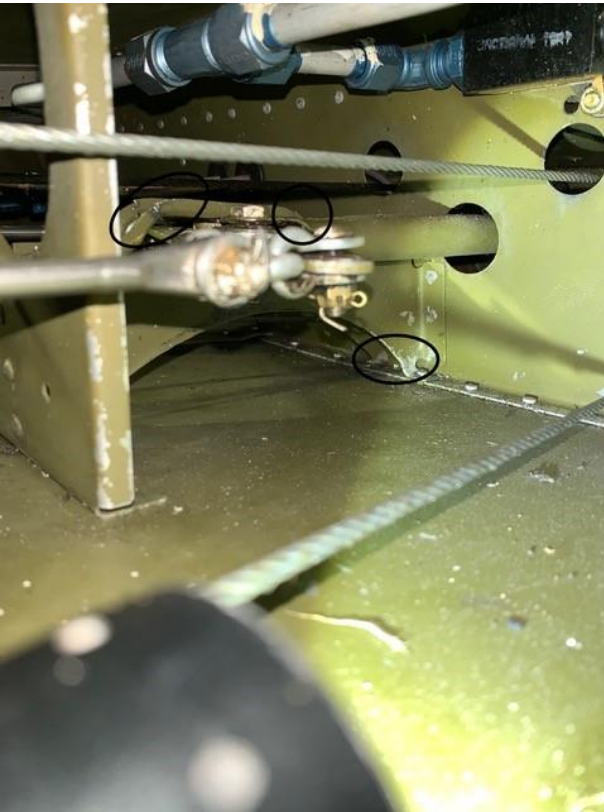
During a 100-hour inspection on a Cessna A152, cracks were found in brackets P/N 0411289-1 and P/N 0411290. These brackets are part of the elevator bellcrank and bracket assembly located below floor level in the forward cockpit area. For further details refer to Figure 25 in the Cessna 152 and A152 Parts Catalogue and the two photos provided in this CAN.

Photo 1: Elevator Bellcrank and Bracket Assembly - Cracks found in upper bracket P/N 0411290 and lower bracket P/N 0411289-1.

The CAA strongly recommends a detailed visual inspection of the elevator bellcrank and bracket assembly located below floor level in the forward cockpit area for any defects, corrosion and cracks at every 100 hour/annual control system inspection.

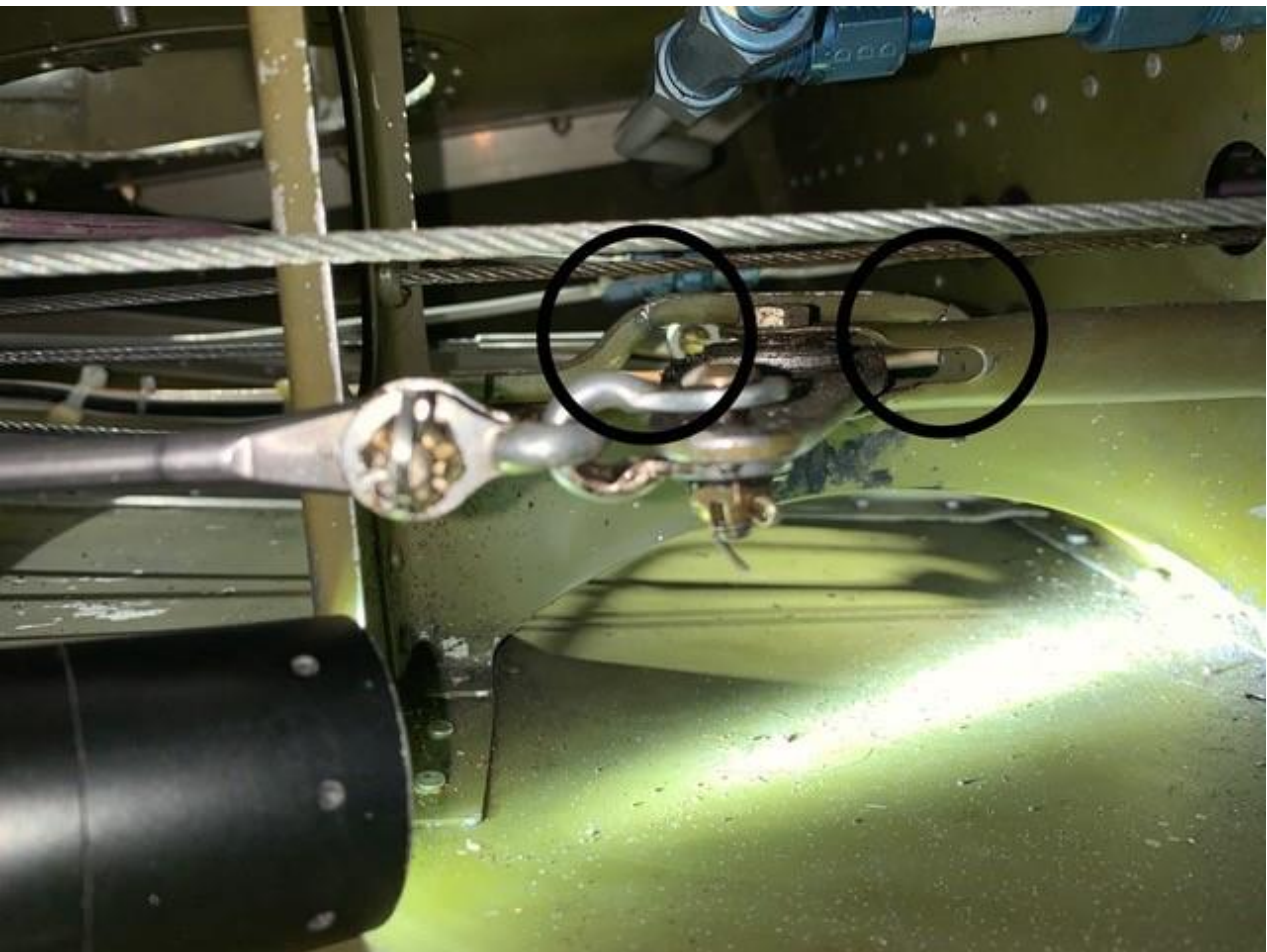
Photo 2: Elevator Bellcrank and Bracket Assembly - Cracks found in upper bracket P/N 0411290.
