Continuing Airworthiness Notice – 74-002

Denso W24EMR-C Spark Plugs – Inspection

10 August 2016

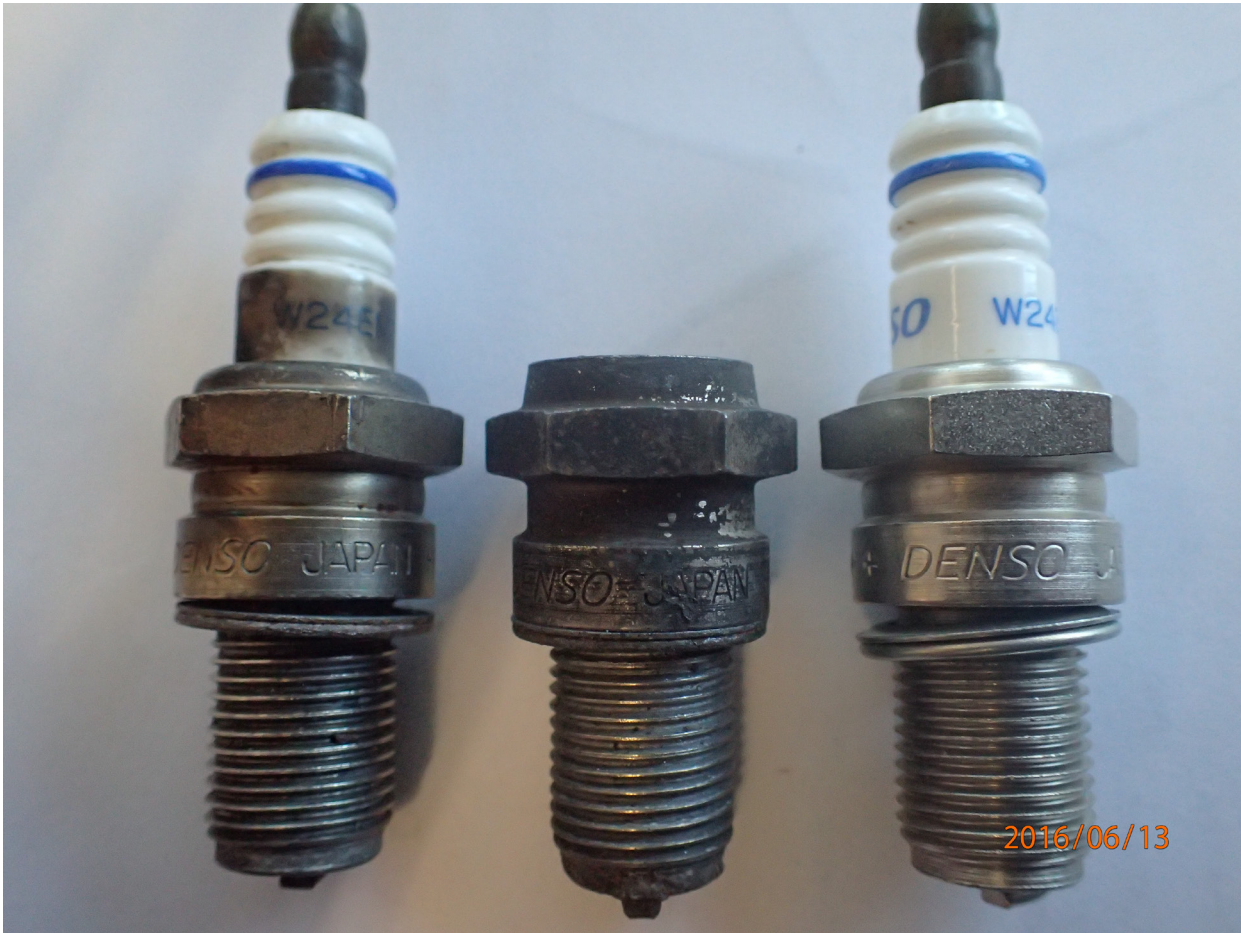
This CAN is prompted by a TAIC investigation of an in-flight fire on a Guimbal Cabri G2. Examination of the engine found that one of the four upper spark plugs fitted to the engine was missing its insulator which appeared to have been ejected.

The centre spark plug in the attached photograph with missing insulator is the faulty spark plug from the aforementioned aircraft. You will notice that the swaging at the top of the plug has not been crimped, and there is also no bulging of the plug body below the hexagon. To the left in the photograph is another plug removed from the affected engine, and to the right is a new plug.

- LH spark plug – A serviceable plug removed from the affected engine.
- Centre spark plug – The defective plug removed from the affected engine (insulator missing).
- RH spark plug – A new spark plug included in the photograph for comparison.

The CAA strongly recommends that operators/maintenance providers inspect Denso W24EMR-C spark plugs for defects. If any defects are found, replace affected plugs before further flight.
