Airworthiness Concern Sheet

Federal Aviation Administration (FAA) Description of Airworthiness Concern

The FAA was notified that a tail skid featuring a J-shaped, hook design as illustrated in Figure 1, manufactured by AirKit LLC under Part Number 16316, has been installed on an FAA type-certificated small airplane. This discovery was made following an incident on a Cessna 172 instructional flight in which the aircraft experienced a minor tail strike. During the strike, the tail skid bracket bent backward and upward, penetrated the rudder's bottom skin panel, and subsequently jammed the rudder. Although the pilot was able to recover without further incident, loss of flight controls may result in loss of control of the aircraft. Photographs of the failed tail skid bracket are shown in Figures 2 and 3.

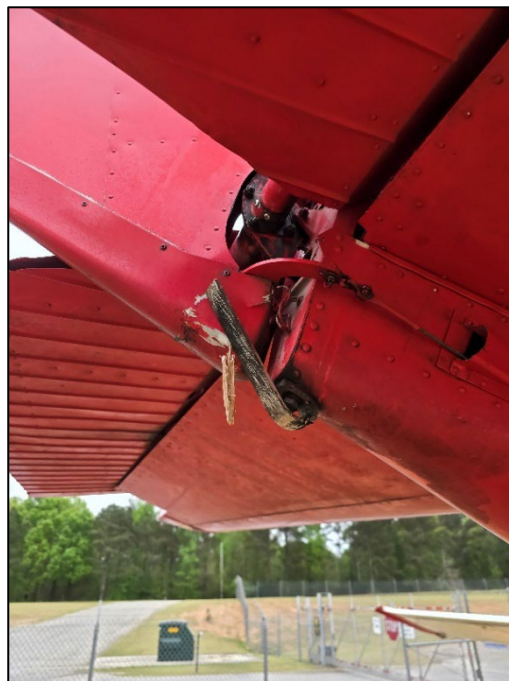
Figure 2. Cessna C172 Tail Skid side view after incident.

The FAA is currently investigating the safety issue. However, through this ACS, the FAA is notifying the fleet of the airworthiness concern, reiterating that the AirKit LLC tail skid, Part Number 16316, is not eligible for installation on type-certified aircraft without further approval, and requesting further information as described below.

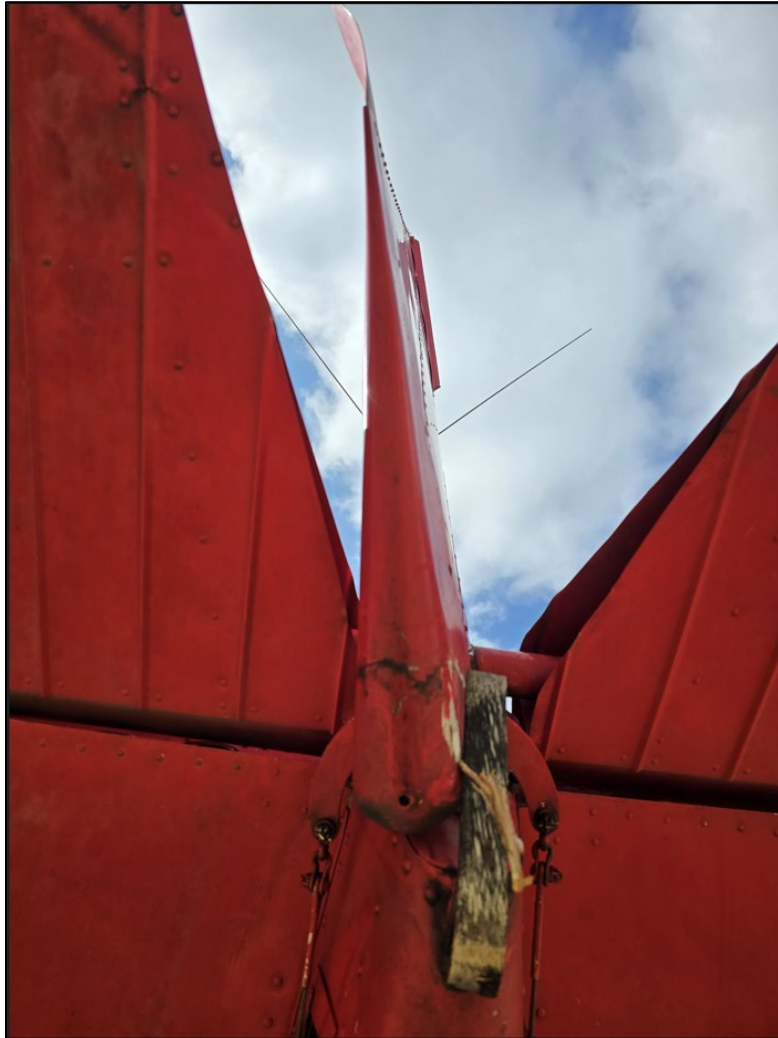
Figure 3. Cessna C172 Tail Skid bottom view after incident.
