## Clutter in the Cockpit

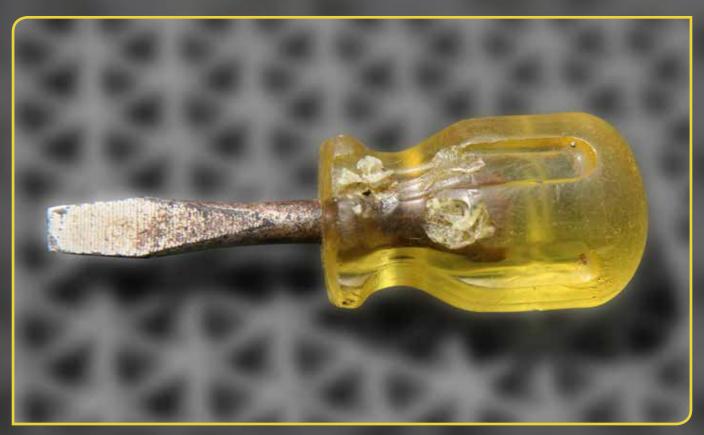
Safety investigators looking into a fatal crash in 2012 concluded that this screwdriver had remained in the rear-most section of the fuselage for some time.

Accident investigators discovered that a screwdriver had been left in the fuselage. It is believed that it restricted elevator control, which did not allow sufficient nose up authority.

The screwdriver showed signs of moisture damage which led the investigators to conclude that it had remained undetected in the rear-most section of the fuselage for some time.

To help reduce the danger of this, the latest version of Yak-52 aircraft now has two Perspex® windows, either side of the aircraft, to allow pilots to inspect the interior during their preflight checks.
