Installation of Ballistic Parachutes

A recent defect reported to the CAA serves as a good reminder about correctly installing and checking your safety equipment.

In February 2018, a mistake was identified with the installation of a ballistic recovery system. An engineer had incorrectly connected a Kevlar® parachute strap when installing a system into a microlight aircraft.

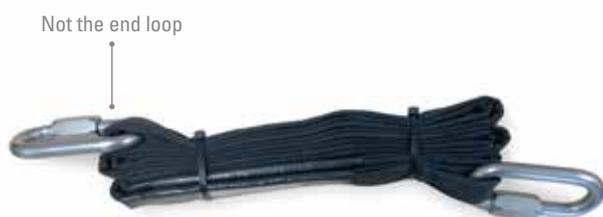
Figure 1 Incorrect installation

The investigation revealed that a carabiner was clipped onto one of the 'looped folds' of the supplied Kevlar strap package (Figure 1).

If activated, this could have resulted in the rocket launching and pulling the Kevlar strap through the incorrectly fitted carabiner, therefore not deploying the parachute.

The maintenance provider advised the manufacturer of the error and suggested that the black heat wrap at each end of the strap be different colours to alert installers where the strap ends are (Figures 2 and 3).

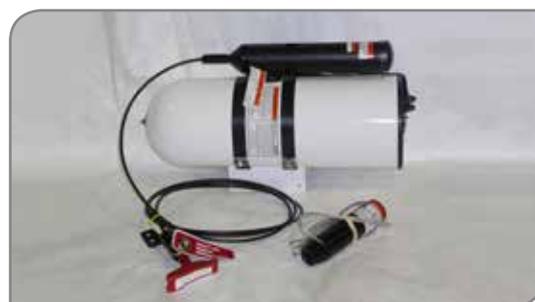
A complete ballistic recovery system showing the rocket (top), the canister holding the parachute, and the firing handle.
