# Airworthiness Directive Schedule

## Engines

### Continental

27 June 2019

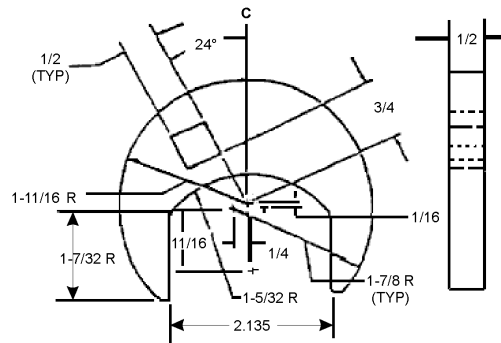
DETAIL A

2. For oil filter adapter assemblies that do have torque putty between the engine filter adapter assembly, nut, and oil pump housing, inspect the torque putty for misalignment, evidence of oil leakage, or cracks.

- (a) Inspect the adapter locking nut installation for evidence of oil leakage.
- (b) Check the torque of the adapter nut installation and ensure that the torque value is within the limits of 50 through 60 foot pounds.
- (c) If evidence of oil leakage is found or the torque is not within the 50 through 60 foot pound limit, prior to further flight, remove the adapter and filter assembly, and:
  - (i) Inspect the threads of the adapter assembly and engine for signs of damaged or cracked threads; and
  - (ii) Replace any adapter assembly and engine oil pump housing (if necessary) that have evidence of thread damage or cracks.
- (d) Apply torque putty between the engine filter adapter assembly, nut, and oil pump housing as specified in the diagram.
- (e) Reassemble the engine oil filter assembly.

If any misalignment, evidence of oil leakage, or torque putty cracks are found, prior to further flight, accomplish the requirements specified in paragraph (1) of this AD, including all subparagraphs.
