**FAA  
Aviation Safety**

## **SPECIAL AIRWORTHINESS INFORMATION BULLETIN**

**SAIB:** 2026-10R1

**SUBJ:** Equipment / Furnishings - Restraint Systems

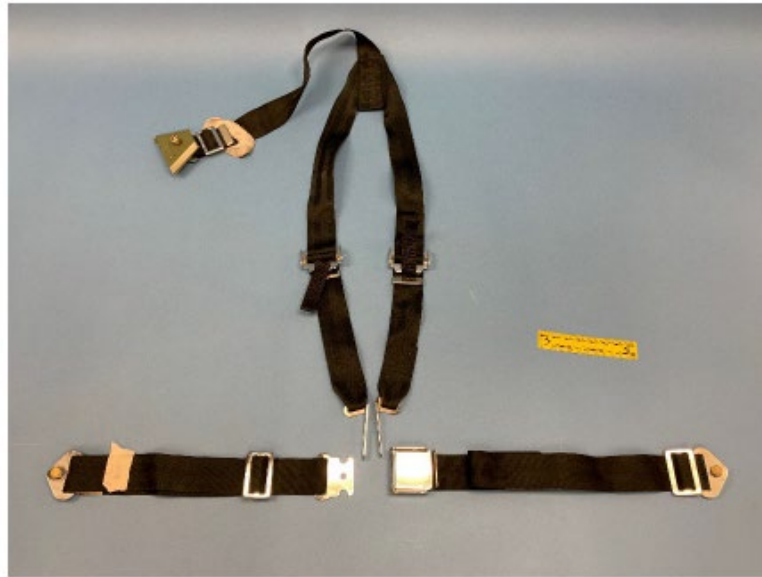
Figure 1  
Four-point restraint assembly

A search of NTSB public dockets identified at least fifteen other general aviation accidents resulting in full or partial failure of the occupants' restraint system. Many of these failures occurred at the Y-junction threading as shown in Figure 2. These accidents often involved serious or fatal injuries of the occupants. Further inspection of the accident findings revealed that these restraints are often designed to obsolete TSO requirements. Minimum torso restraint system performance requirements are currently prescribed in [TSO-C114](#) dated March 27, 1987. Minimum safety belt performance requirements are currently prescribed in [TSO-C22g](#) dated March 5, 1993. Both TSOs provide standards equivalent to SAE Aerospace Standard (AS) Document No. AS8043, "Torso

- Perform routine preflight and annual visual inspections of both the shoulder and pelvic restraints to check for signs of wear, deformation, discoloration, defects, or fraying. Special attention should be paid to the threading on the Y-junction that separates the two shoulder straps and connects to the fuselage attach strap behind the occupant’s head as well as the fastener hardware.
- Report findings of damage to the FAA point of contact. Please include the make, model, and serial number of the restraint and aircraft; a description of the damage; photographs; recommended inspection techniques to locate the damage; the damaged parts’ time in service; and any other information that may assist in our evaluation of this issue.
