## Report on aircraft accident

Case no: **M-01313/AIG-09**

Location: **Keflavik Airport (BIKF)**

Description: **Runway excursion during flight testing**

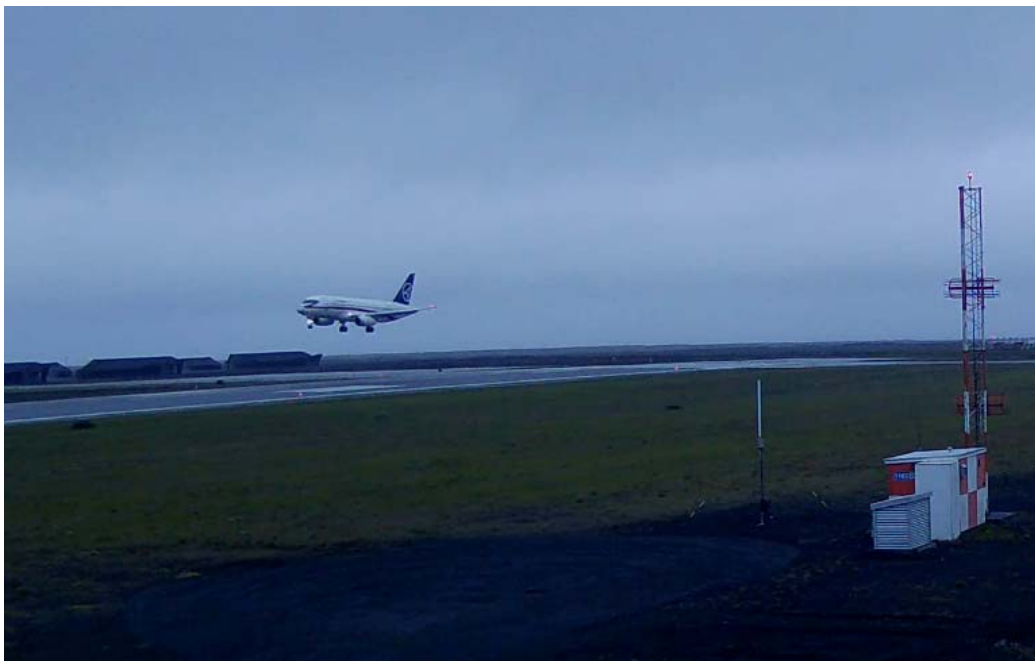
During the final approach to RWY 11 at 05:22:22, the landing gear was selected to down position. See Figure 1. The approach was normal.

**Figure 1: Landing gear down on final approach to RWY 11**

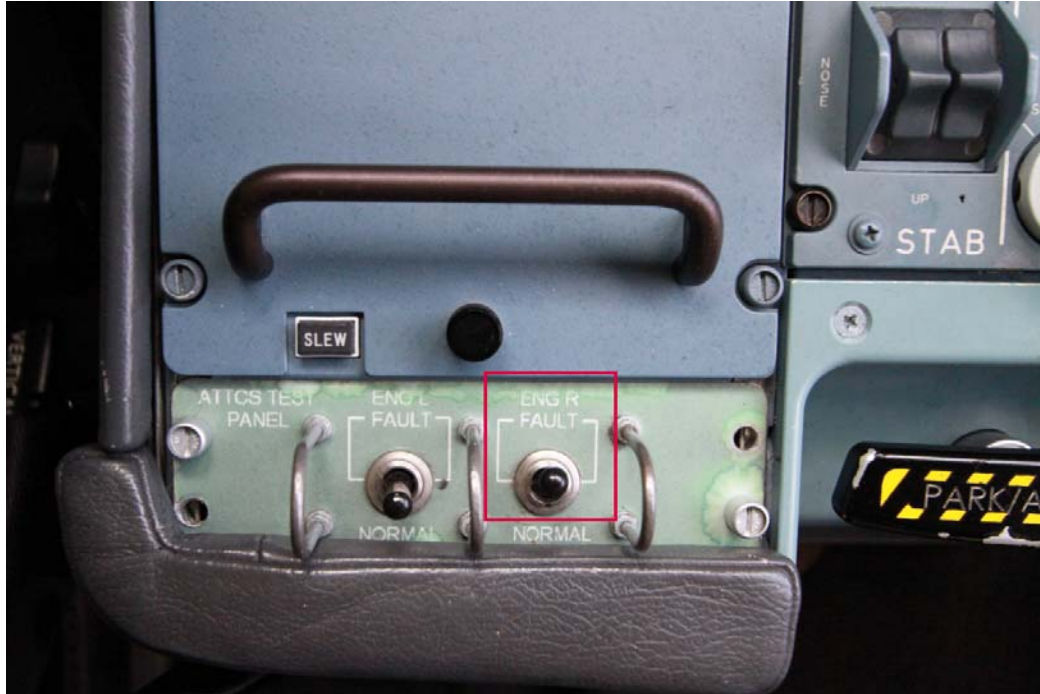
certification expert sitting in the jump seat in the cockpit selected right engine failure on the ATTCS<sup>6</sup> Test Panel located on the pedestal before approach. See Figure 2.

**Figure 2: Right engine fault selected on the ATTCS test panel**

At circling height<sup>49</sup> the flight crew was to set the critical (right) engine switch on the ATTCS TEST PANEL to FAULT (see Figure 2).

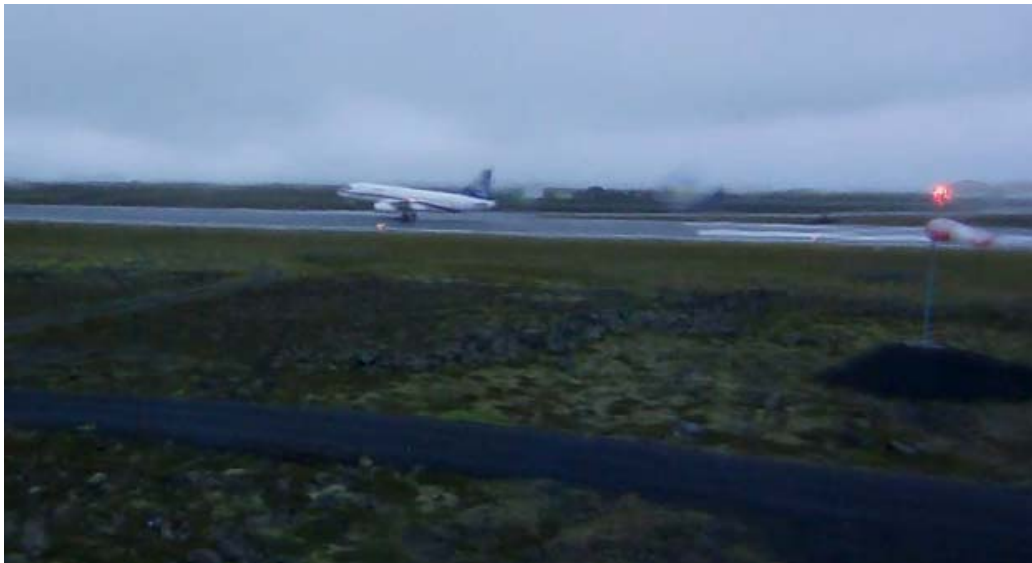
Almost simultaneously, at 05:23:28.70, the main landing gear touched the RW and as a result of left main LG shock strut compression a/c avionics complex received WOW signal (weight on wheels). See Figure 3.

**Figure 3: Touchdown with the landing gear down**

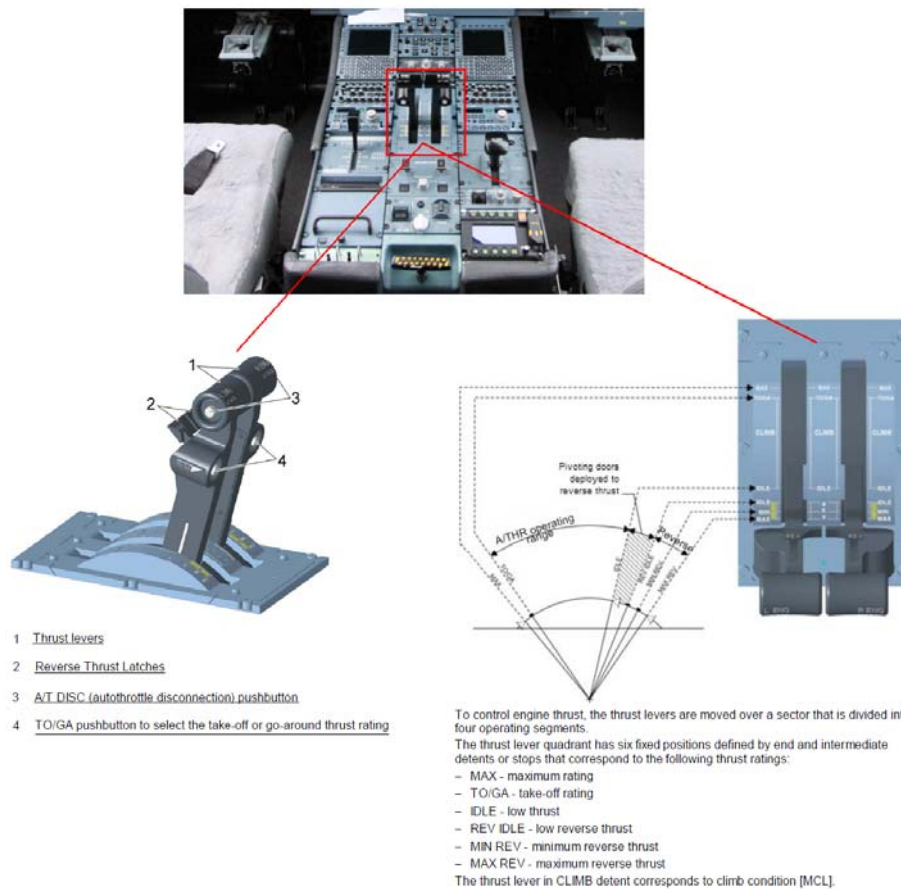
The pilot flying then noticed at the primary flight display that the go-around mode had not engaged when he selected the TOGA switch. Details on this system can be found in Figure 4. The pilot flying also noticed that the FD was not available and that the A/T was switched off.

**Figure 4: Explanation of the TQL and the TOGA**

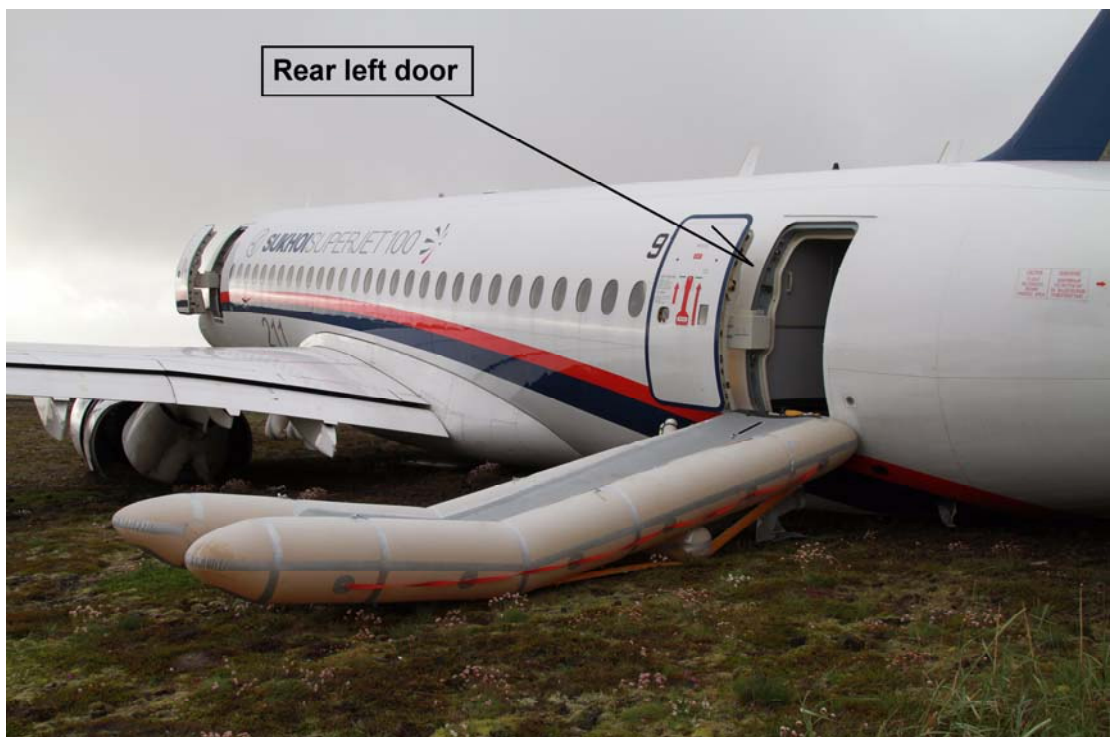
After the airplane had come to a stop, the pilot in command, who was also the pilot flying, ordered an emergency evacuation. The forward left door was opened by the cockpit crew, but the emergency escape slide did not deploy. See Figure 6. The crew member operating the test equipment in the cabin opened the rear left door and its slide deployed. The cockpit crew then opened the forward right door. The slide deployed, but due to the crosswind it blew underneath the belly of the airplane and was unusable. The whole crew evacuated the airplane via the rear left door. See Figure 7.

**Figure 7: Crew evacuated the airplane via the rear left door**

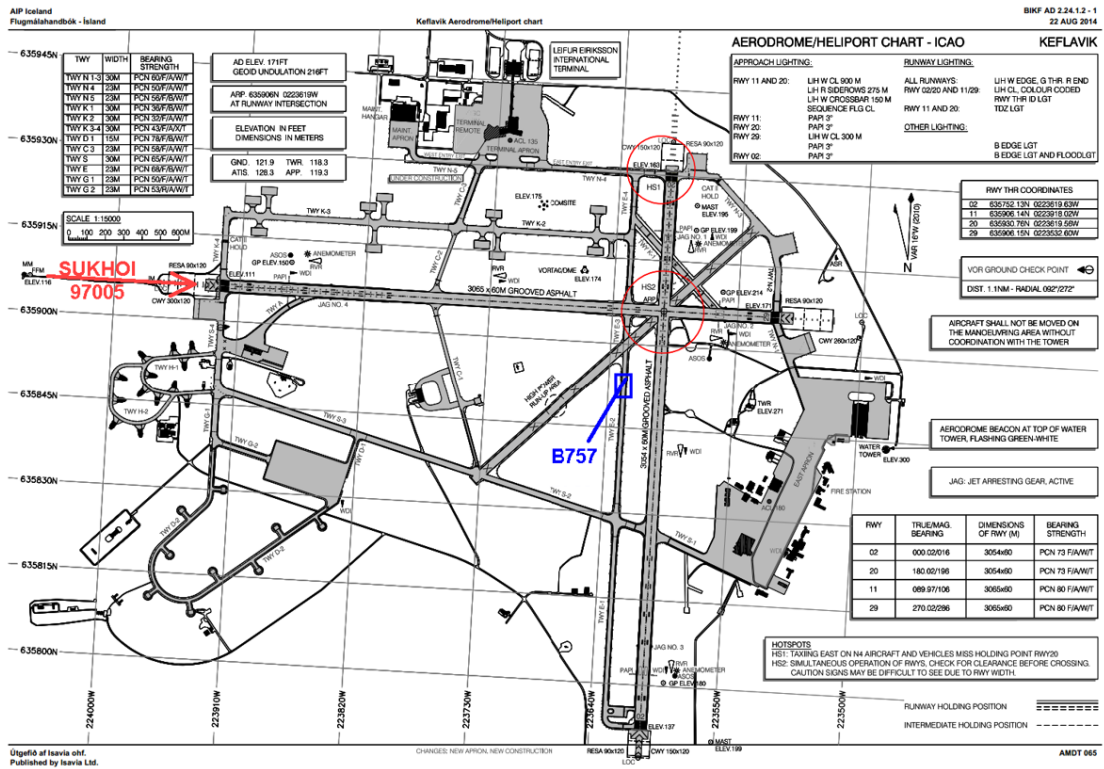
When the Sukhoi 97005 airplane skidded down RWY 11, a B757 airplane that had landed previously on RWY 20 was holding short of RWY 11 on TWY E-2 (Echo), near the end where TWY E-3 begins. See Figure 9 for details.

Figure 9: Chart showing Keflavik Airport (Isavia)

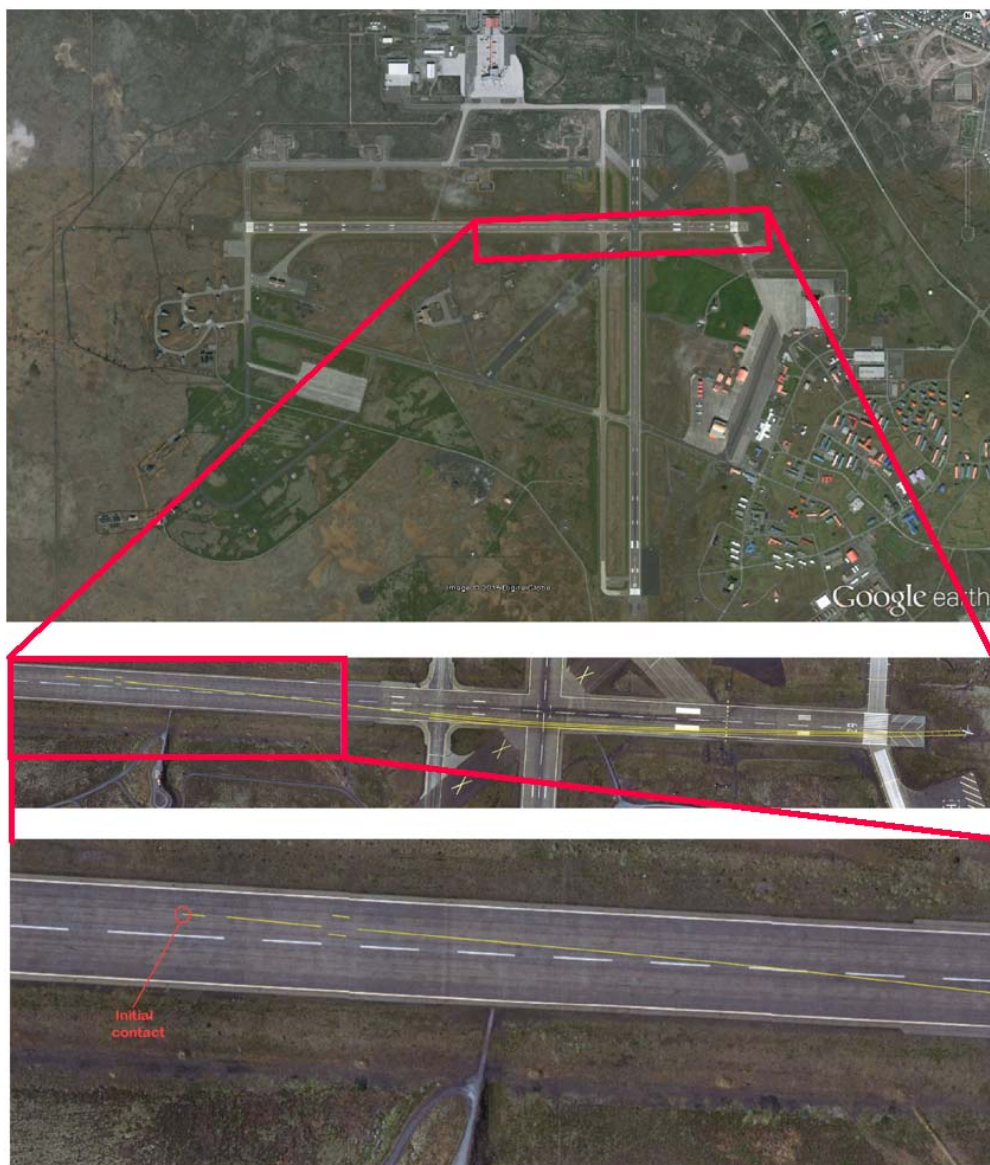
The airplane landed on RWY 11 on its lower aft fuselage belly left of the center line, about 360 meters beyond TWY C1/C2. The airplane then skidded 1.6 km down the runway and came to rest after having passed 163 meters beyond the threshold of RWY 29.

Figure 10: Keflavik Airport (BIKF) and RWY 11 (view in red enlarged twice)

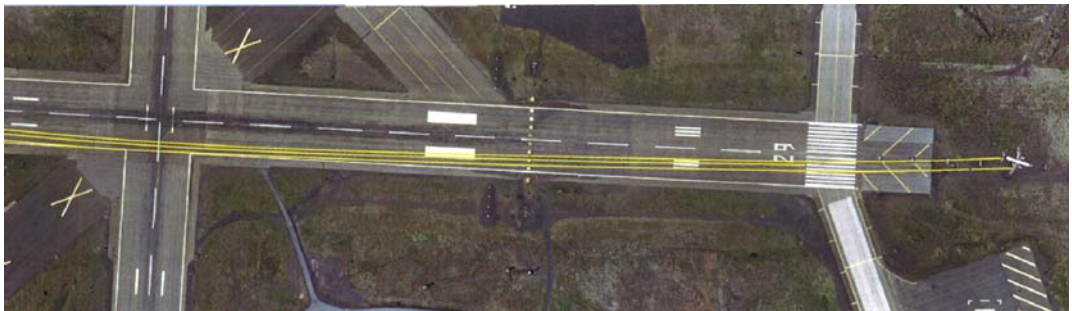
**Figure 12: Airplane at RWY 11 right edge when crossing RWY 20**

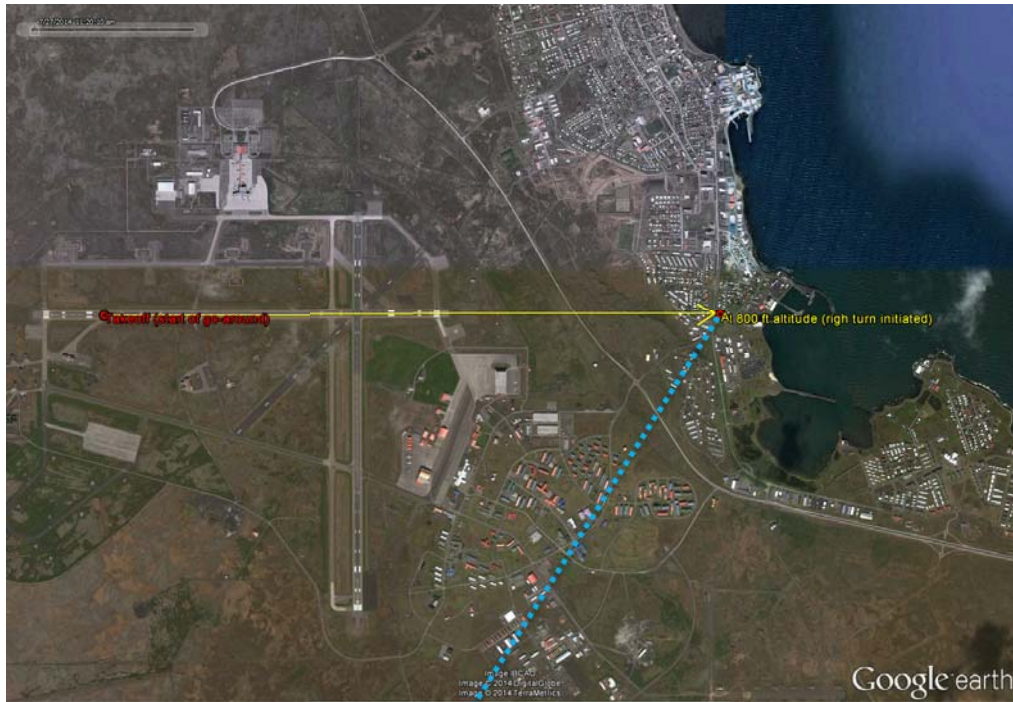
The investigation revealed that the flight testing of an airplane on RWY 11 at Keflavik Airport would take the airplane over populated residential area in Innri-Njarðvík, Reykjanesbær, at minimum clearance altitude with one engine inoperative, during the take-off section of the testing. See Figure 17 and Figure 18 for details.

Figure 17: Calculated track from takeoff to 800 feet altitude under test condition

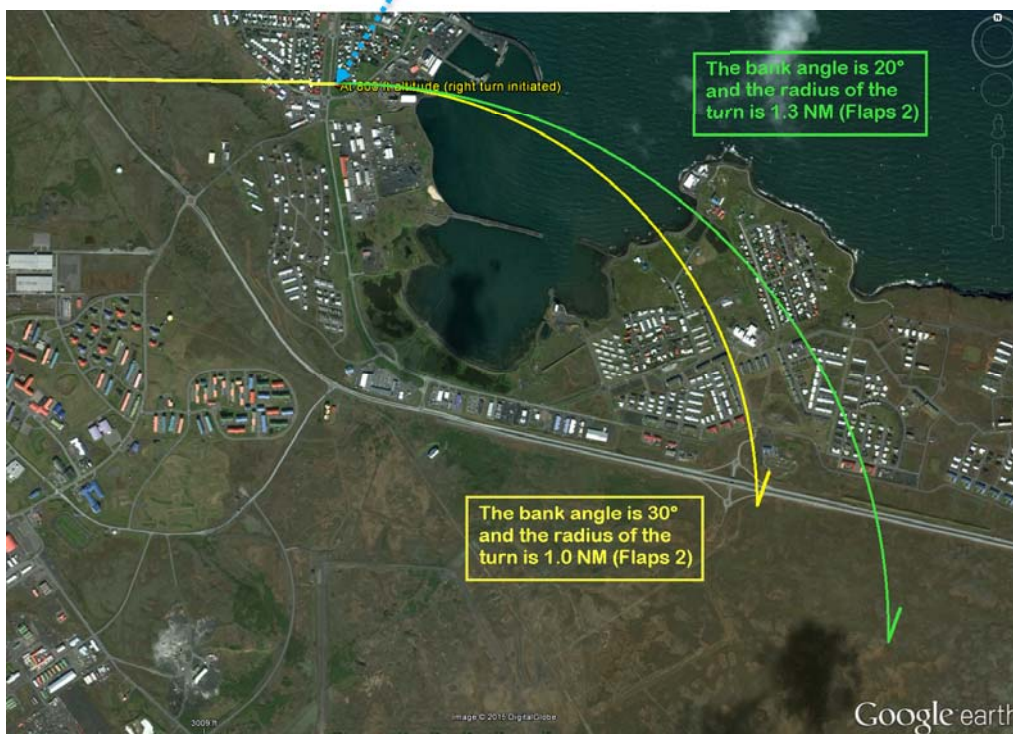
Figure 18: Turn based on right turn at 800 feet altitude for 20° / 30° bank angle
