## CAA SAFETY INVESTIGATION REPORT

# Controlled flight into terrain

## ZK-COM Cessna 172G

CAA Final report 21/529

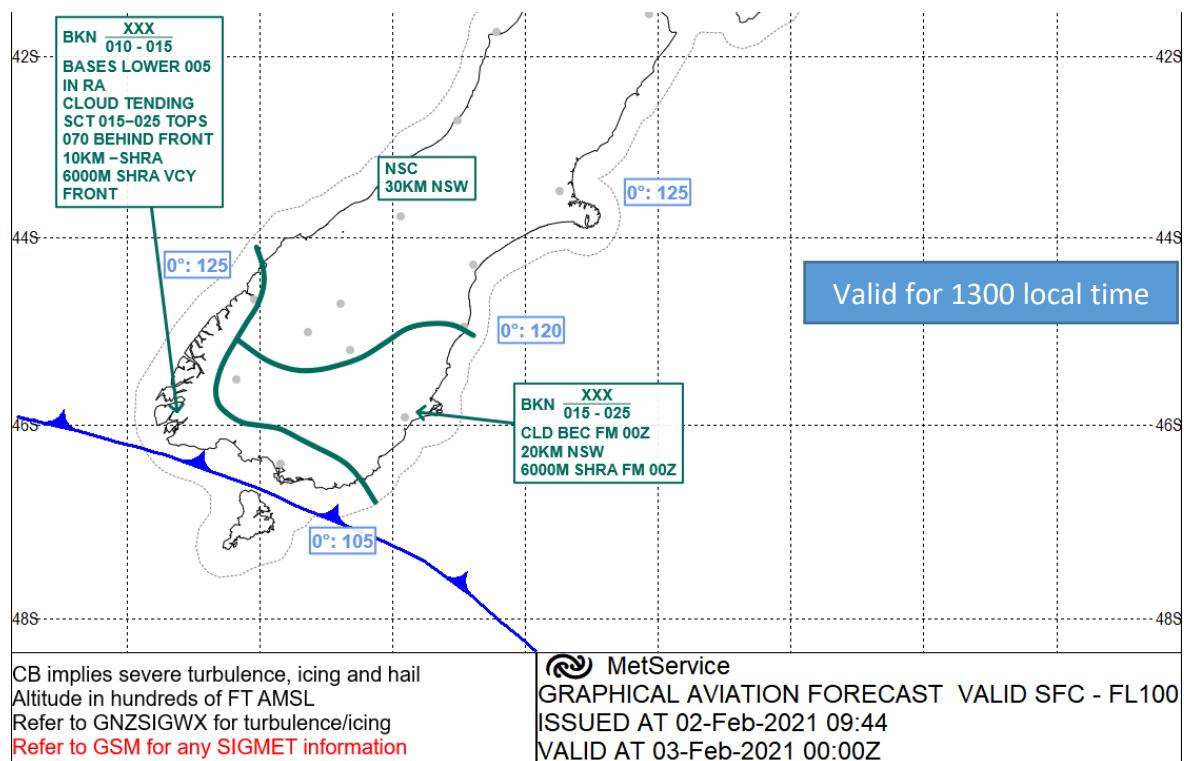
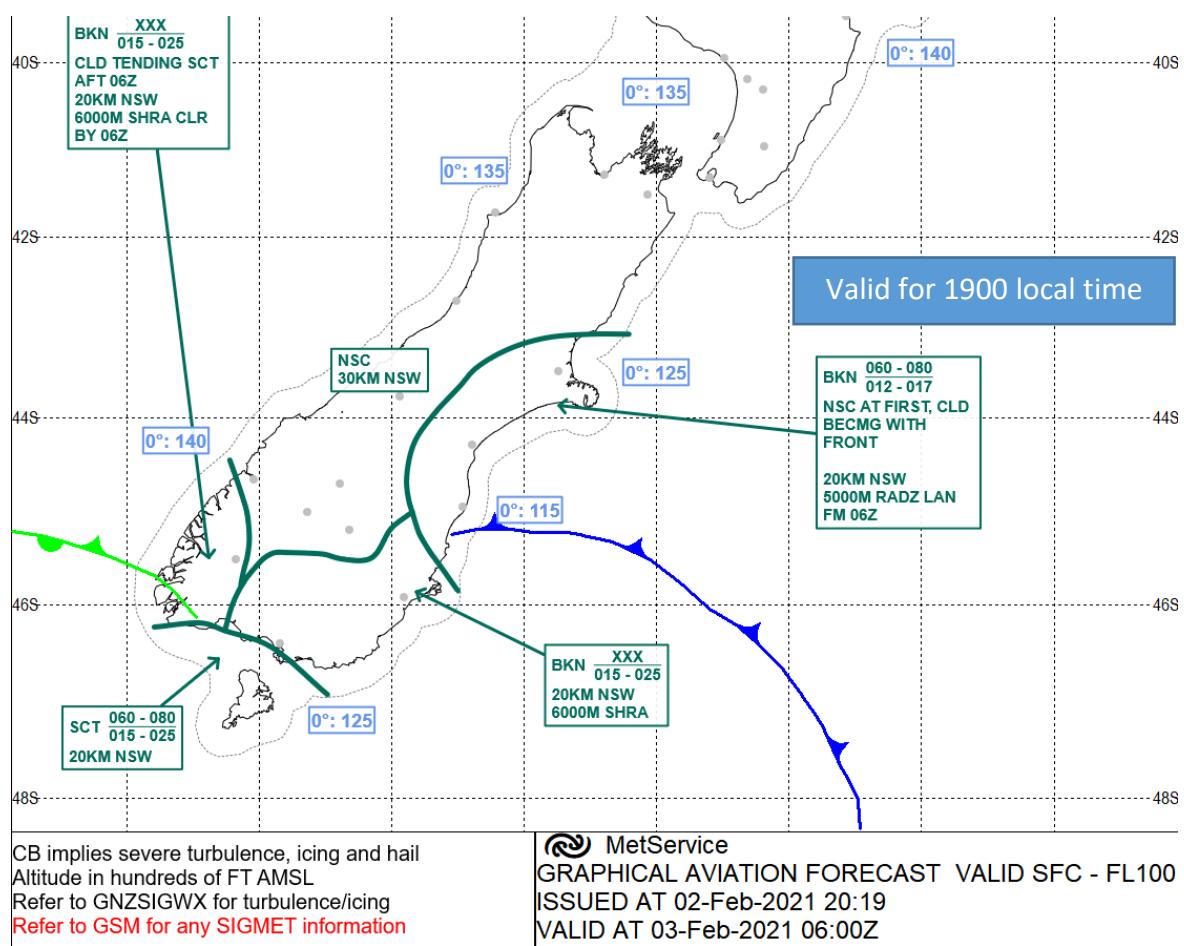
## Appendix A: Metservice weather forecast

The closest aerodrome forecast to the point of departure and the accident site was Alexandra, and this forecast a change of the 2000 feet AGL wind to 15kts from the south between 1600 and 1800. The closest aerodrome forecast to the destination was Invercargill, which initially forecast southerly wind and broken<sup>6</sup> cloud cover at 3000 feet AGL, with rain and broken cloud at 1200 feet AGL temporarily between midday and 1700.
