CAA OCCURRENCE 22/204

SCHEMPP-HIRTH DISCUS-2b

ZK-GZP

DEPARTURE FROM CONTROLLED FLIGHT

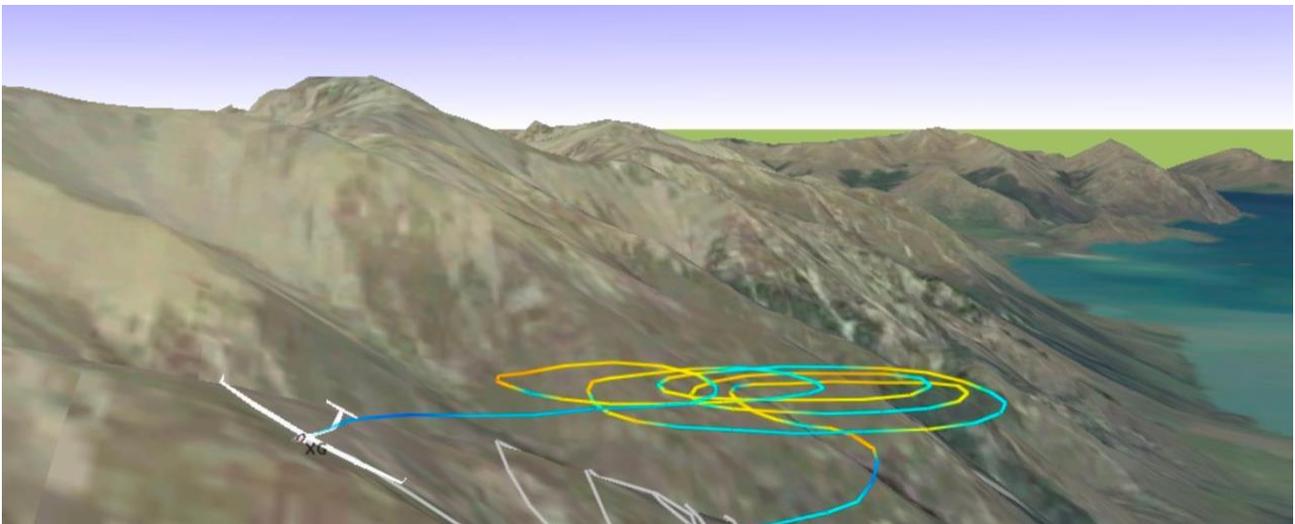
Fig 12: Late Decision to Stop Circling

In this fatal crash the pilot was circling to the right without gaining any height, but was drifting towards the mountain. After five circles he started to roll the glider from a right turn to a left turn. There was a sudden loss of energy due to leaving the thermal (even though it was weak), plus the glider now had a tail wind component which had the same effect as a gust from behind. The turn away from the ridge was started too late, and took longer than expected. The sudden loss of energy meant that the pilot was unable to complete the turn before the glider impacted the ridge. If the pilot had kept turning to the right it was estimated that he would not have hit the mountain.
