**AIRCRAFT ACCIDENT REPORT**  
**OCCURRENCE NUMBER 02/1167**  
**NZ AEROSPACE FU24-950**  
**ZK-EGO**  
**12 KM SOUTH-SOUTH-EAST OF MASTERTON**  
**19 APRIL 2002**

### OCCURRENCE No 02/1167

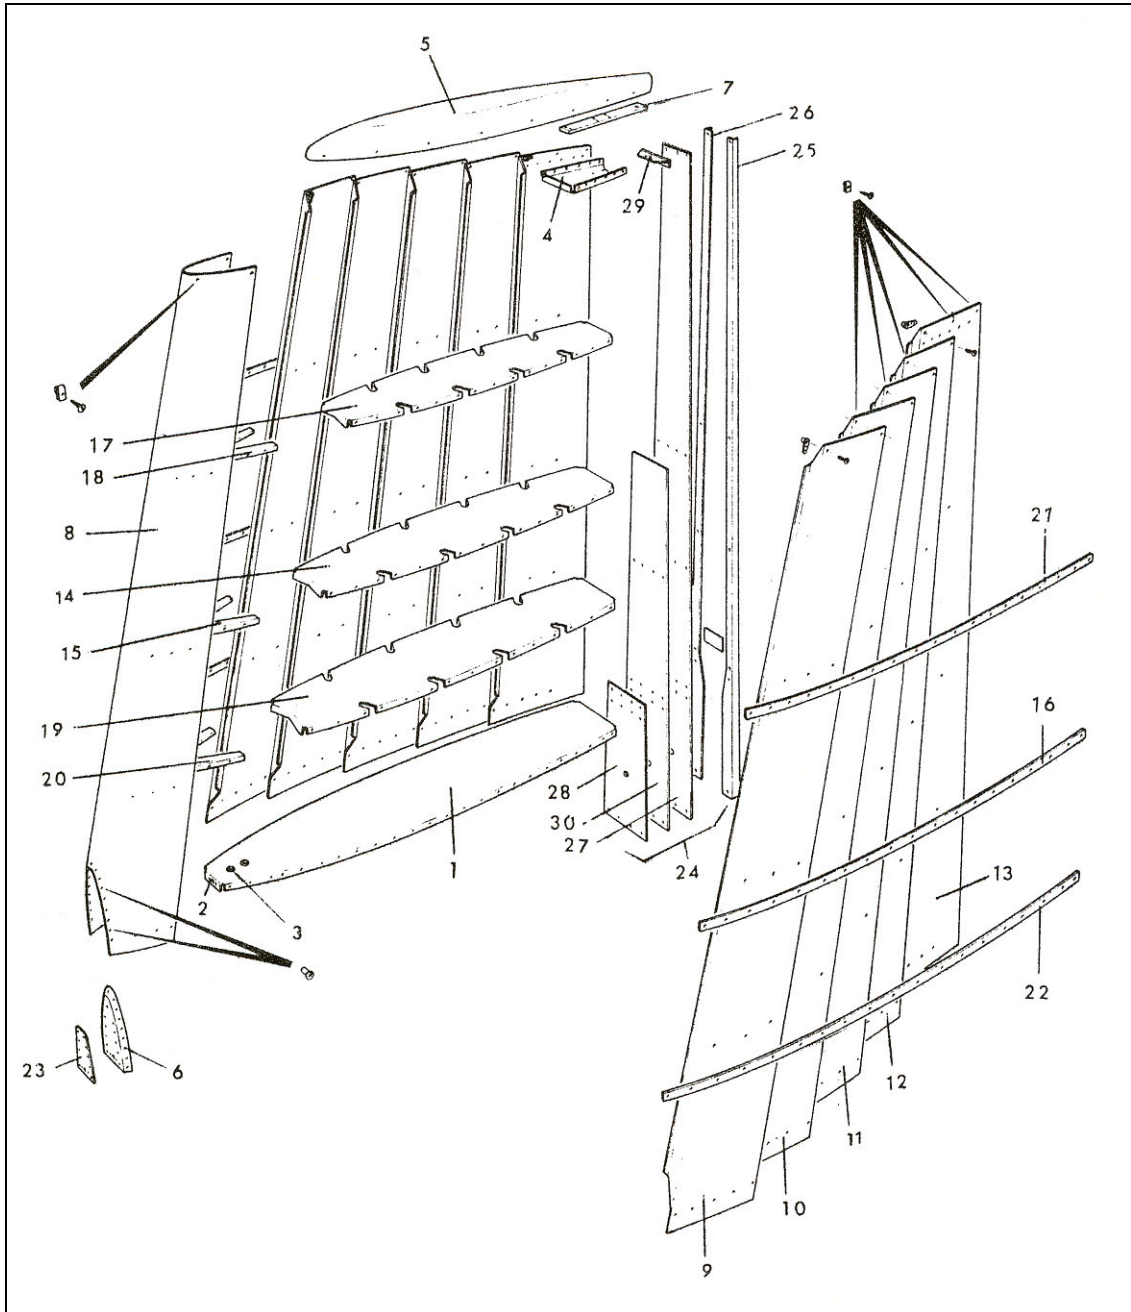
**Figure 1: fin construction**

(8 is the leading edge skin; 6 and 23 are the forward bulkhead and doubler plate respectively; 24, 25 and 26 comprise the rear post assembly.)

1.12.6 It was found that the fin leading edge skin had failed in the area of the forward bulkhead, which remained attached to the corresponding fuselage fitting. The fin post had failed in overload, the fracture surface indicating that the fin had rotated downward and to the left as it departed. Mutually compatible impact marks indicated that the top of the fin had struck the leading edge of the tailplane during the departure sequence.

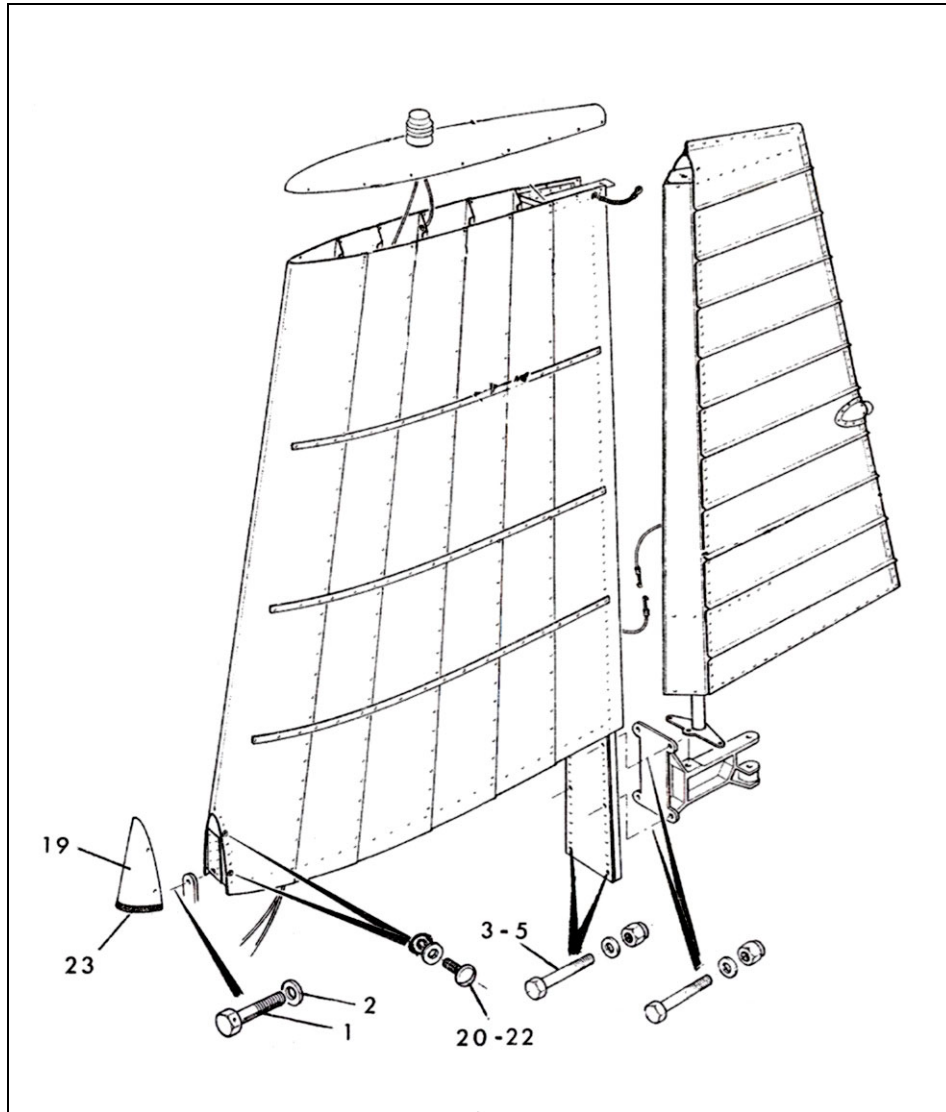
**Figure 2: fin and rudder assembly**

(19 is the forward fairing, to the right of which can be seen the fuselage attachment point. The fairing is attached by two screws each side, which mate with captive nuts inside the bulkhead flange.)
