**AIRCRAFT ACCIDENT REPORT**  
**OCCURRENCE NUMBER 04/39**  
**ROBINSON R22 BETA**  
**ZK-HXT**  
**10km NORTH EAST OF TAUPO**  
**10 JANUARY 2004**

### OCCURRENCE No 04/39

<b>Aircraft type, serial number and registration:</b>	Robinson R22 Beta ZK-HXT
<b>Number and type of engines:</b>	1 Lycoming O-360-J2A
<b>Year of manufacture:</b>	2000
<b>Date and time:</b>	10 January 2004, 1130 hours <sup>1</sup> (approx)
<b>Location:</b>	Near Lake Rotokawa , 12 km NE of Taupo Latitude <sup>2</sup> : S 37° 14.4' Longitude: E 175° 14.1'
<b>Type of flight:</b>	Private
<b>Persons on board:</b>	Crew: 1 Passengers: 1
<b>Injuries:</b>	Crew: 1 fatal Passengers: 1 fatal
<b>Nature of damage:</b>	Aircraft destroyed
<b>Pilot's licence:</b>	Private Pilot Licence (Helicopter)
<b>Pilot's age:</b>	50 years
<b>Pilot's total flying experience:</b>	200.45 hours, 22 on type
<b>Information sources:</b>	Civil Aviation Authority field investigation
<b>Investigator in Charge:</b>	Mr T.P. McCready

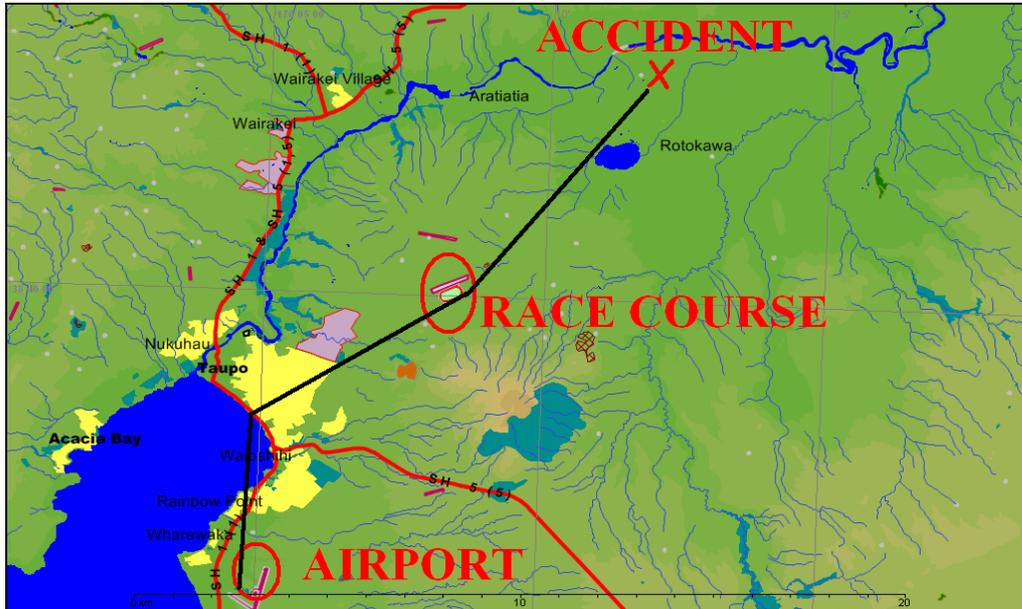
**Figure 1: Flight was from runway 17 at Taupo Airport to the lake front and overhead the race course to the accident site NE of Lake Rotokawa.**
