CAA Safety Investigation Report

Collision with terrain

ZK-ING, Hughes Tool Company H269B

CAA Final Report 13/5710

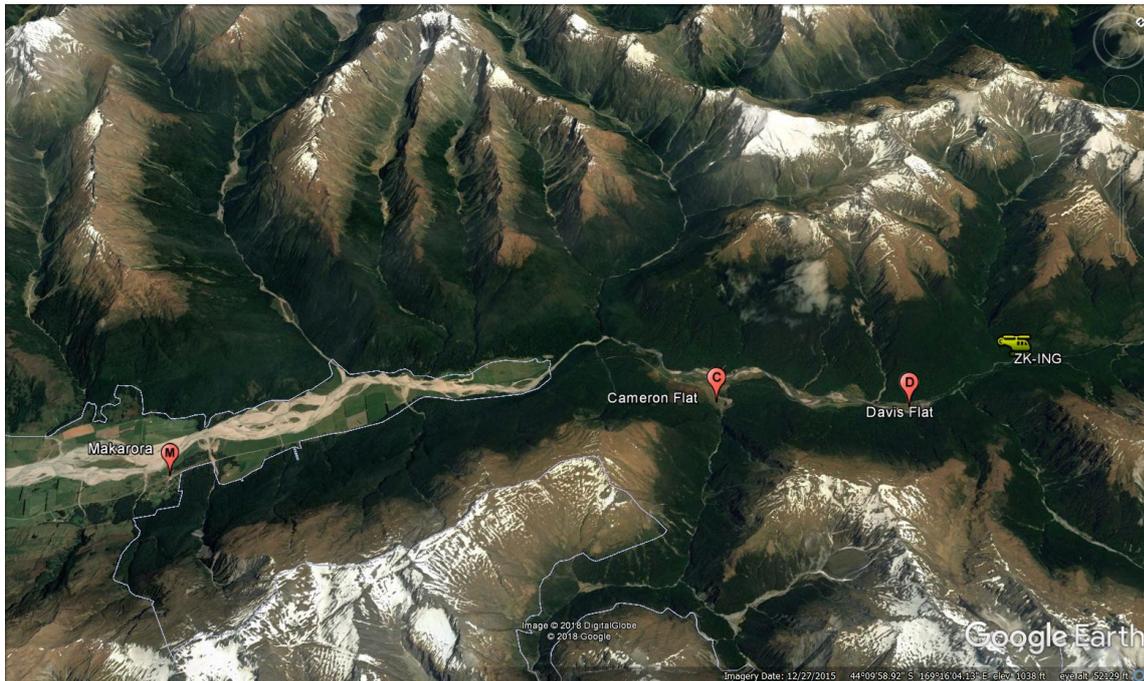
Figure 1. Image of Makarora and Haast Pass indicating accident site. (adapted from Google Earth)

The accident occurred within the Haast Pass where open plain river flats change to more dense native forestry. The accident site was 2.4 km from Davis Flats (Figure 1.), a significant open landing area. State Highway 6 would be positioned to the left of the aircraft as it travelled north toward Haast. The presence of cloud near the site at the time of the accident was likely due to the narrowing of the Pass. The development and sustaining of cloud would have been aided by vegetation coverage in the forest. A helicopter operating in a high level of relative humidity could quickly create localised cloud which could envelope it.
