Loss of control during approach to land

ZK-JRX Van's Aircraft Incorporated RV-4

17 December 2018

CAA final report 18/8850

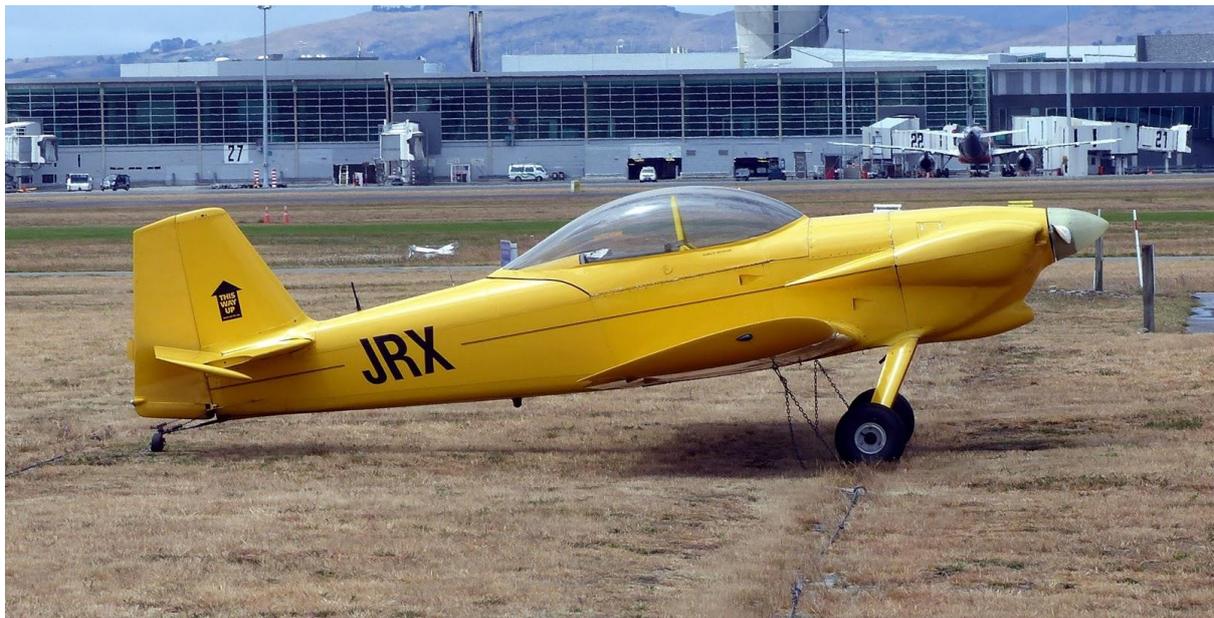
Figure 1: ZK-JRX (Photo source NZ Civil Aircraft)

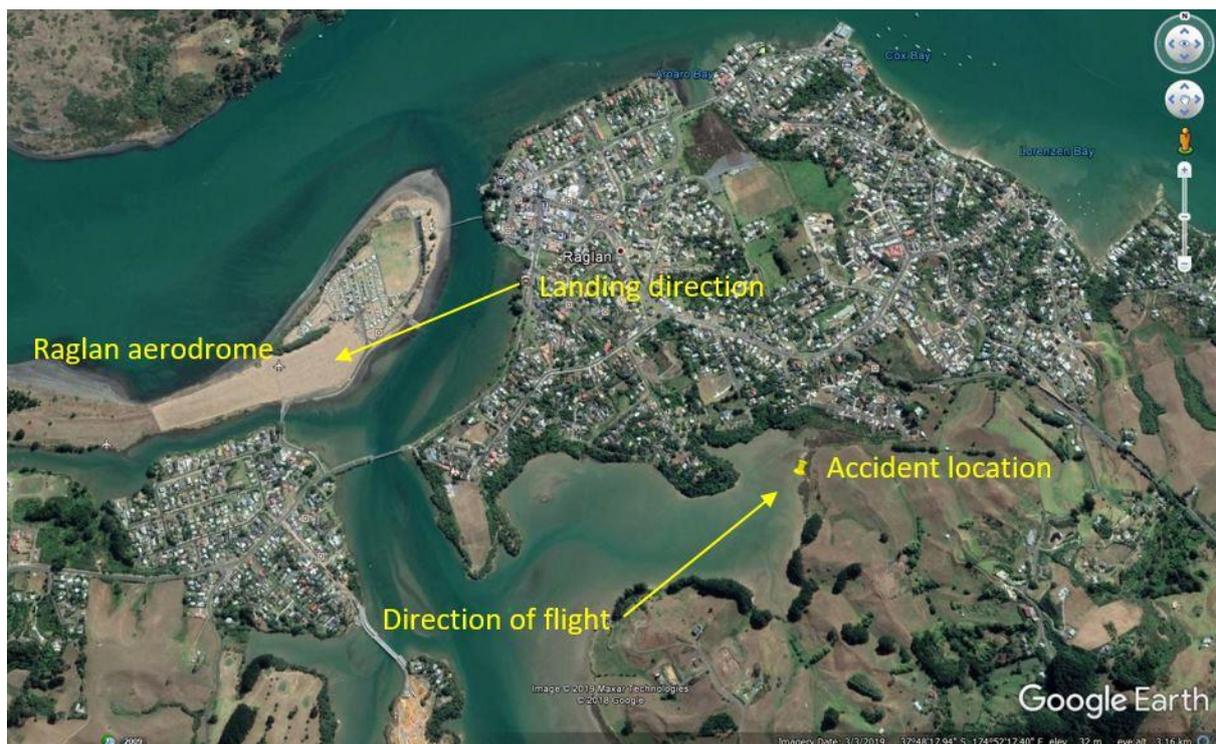
Figure 2: Accident location (Image source Google Earth)

The aircraft was observed by several witnesses, including another pilot, approaching and turning towards Raglan aerodrome when it rapidly rolled to the left and descended at a high rate. The aircraft then struck the mud flats in an approximate 40 degree nose down attitude, with rotation to the left. The impact signatures are consistent with the aircraft being in a spin to the left when it struck the mud flats.
