**AIRCRAFT ACCIDENT REPORT  
OCCURRENCE NUMBER 05/3501**

**Eurocopter EC120B**

**ZK-HTF**

**4 November 2005**

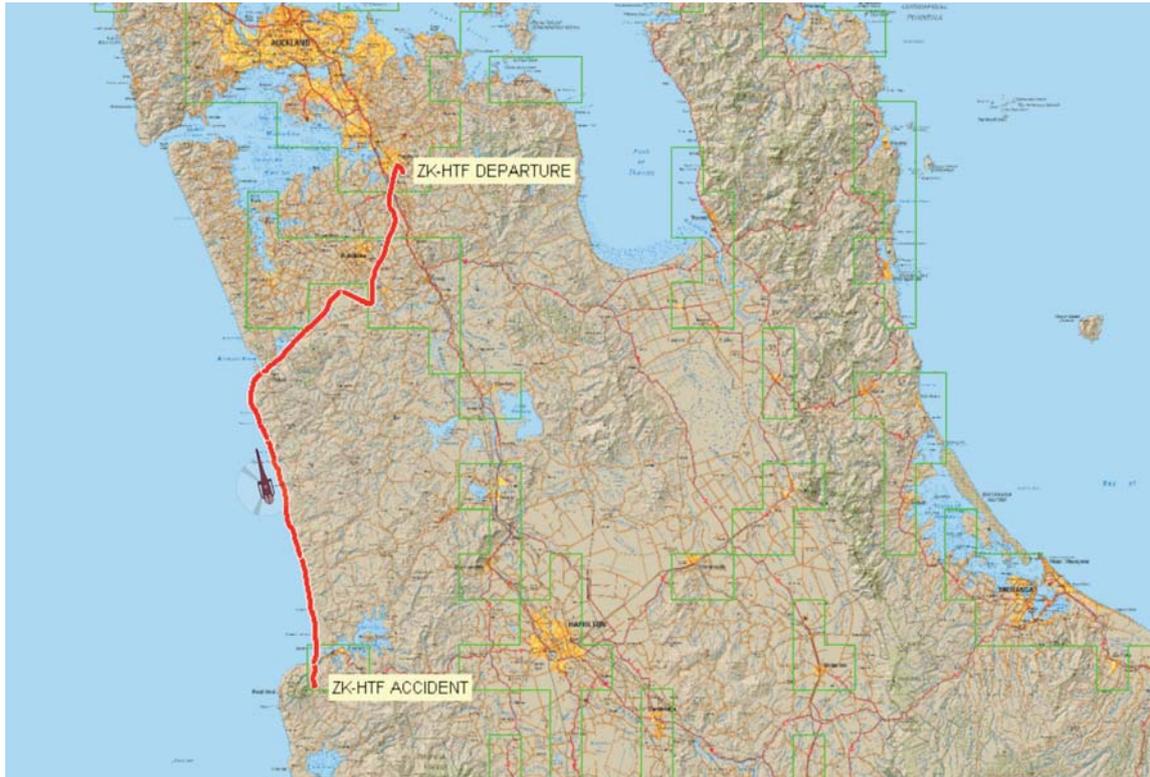
Figure 1

- 1.1.5 The pilot did not make radio contact with Air Traffic Services to activate his flight plan. Such contact would have been normal procedure.
- 1.1.6 Later analysis of the SSR (radar) plots of an aircraft showing transponder code 0372 indicated that the helicopter tracked south-west from Papakura until overhead the Waikato River where the helicopter turned west and followed the river to the river mouth. See Figure 1.

- 1.1.7 On reaching the Waikato River mouth the helicopter then followed the coastline south to a point abeam of Raglan. Recorded radar altitude and ground speed for the majority of the flight along the coast was 600 ft AMSL and 110 knots.

- 1.1.8 From the point abeam of Raglan the helicopter maintained a direct track for Wanganui Aerodrome rather than continuing to follow the coastline. In doing so, the helicopter tracked inland to the east of Mount Karioi and continued in a south-easterly direction for approximately six nm towards ground rising to 900 ft AMSL.

ZK-HTF flight track depicted in red.
