2025-00556

Dingle Burn, 29 March 2025.

Loss of control during low level turn.

Investigation Final Report

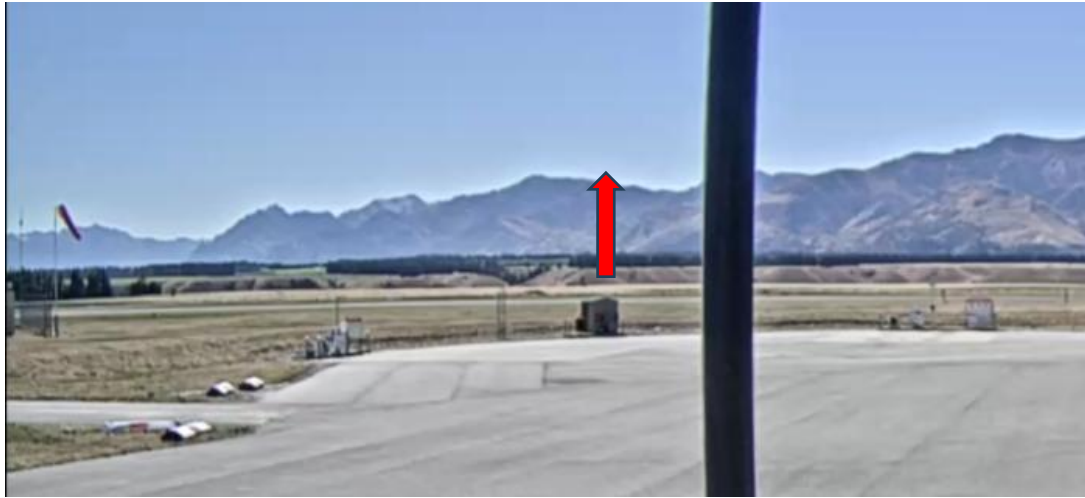
36. Above is a section of a Wanaka aerodrome security camera image taken at 13:00 on 29 March 2025. The red arrow points in the direction of the Dingle Burn valley which is located beyond the hills on the skyline.
37. Aeronautical meteorological data provided to the CAA showed that adverse weather was not a contributory factor in this accident as also evidenced by the above image. Carburettor icing was also ruled out due to the low relative humidity.
38. The wind velocity was assessed by witnesses¹² at the airstrip to be 2 to 5 kts blowing up the valley, i.e. from south-west to north-east. The density¹³ altitude at the airstrip was approximately 3300ft amsl¹⁴.
39. As can be seen from the graph at Appendix 1, the aircraft was climbing and slowly accelerating therefore the 3300 ft density altitude was not a contributory factor in this accident.
