**AIRCRAFT ACCIDENT REPORT**  
**CAA OCCURRENCE NUMBER 09/919**  
**SKY ARROW 450T**  
**ZK-SKA**  
**LOSS OF PITCH CONTROL**  
**NEAR INANGAHUA JUNCTION**  
**15 MARCH 2009**

## AIRCRAFT ACCIDENT REPORT

### CAA OCCURRENCE No. 09/919

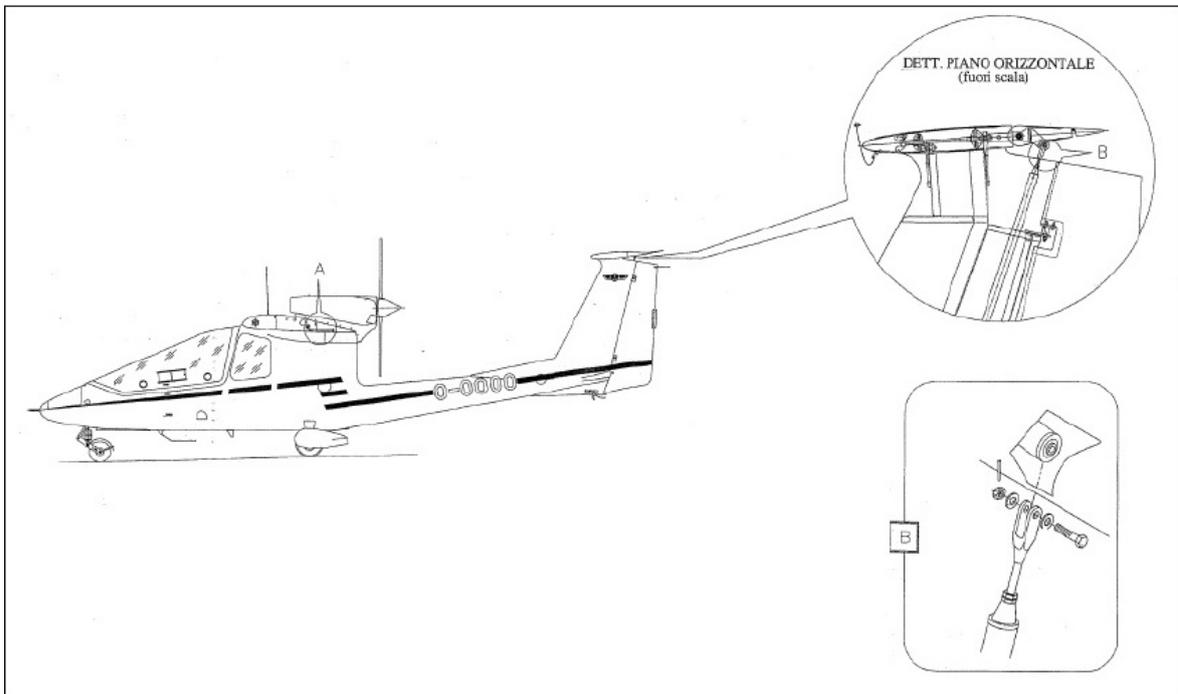
**Figure 1: Elevator control linkage**

- 1.6.7 The centre of gravity for the aircraft was determined by calculation to be within limits.
- 1.6.8 Pitch control for the aircraft is via sidesticks in the cockpit connected to a mixing unit behind the rear bulkhead. The control line is then via aluminium push/pull tubes which connect to a bellcrank at the rear of the fuselage transferring to a

vertical tube (elevator control arm) inside the tail fin to a control linkage attached to the elevator on the “T” tail. Refer to Figure 1 (item B).
