CAA Safety Investigation Report

Departure from controlled flight

ZK-MBX RANS Aircraft S-19

CAA Final Report 17/3767

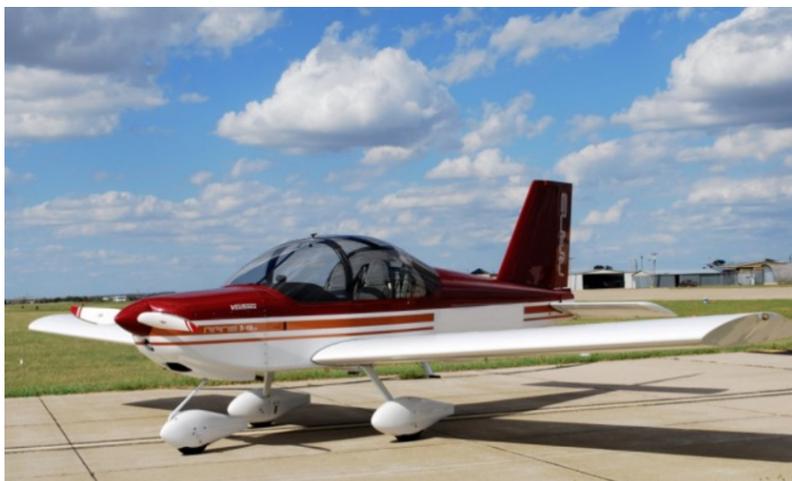
Figure 2: Example of a Rans Aircraft S-19

The aircraft was a single engine Rans Aircraft S-19 Class 2 Microlight (See Fig 2). It was an all metal low wing microlight aircraft with fixed tricycle landing gear and two seats in a side by side configuration. It was fitted with an Electronic Flight Information System (EFIS) which displayed the aircraft instruments on two glass screens (See Fig 3). The safety investigation found no faults with the aircraft or its systems.
