VECTOR

**Secondary Damage
to Aircraft**

January / February 2005

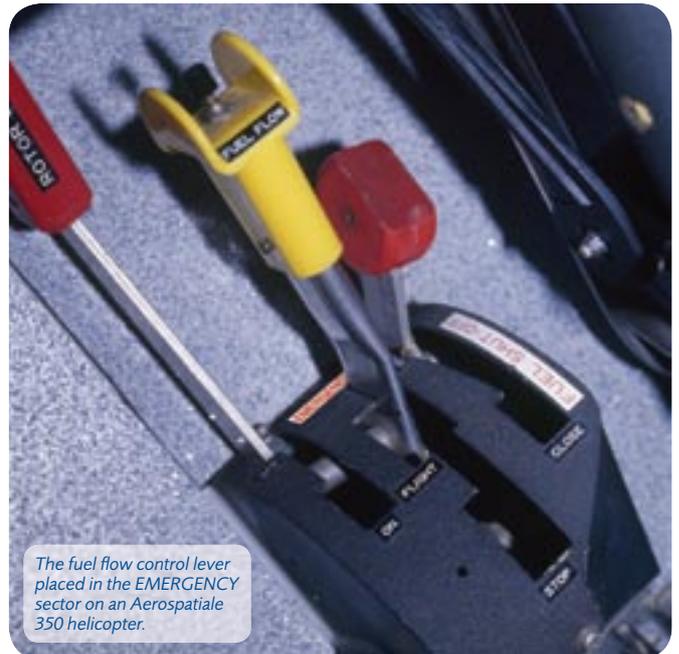
In helicopters (such as the Aerospatiale 350) that have a manual fuel control position on the fuel control lever, it may be possible to recover from a governor underspeed, when altitude and time permit. In the event of a governor underspeed, the fuel control lever can be moved beyond the FLIGHT detent position, and into the EMERGENCY sector. This will progressively open the emergency control valve and override the governing of the power turbine. In this situation the pilot has to monitor the gas generator speed (N_g), rotor rpm, and the exhaust gas temperature (T_4), since the governing system no longer provides any protection. Each time the collective is moved, a compensating manual adjustment will be required in the fuel flow control to maintain parameters in the permitted operating range.

The fuel flow control lever placed in the EMERGENCY sector on an Aerospatiale 350 helicopter.

For information on how to handle a governor failure in your type of helicopter, refer to the emergency section in the flight manual.
