# Airworthiness Bulletin

## AWB 63-006 Issue 5 - 10 August 2026

### Issues related to the Robinson Helicopter Company (RHC) R22 Main Rotor Drive System

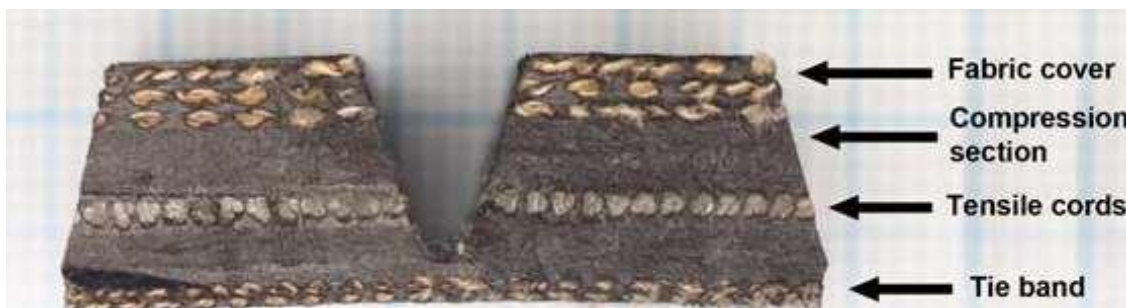
Cross-Section through a v-belt (Revision Z)

ATSB Transport Safety Report - Aviation Occurrence Investigation AO-2014-058

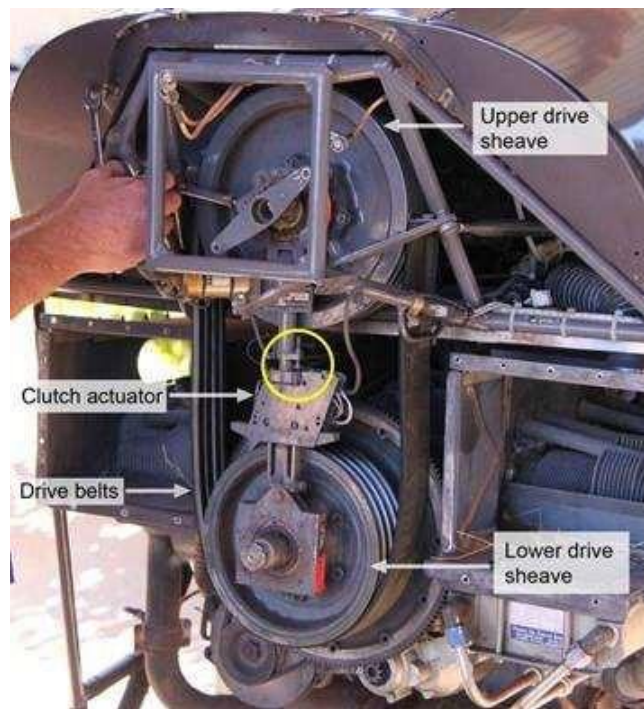
Mechanical arrangement of the R22 rotor drive system

ATSB Transport Safety Report - Aviation Occurrence Investigation AO-2014-058

Tests conducted by RHC indicate that most main drive belt drive problems and failures of the fan shaft bearing or upper actuator bearings are caused by misalignment of the main drive belt sheaves. Misalignment will contribute to abnormal main drive belt and sheave wear and belts jumping out of the drive grooves. Adverse loadings on the main drive belt drive faces will result in adverse wear of the drive belts and the sheave grooves. In addition to abnormal wear, the structure of the main drive belts will be stressed in a way not anticipated by the design of the belt and may contribute to premature drive belt failure. Alignment should also be checked typically:
