REPAIR OF

Fairey
METAL PROPELLERS

GENERAL SPECIFICATION F.A.C. I

REPAIR SPECIFICATION NO. F.A.C. 1.

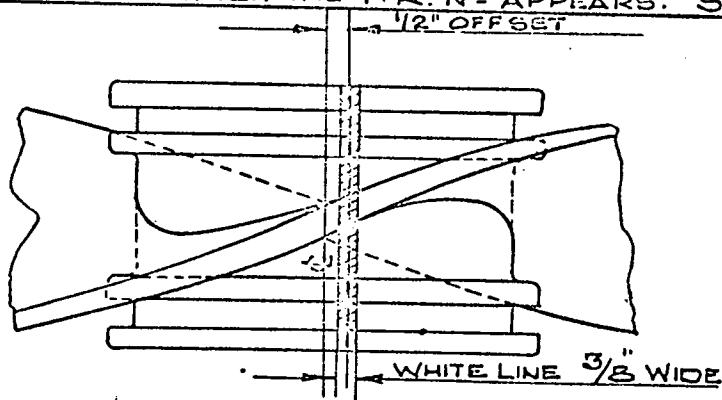
FIG. 1

(1) IT IS IMPORTANT THAT THE BOSS BLOCKS REMOVED FROM THESE PROPELLERS ARE RE-ASSEMBLED IN THE SAME RELATIVE POSITION. TO THIS END AN UN-BROKEN WHITE LINE APPROX. $\frac{3}{8}$ " WIDE IS PAINTED FORE & AFT ACROSS THE SIDE OF THE FRONT BOSS, ACROSS THE EDGE OF THE CENTRE PORTION OF THE BLADE & ACROSS THE SIDE OF THE REAR BOSS. THIS LINE MUST BE CONTINUOUS ON RE-ASSY.

NOTE. BEFORE THE INTRODUCTION OF THIS WHITE LINE, ASSEMBLY MARKS IN THE FORM OF A LETTER 'O' FOR EXAMPLE WERE STAMPED IN LINE ON THE SIDE OF THE FRONT BOSS, THE EDGE OF THE BLADE, & THE SIDE OF THE REAR BOSS. ALL PROPELLERS IN THIS CONDITION MUST BE BROUGHT INTO LINE WITH THE LATEST PRACTICE BEFORE DISMANTLING THE BOSSES BY PAINTING A WHITE LINE AS DESCRIBED ABOVE ON THE SIDE OF THE PROP: REMOTE FROM THAT ON WHICH THE F.R. NO APPEARS. SEE FIG. 1.

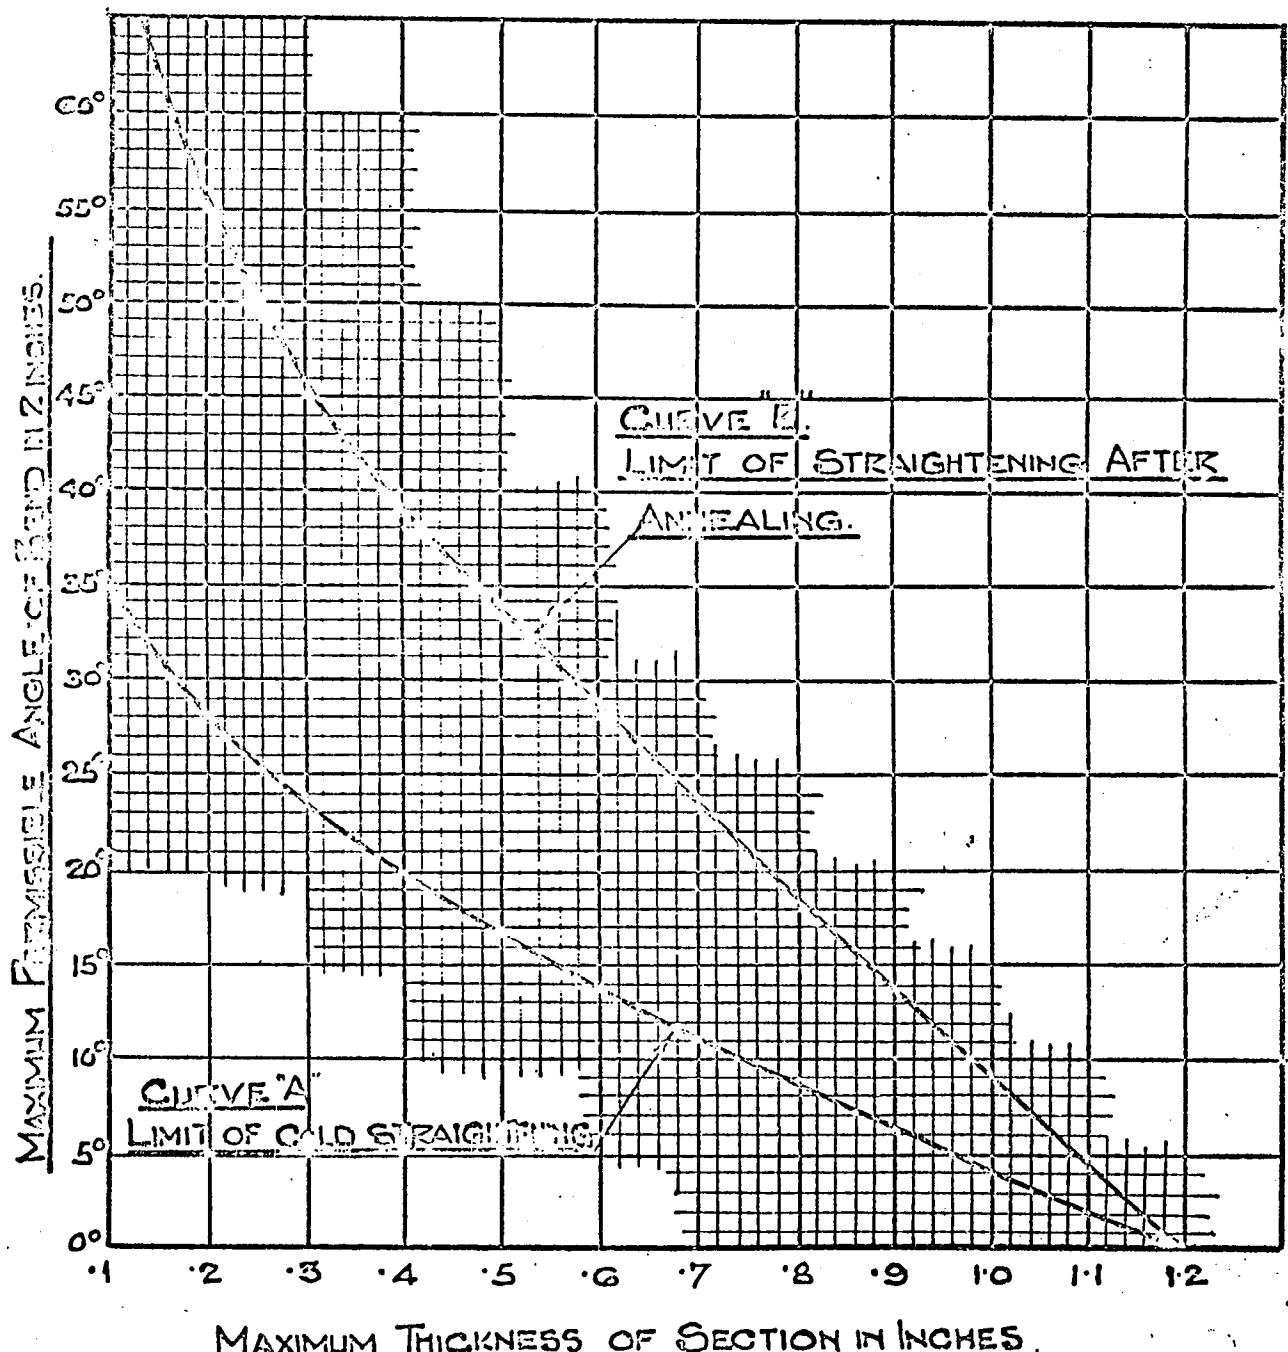
MAXIMUM PERMISSIBLE FOR COLD AND HOT

STRAIGHTENING - PECZELERS MANUFACTURED IN D.T.D 147.

(ii) Blades bent to angles not exceeding those given by curve "A" Appendix II may be straightened cold (without annealing) twice only in succession; for the third repair they must be annealed before straightening and finally heat treated.

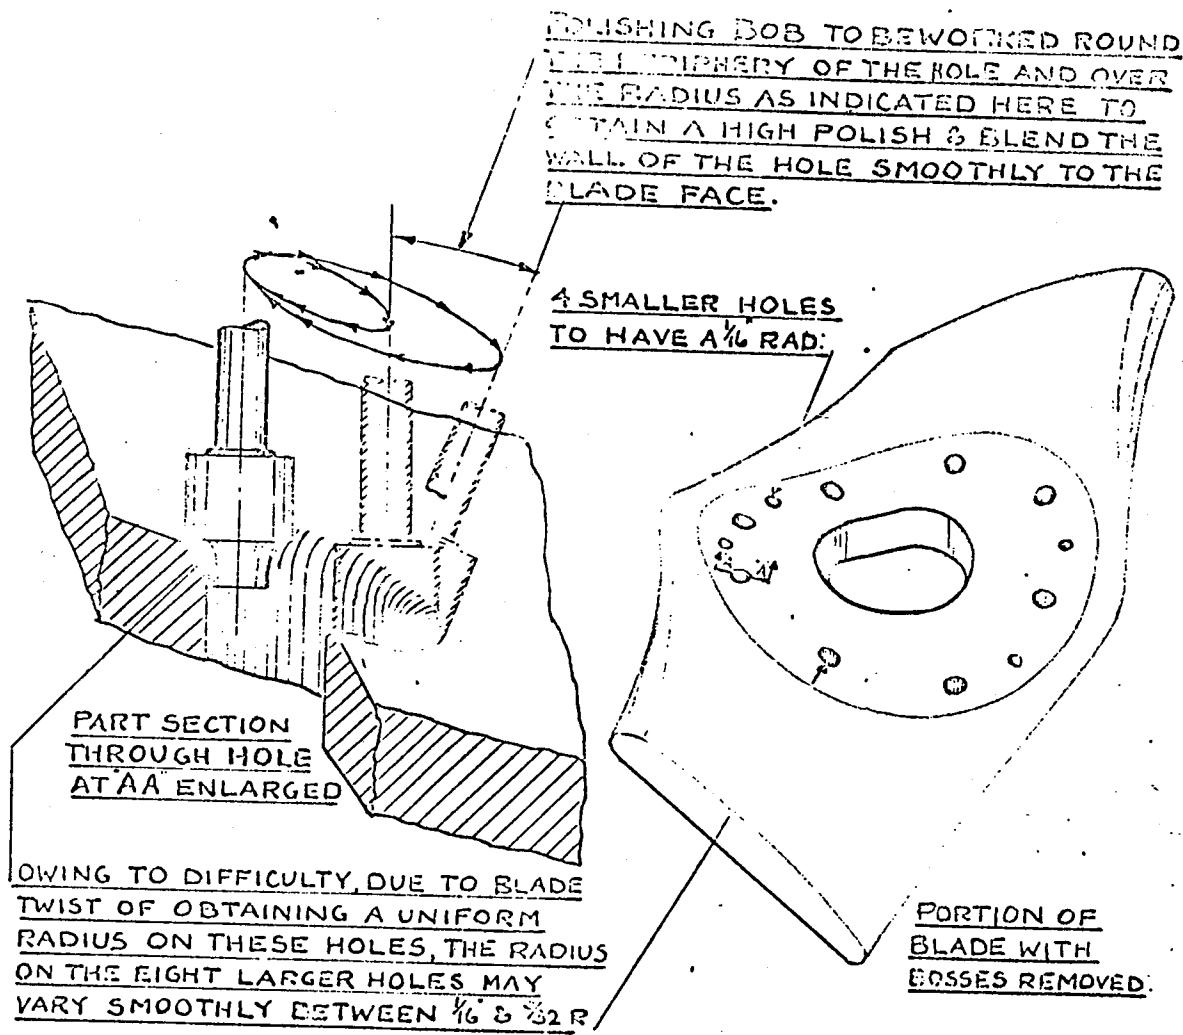
FIG: 2

- (V) APPLY PROTECTIVE VARNISH SPEC: B.E.S.A 2X 17 THINLY AND EVENLY TO ALL PARTS WHERE THE ANODIC FILM HAS BEEN BROKEN, TO GIVE PROTECTION AGAINST CORROSION.
- (VI) CLEAN THOROUGHLY WITH RAG ALL CONTACTING SURFACES AND RE-ASSEMBLE THE BOSSES IN THE SAME POSITION AS THEY OCCUPIED BEFORE DIS-MANTLING. REFER TO ASSEMBLY MARKS.
- (VII) REPLACE BOLTS WITH THE HEAD IN THE REAR BOSS, (WASHERS FITTED UNDER THE HEADS OF THESE BOLTS MUST HAVE A 1/32" RADIUS APPLIED TO THE EDGES OF THE CENTRE HOLE WHERE THIS DOES NOT ALREADY EXIST) AND TIGHTEN ALL NUTS EQUALLY. WHERE FACILITIES ARE AVAILABLE, CORRECT ASSEMBLY CAN BE CHECKED BY PLACING THE PROPELLER ON A SURFACE TABLE. TRACK DIMS: SHOULD BE WITHIN THE LIMITS GIVEN ON SHEET N°3 OF THE APPROPRIATE SUPPLEMENT.
- (VIII) EXAMINE FERODO FRICTION WASHERS IF FITTED AND REPLACE WITH NEW ONES TO DRG N° C.66307, ALL WHICH SHOW SIGNS OF WEAR OR FRAYING

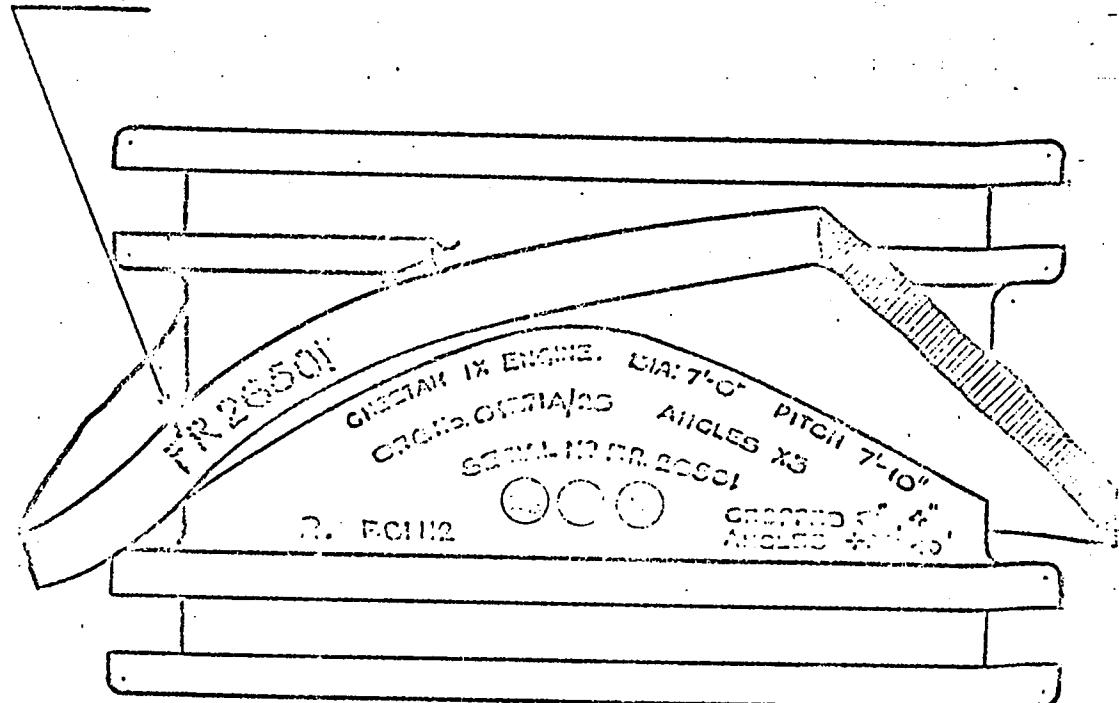
THE F.R. NO WHICH WILL BE FOUND LIGHTLY ENGRAVED
HERE IS THE ONLY MARKING TO APPEAR ON THE PLATE
SHEET

THE EXAMPLE GIVEN ABOVE REPRESENTS AN AVERAGE
SITUATION THAT HAS BEEN ESTIMATED ON TWO
OCCASIONS BY THE PAINTED FURNITION COUNCIL.

THE MARKING SHOWS THAT!

THE FIRST REPAIR WAS A "COLD" REPAIR (C1) AND THAT EACH BLADE HAS BEEN REDUCED IN LENGTH $1\frac{1}{2}$ " (3" ON DIA.). TO COMPENSATE FOR THIS THE BLADE ANGLES HAVE BEEN INCREASED TO 50°

THE CHANGES MADE IN A "HOT" REPAIR (H2)

NEGOTIATING AN URGING. A FURTHER REDUCTION OF
BLADE LENGTH AND INCREASE IN BLADE ANGLES HAS
TAKEN PLACE, SO THAT THE RIM IS NOW -4° AND THE

The above details will be found marked on the periphery of the boss blocks, as shown in Appendix IV.

(x) Typical example of marking a repaired blade is shown on Appendix IV.

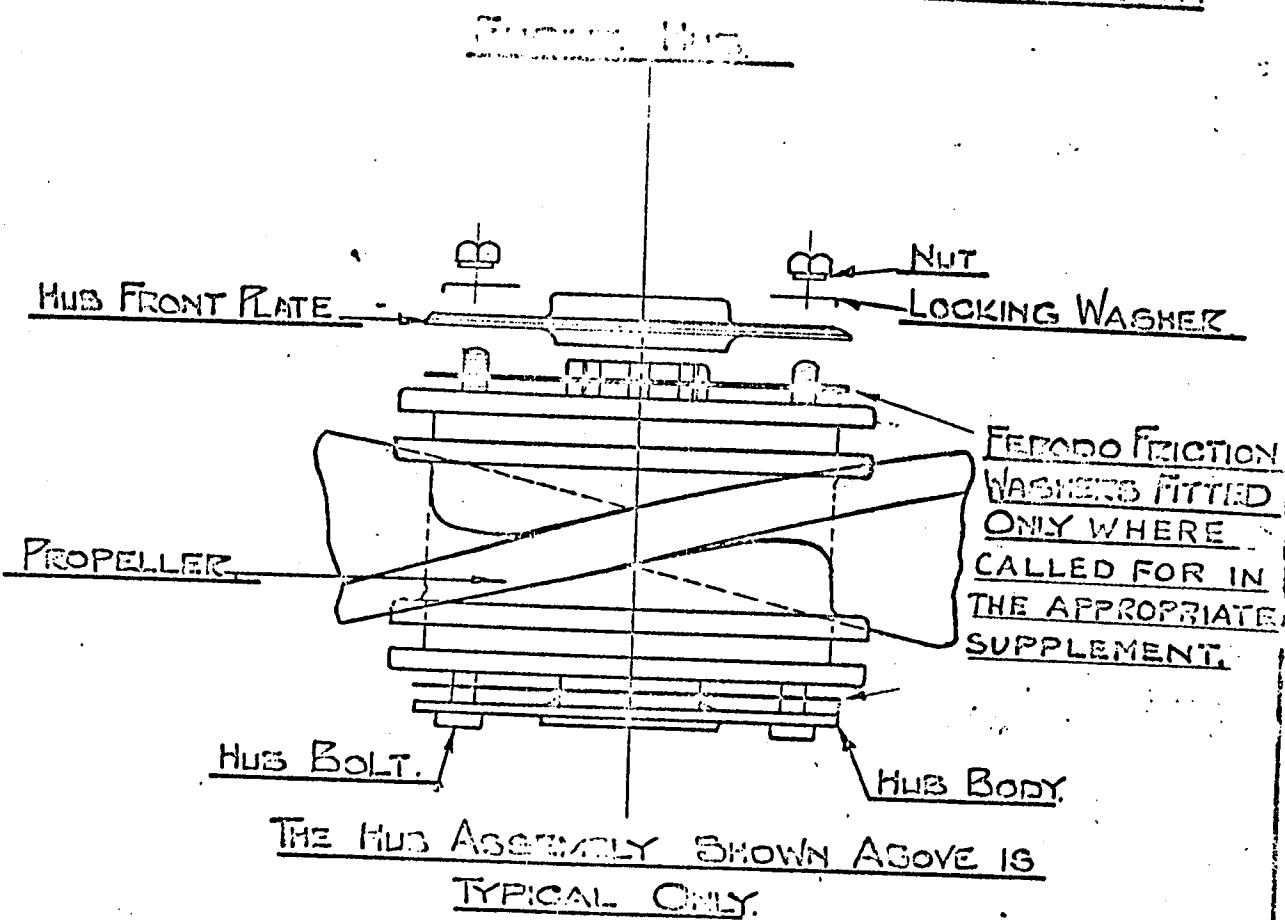
ASSEMBLY OF THE BLADES FOR METAL PROPELLER ON

THE Hub ASSEMBLY Shown ABOVE IS
TYPICAL ONLY.

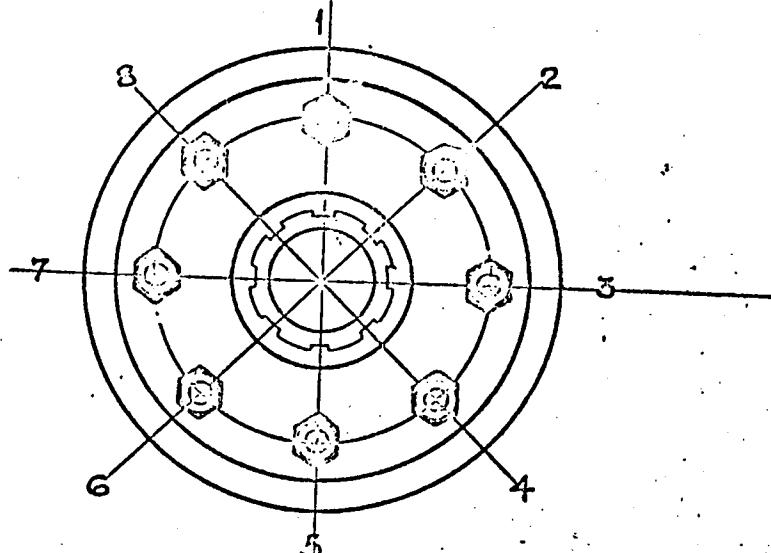
INSTRUCTIONS FOR TIGHTENING THE HUB BOLTS

- (i) RUN ALL NUTS ON FINGER TIGHT.
- (ii) TIGHTEN NUTS ONE HALF OF A TURN AT A TIME IN THE FOLLOWING ORDER 3,7,1,5,2,6,4,8. REPEAT IN THIS ORDER TILL ALL NUTS ARE TIGHTENED.
- (iii) TURN OVER TAB OF LOCKING WASHER, OR FIT LOCKING

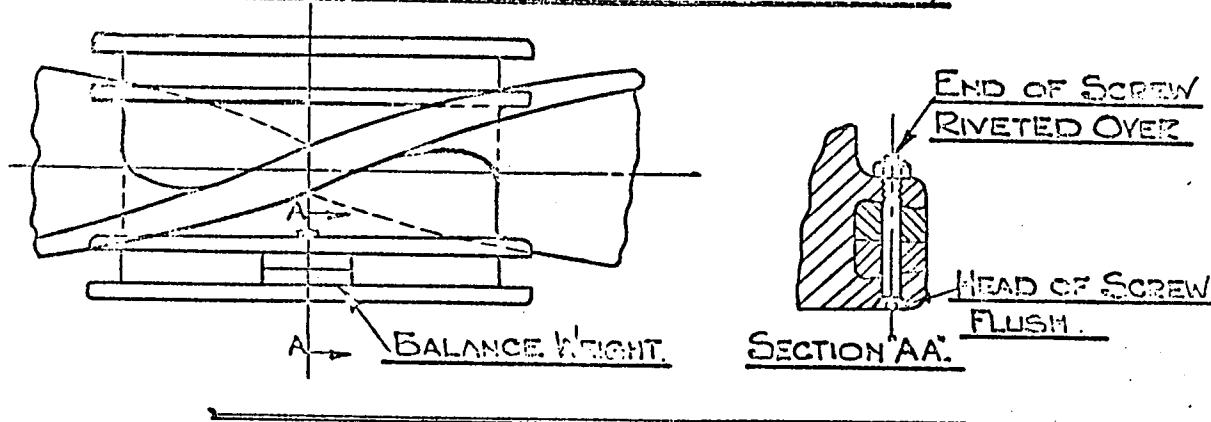
PROPELLERS FITTED WITH METAL BOSSSES.

The illustrations below show the method of securing Mass Balance Weights to Fairley Two Bladed Metal Propellers. These weights are fitted in the hub and must not be disturbed. When removing bosses from the propeller blade, any out of balance caused by the removal of damaged material from one blade must be corrected by removing a similar amount of material from the other blade, not by altering the size or position of these weights.

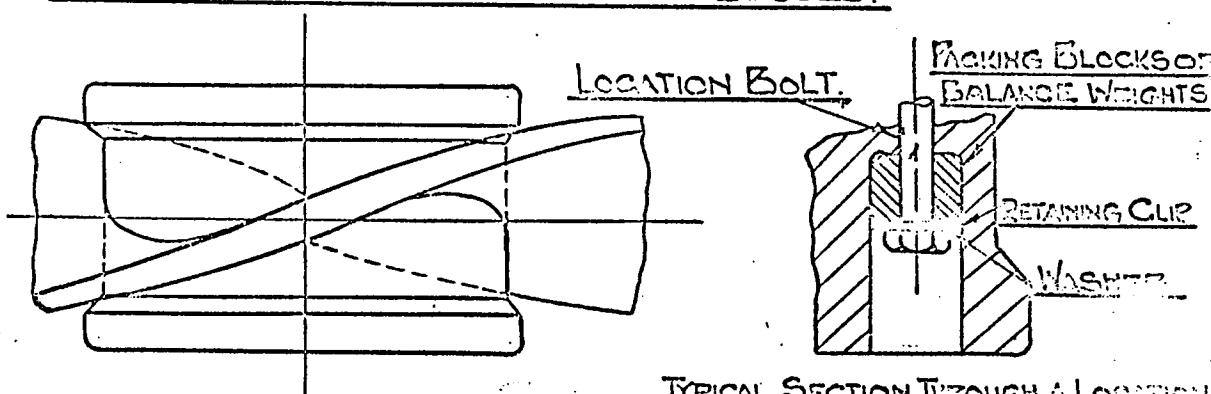
PROPELLERS FITTED WITH PHENOLIC BOSSSES.

PACKING BLOCKS OF LIGHT MATERIAL SUCH AS ALUM^{INUM} OR DURAL ARE FITTED UNDER THE NUTS & BOLT HEADS OF THE FOUR LOCATION BOLTS, WHERE BALANCE WEIGHTS ARE REQUIRED A HEAVIER MATERIAL SUCH AS STEEL IS SUBSTITUTED FOR SOME OR ALL OF THE LIGHT PACKING ON TWO OF THE BOLTS. PACKING BLOCKS AND/OR BALANCE WEIGHTS ARE RETAINED IN THE COUNTERBORES BY SPRING CLIPS WHICH MUST NOT ON ANY ACCOUNT BE REMOVED. ANY OUT OF BALANCE CAUSED BY THE REMOVAL OF DAMAGED MATERIAL FROM ONE BLADE MUST BE CORRECTED BY REMOVING A SIMILAR AMOUNT OF MATERIAL FROM THE OTHER BLADE NOT BY ALTERING THE SIZE OR REVERSING THE POSITION OF THESE WEIGHTS.

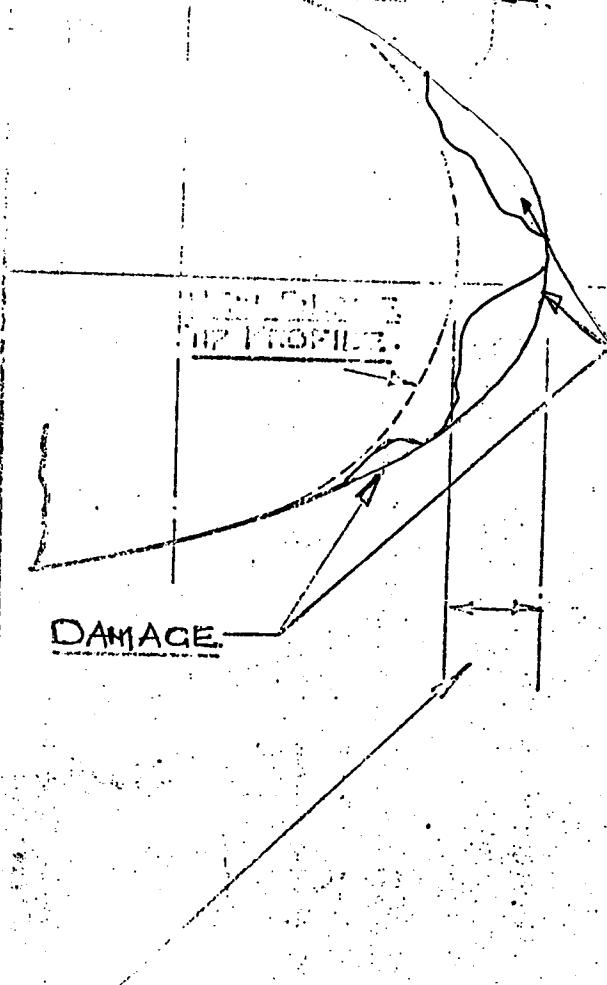
Repair on Blade Tips.

REFERENCE EDGE OF TEMPLATE

ORIGINAL BLADE
TIP PROFILE:

CUT ALUMINUM TIP TEMPLATE
MOUNT CUTTING BLADE ON THE
SAME PROPELLER IN THE
SUPPORTED BY THE SAME
ANCHOR.

SEE APPROPRIATE SUPPLY
AMOUNT WHICH MAY BE REMOVED FROM THE TIP
IN PARTICULAR PROPELLER.

(14) Extensive damage to blade tips may be removed by cropping within the limits shown on Sheet No. 5, of the Supplement appropriate to the particular propeller, and retwisting where necessary.

(iii) When carrying out repairs of this character, the blade tip shall be dressed down to a smooth radius blending with the surrounding surfaces. No more metal shall be removed than is necessary to eliminate all the defects.
