# Aviation Safety Summary

1 July to 30 September 2017

## Introduction to the Quarterly Safety Summary Report

Welcome to the quarterly safety summary report for the winter of 2017 (Jul/Aug/Sep).

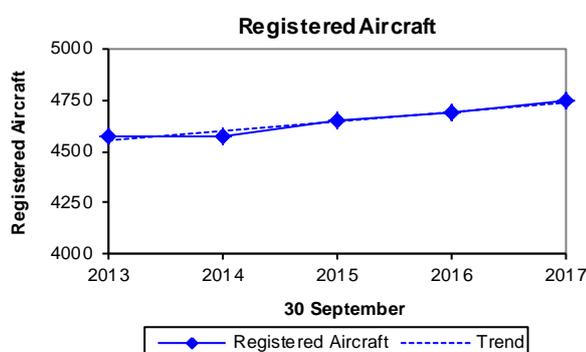
The following graph shows the number of registered aircraft at 30 September for each of the five-years 2013 to 2017.

Note that the scale on this graph does not start at zero.
