VECTOR

Pointing to Safer Aviation

May / June 2000

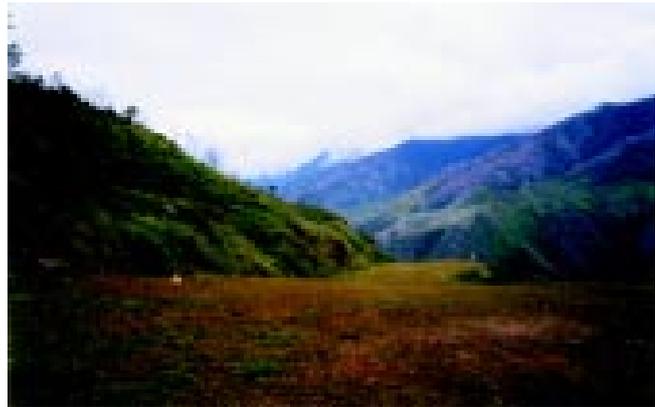
Photograph courtesy of Bruce Alabaster of MBA

Typical airstrips found in PNG can be up to 6000 ft AMSL with a 12 percent slope.
