VECTOR

Pointing to Safer Aviation

Ice

This is the first in a series of articles on airframe icing and its effects. It is part of an on-going educational campaign by the CAA aimed at IFR pilots – particularly those who regularly fly at medium-level altitudes where airframe icing is most likely to occur.

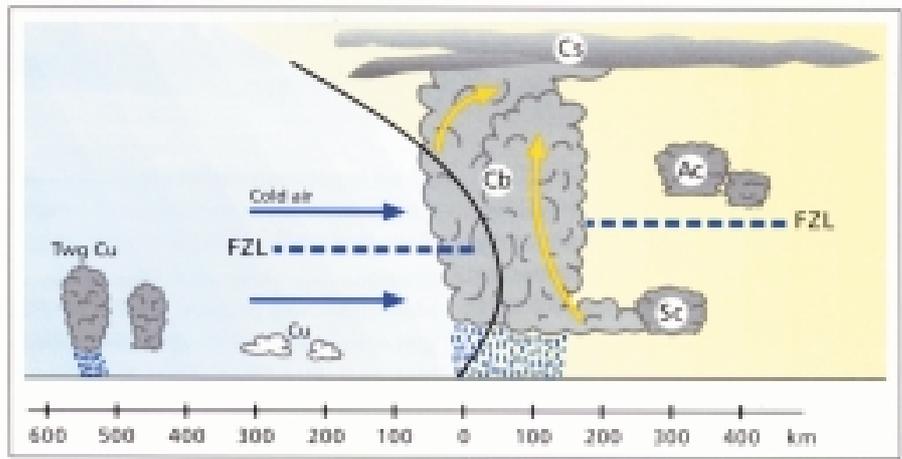
A cross-sectional model of a cold front

The above diagrams show the typical cloud types and freezing levels associated with frontal activity. The FZL can vary considerably, depending on latitude, season and airmass characteristics. Note the area above the FZL ahead of the warm front where freezing rain is likely to occur.

Freezing rain is normally associated with the cold sector directly under the slope of a warm front, or in the cold sector just behind a cold front. Sometimes it can occur where there is a strong temperature inversion and rain falls from warmer air at altitude into cooler air just above the freezing level.

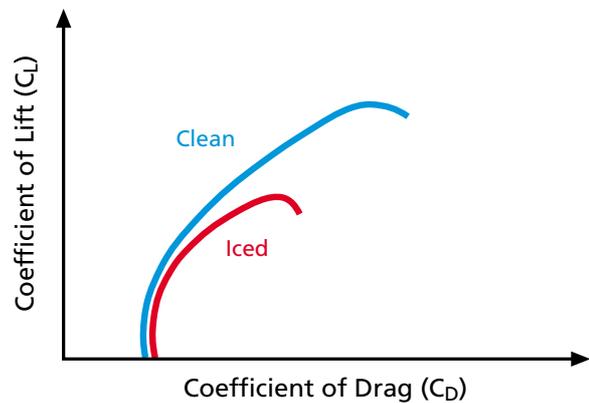
The effect of ice build-ups on C_L and C_D for a typical aerofoil.

Although ice can accrete on many aeroplane surfaces, of most concern is mainplane aerofoil icing. Ice destroys the smooth flow of air over the wing, diminishing its ability to generate lift. Ice increases drag, increases the aircraft weight, and degrades the pilot's control authority. As power is added to compensate

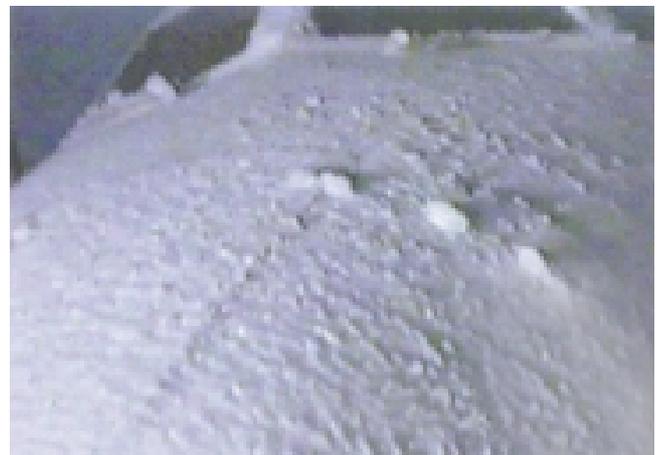
Ice accumulation on the nose of an aircraft.

Ice accumulates on every exposed frontal surface of the aircraft – not just its wings, tail, fuselage and propellers – but also on the windshield, antennas, intakes, vents, and cowlings. Most aircraft do not have anti-ice equipment that is effective in controlling ice accretion on these appendages. A severe icing problem can therefore develop very quickly. In moderate to severe icing conditions some aircraft (especially some light twins) can become so iced up that flight is impossible.

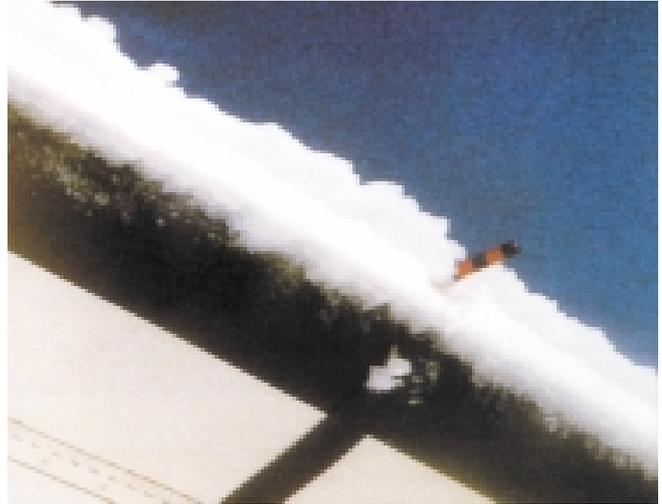
Rime ice on the leading edge of an ATR wing. It is typically very brittle and frost-like in its appearance.

The large amount of air trapped within the ice gives it rough and crystalline characteristics. As it builds up on the leading edges of the wings and tail, it dramatically affects their aerodynamic qualities – accumulations around engine intakes can also have a detrimental effect on engine performance. The large increase in drag and loss of lift associated with rime ice build-up does not require elaboration, other than to stress the importance of clearing it quickly – there are numerous overseas examples of aircraft suffering tailplane stalling due to severe rime ice build-ups. Unlike clear ice, rime ice does not usually cause a significant increase in aircraft weight, and it can be readily cleared by the activation of de-ice equipment.

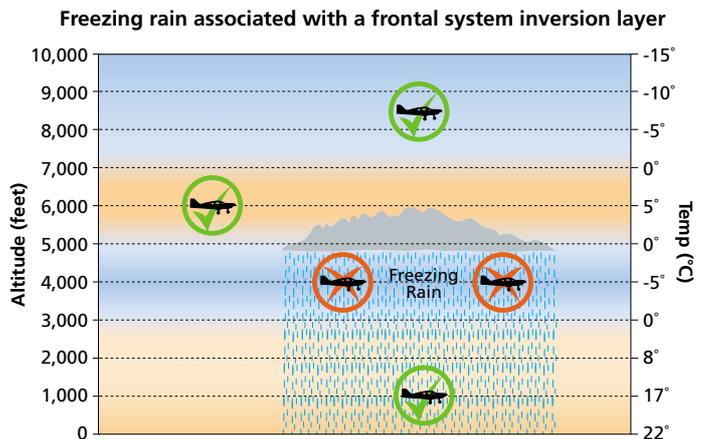
This graph shows how a temperature inversion at altitude can produce conditions conducive to freezing rain.

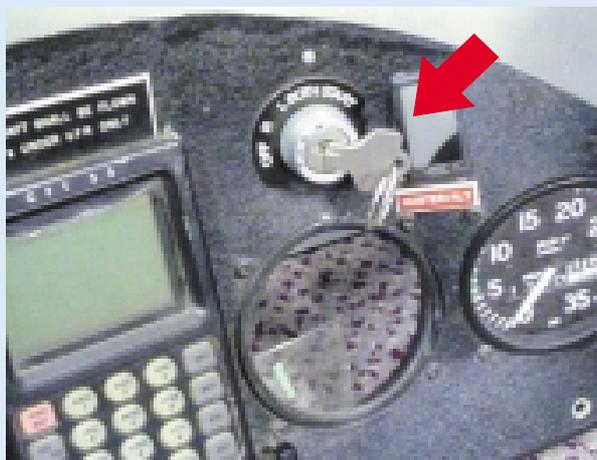
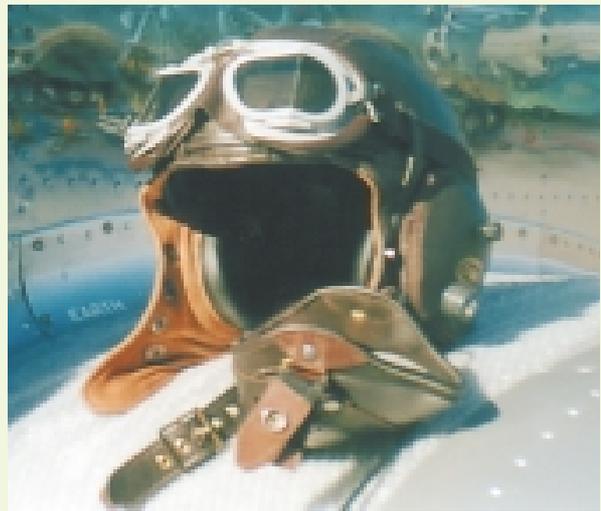
The photograph below shows the instrument panel after an aircraft with an open cockpit came to a sudden stop. The arrow points to the ignition key, which is, as you can see, rather bent.

The bending was caused by the head of the pilot as he hit the instrument panel. Since he was wearing lap and shoulder harness at the time, it makes one worry what the outcome would have been if he had not been. He was in fact wearing a helmet as we recommend in an open cockpit aircraft, and that was what hit the key, saving him from serious injury. Unfortunately, his passenger was not wearing a helmet, and suffered facial injuries in the front cockpit.

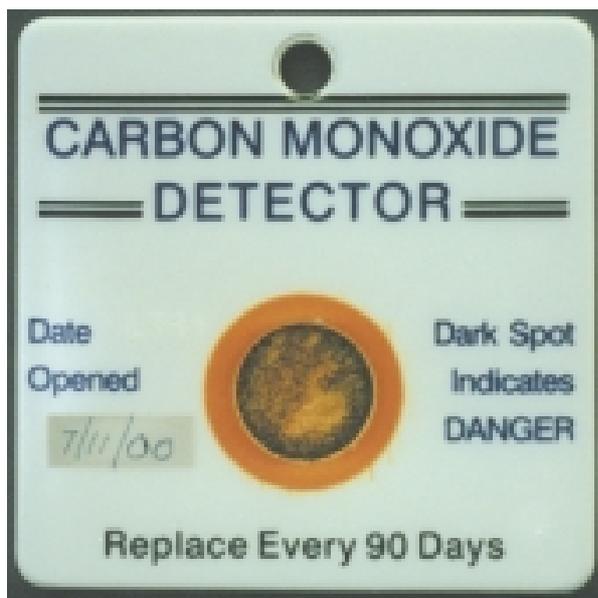
The expired CO detector.

Previous issues of *Vector* (see 1997 Issues 1, 2, 5 and 7) have suggested that aircraft owners and operators of piston-engine aircraft, and aircraft with heating systems that use fuel as a heat source, should consider fitting Carbon Monoxide (CO) detectors.
