# VECTOR

*Pointing to Safer Aviation*

## Surviving on Limited Panel

# SURVIVING ON LIMITED PANEL

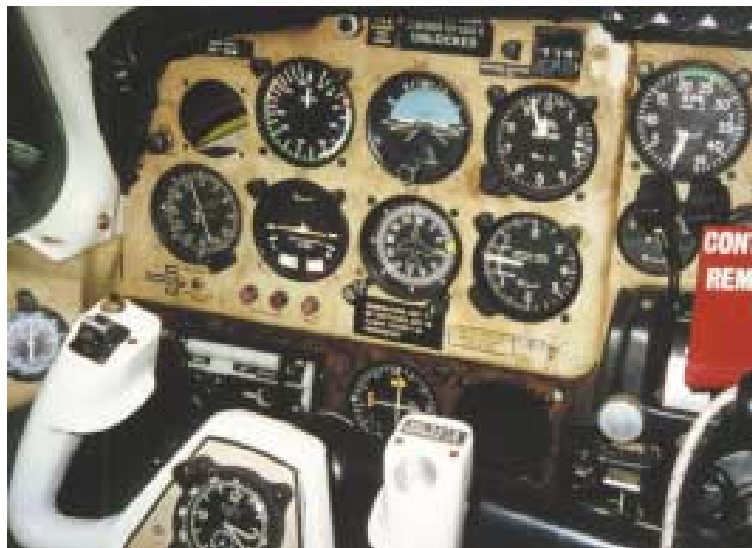
An example of poor cockpit ergonomics. This ILS indicator is positioned low down and behind the control yoke resulting in obstructed vision and parallax error.

Let's examine the reality of using the second AH in IMC or at night. In doing so we need to think about ergonomics, which means the art of matching the environment and the machine to the operator. Or in simple terms, matching the pilot to the flight deck or cockpit. This subject was covered in the Australian *Aviation Safety Digest* several years ago, but some parts of the

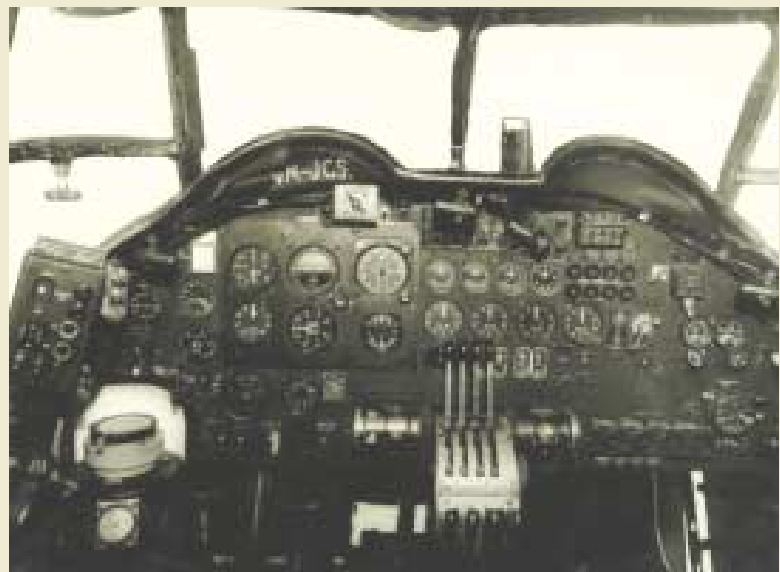
The instrument layout of a Lincoln MK31 that I flew. Sometimes we flew with one pilot and a navigator, who operated the starboard panel. Note the caging knob next to the AH.

The flight proceeded normally until abeam Mornington Island, where the AH toppled without warning. Remedial action, such as the operation of the re-erection caging knob and selection of the alternate vacuum pump from the No 3 to No 2 engine, failed to bring the AH back to life. Fortunately the automatic pilot was unaffected and it was decided to leave it engaged for the time being. Without the AH, I was now down to the 1940s-vintage turn-and-slip indicator. Continuing towards Darwin and now in cloud, the situation was potentially serious, particularly as thunderstorms had been forecast. If the autopilot failed to cope safely with severe turbulence, hand flying on limited panel was the only remaining option. Fortunately I was current and well trained in limited panel instrument flying. The RAAF placed strong emphasis on limited panel skills because most service aircraft only had one AH. Early model artificial horizons were not that reliable and

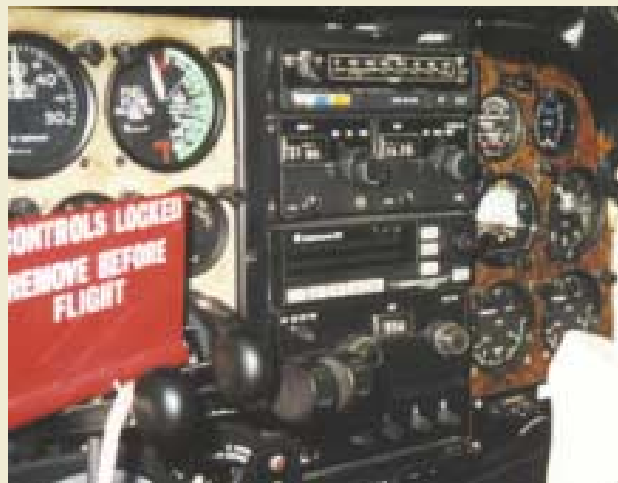
The AH as viewed from the lefthand seat of a Baron B58. The parallax error associated with its position is very apparent; being partially obscured by the radio stack does not help either.

Part of the flight sequence included covering the pilot's AH to simulate instrument failure. The pilot then attempted several turns by leaning well across the cockpit and using the second AH on the right-side instrument panel. These were unsuccessful, resulting in flight well outside instrument rating limits. The difficulty was that, while the pilot could scan the ASI, VSI, DI and altimeter which were in front of him, he became quickly disorientated when forced to split his

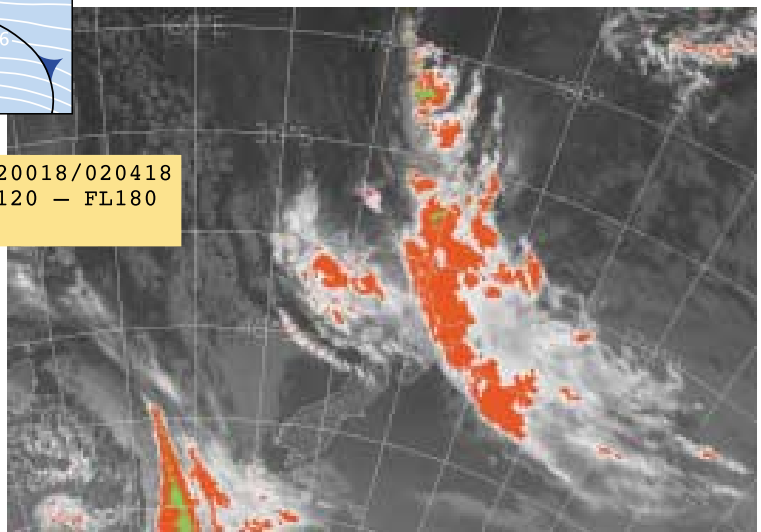
NZC SIGMET 04 011218/011618 UTC OR 020018/020418  
NZST NZKLNZ FIR ISOL SEV ICING FCST FL120 – FL180  
E OF A LINE NZWK/NZNR. INTST NC.

The satellite image pictured below (at midnight on April 1st, 2001) clearly shows two conveyor belts of cloud over the North Island. The lower level conveyor belt is associated with the northeast surface flow across the northern half of New Zealand (see the accompanying MSL Analysis chart for 1200 UTC, 01-APR-2001). It can be clearly seen on the satellite image flowing out from underneath the higher-level conveyor belt and away to the west and northwest of the North Island. This flow has a long 'fetch' from well east and north of New Zealand, and is very moist. The upper level conveyor belt is carrying moist mid-tropospheric air from the tropics across Northland and Auckland, then away to the east of the North Island across Hawkes Bay. This flow is being forced to rise as it moves southwards across the North Island along the slope of the warm front drawn on the synoptic analysis chart just to the north of New Zealand. As this flow ascends and flows southwards, forced-cooling produces large super-cooled cloud droplets conducive to severe airframe icing (see accompanying SIGMET).

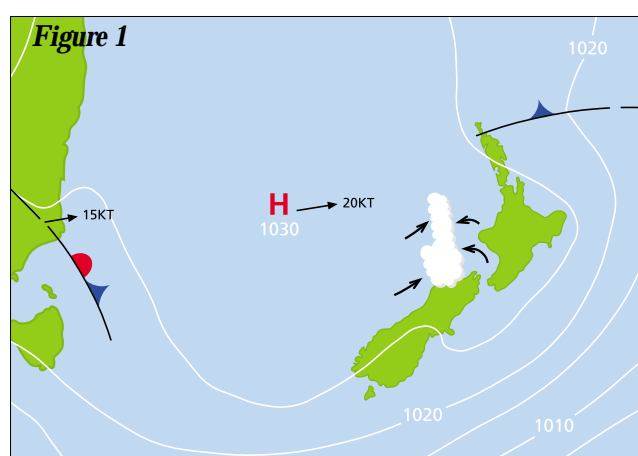
MSL (Mean Sea Level) analysis for midday 10 May 1995. Meso-scale cloud band northwest of Buller formed by convergence of low-level wind flow.

In the atmosphere, when the two airstreams collide – or converge – in the lee of the Alps, some of the air is forced to rise, despite being stable, forming a line of cloud and sometimes showers under the eastern side of the anticyclone, where there are no fronts.

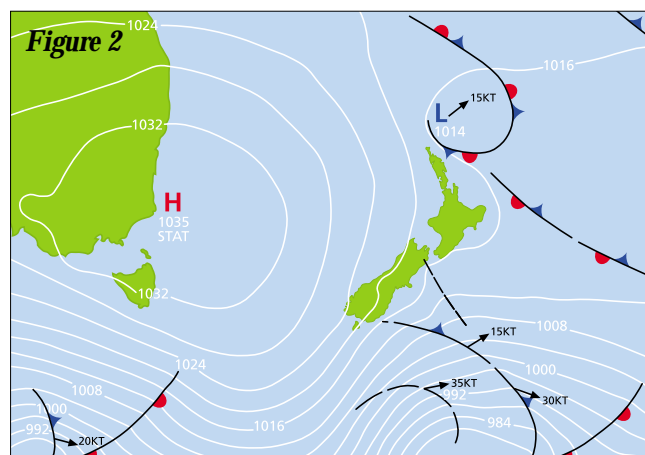
MSL analysis for Midnight 27 June 1999.

At midnight on 27 June 1999 a large anticyclone was moving slowly east across the south Tasman Sea (see figure 2). A cold front southeast of New Zealand was moving northeast towards the Chatham Islands. A lee trough had formed ahead of the front over Canterbury and had passed Kaikoura by midnight. As the lee trough moved eastwards, a southerly change spread

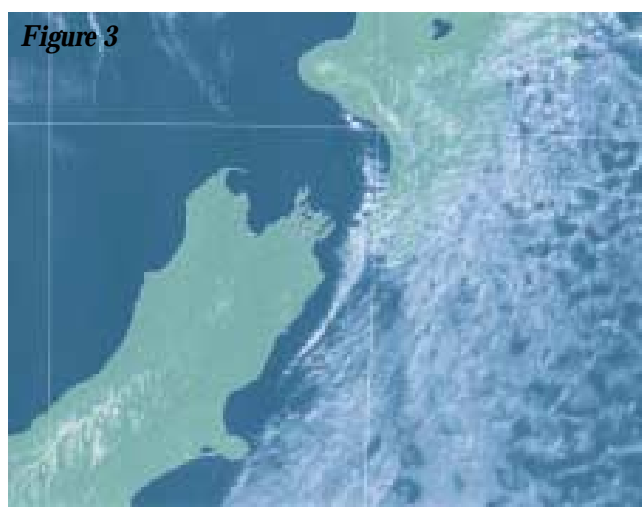
Visible satellite picture for 4 pm 28 June 1999, showing line of enhanced shower cloud parallel with the Kaikoura coast.

About 4 pm, however, the radar showed that a line of stronger echoes had developed in conjunction with the line of enhanced cumulus lying parallel with the Kaikoura coastline and about 25 kilometres offshore, as can be seen in the visible satellite image for this time (see figure 3). The corresponding infrared image showed cloud top temperatures as cold as  $-6^{\circ}\text{C}$  in the line of enhanced cumulus compared to  $-1^{\circ}\text{C}$  further east. This shows that the enhanced cumulus towers in this line had penetrated some way through the subsidence inversion.
