VECTOR

Pointing to Safer Aviation

July / August 2002

Airframe Icing

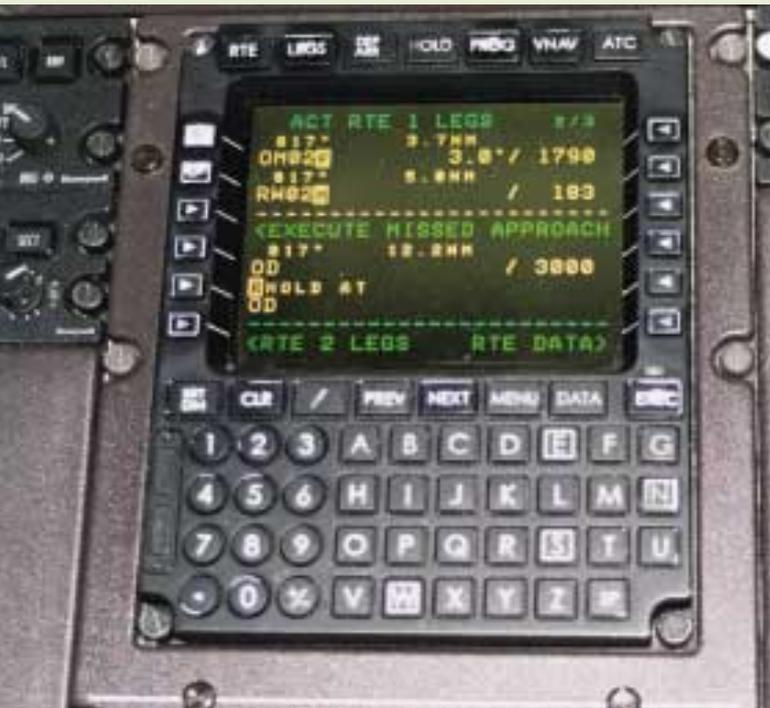
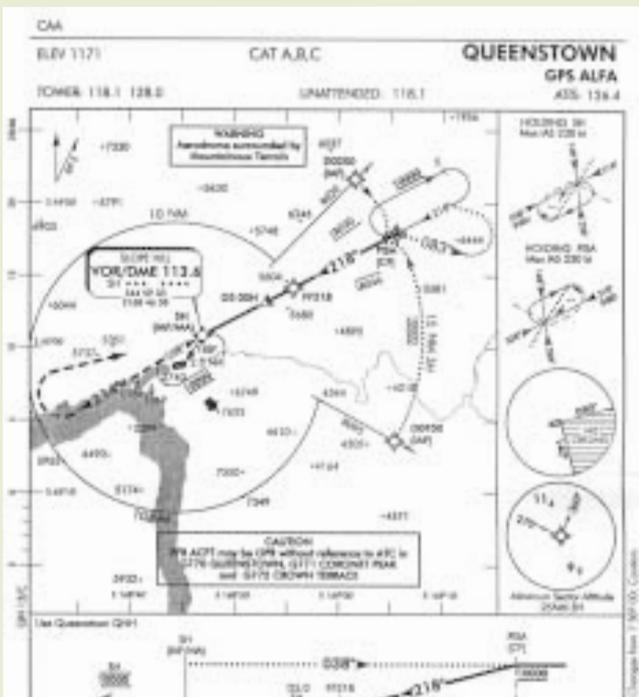
CAUTION: The KLN 90B does not take into account the geometry of the active flight plan when determining the arc intercept point. This point is defined solely on the present radial and the defined arc distance from the reference VOR. For this reason it better to delay selecting approaches that contain DME arcs until the aircraft is closer to the destination."

The crew was very familiar with stand-alone GPS approach procedures, which they had been doing for nearly two years, but this was the first time they had flown a GPS DME arc procedure. Queenstown is the only GPS instrument approach published in New Zealand using the DME arc as part of the procedure. Since the cessation of local Twin Otter operations, there have been limited GPS IFR operations into Queenstown, and the reference flight for the incident was a first for the crew.

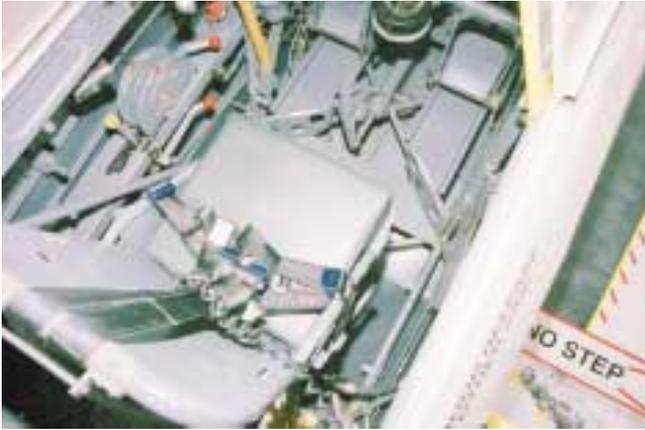
The seat cushion with the straps done up. The straps do not prevent the cushion from moving under negative G.

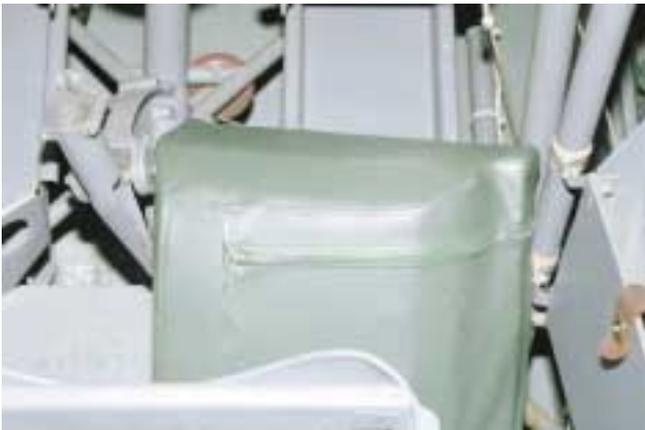
The seat cushion jammed between the fuselage and the control column stub. The rear control column is removed for solo flight. Note the angle at which the ailerons were jammed.

On inspection after landing it was found that the rear seat cushion had apparently come loose from the seat pan and wedged between the control column stub and the fuselage structure.
