September / October 2002

VECTOR

Pointing to Safer Aviation

Maintenance Mistakes and Systems Solutions

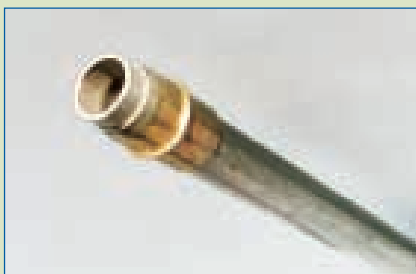
Properly formed (new) tube end: The 'ridge' visible inside the tube end is normal.

It is reasonable to expect that a licensed aircraft maintenance engineer would be familiar with the characteristics and limitations of the MS flareless fittings and would not have attempted to over tighten the fitting to stem a leak. The over tightening is more likely to have been performed by somebody with mechanical skills, but with no training in aircraft maintenance. The simple remedy is to replace a leaking line; the components are readily available and are not expensive.

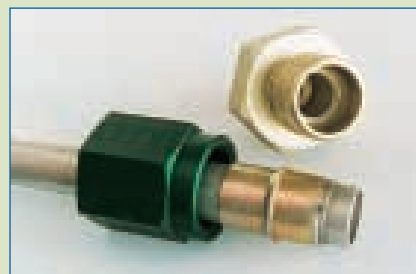
MS flareless fitting components: (Tube, MS 21921 nut, MS 21922 sleeve and MS 21916D reducer)

This accident highlights the susceptibility of MS flareless fittings to damage if over tightened. Ensuring that such fittings are

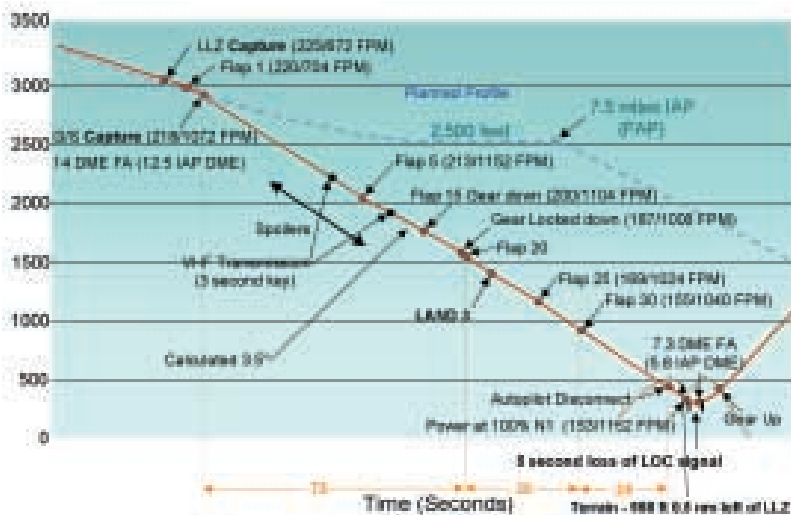
NZ60 Profile – First Approach Apia

Subsequent analysis of the flight data recorder information established that the aircraft had descended on a glide path of approximately 3.5° to a point approximately 5 1/2 miles short

of the runway with 'normal' localiser and glideslope indications displayed on the flight instrumentation.

It was established that the ILS glide path transmitter had inadvertently been left in control (monitor) bypass mode, with the unserviceable transmitter selected. In the bypass mode, the glide path transmitter executive monitor was unable to shut down the faulty transmitter or to transfer to the serviceable transmitter. The result was the radiation of invalid glide path information.
