VECTOR

Pointing to Safer Aviation

Circling Approaches

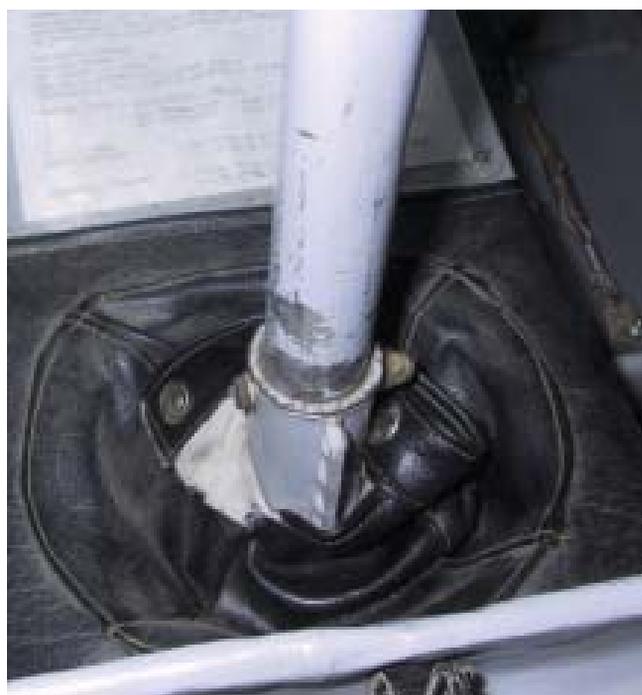
The rear control stick of a DH82A with its attachment assembly exposed.

Two serious, and potentially fatal, accidents have recently occurred in DH82 Tiger Moth aircraft where the master control stick (the rear control stick) was removed and then reinstalled without replacing the through bolt (refer to item A on the accompanying diagram). The clamping collar (item B) is then relying only on a 'friction grip' between it and the control stick for its retention. In both of these accidents the rear control stick actually pulled out of the clamping collar while in flight, the consequences of which were somewhat adverse.
