# VECTOR

*Pointing to Safer Aviation*

**Is Your Engine  
'Up to Speed'?**

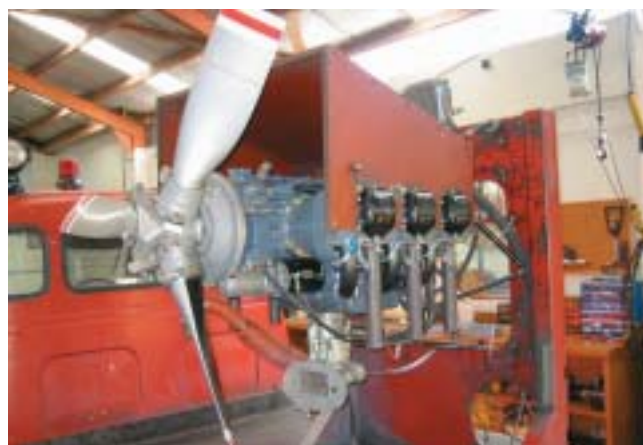
A Lycoming O-540 fitted with a test club propeller on the test stand.

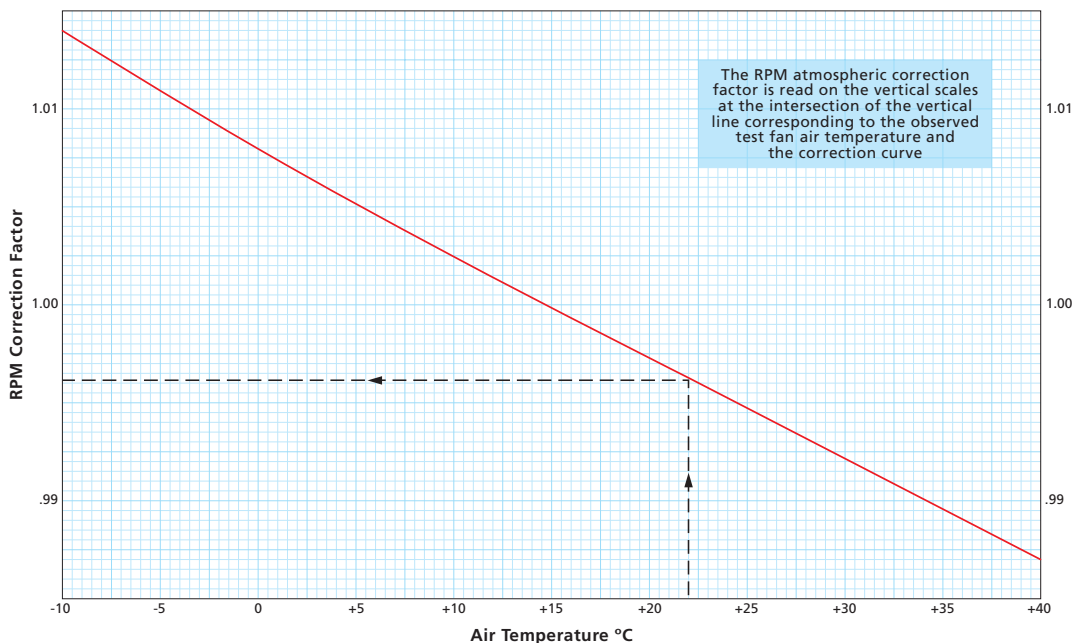
### ENGINE TESTING WITH PROPELLER TEST FANS

Correction of observed engine RPM for observed temperature conditions to the RPM obtainable on a standard day

When testing normally-aspirated engines at full throttle, it can be assumed that barometric change affecting the engine power, and therefore the tendency to increase or decrease engine rpm, are counter-balanced by the variation in fan loading. It is therefore necessary to correct for air temperature only and this is normally done at the time of engine overhaul with the aid of the chart above.

There is a correction chart available (commonly used by engine overhaul agencies when using a test club propeller) to relate the rpm achieved back to that which would be obtainable on a standard day. (See below.) This information is generally used by engine overhaul shops when they establish an engine's reference rpm. CAP562 *Civil Aircraft Airworthiness Information and Procedures*, Leaflet 7-5 has a good explanation of this and includes correction charts.

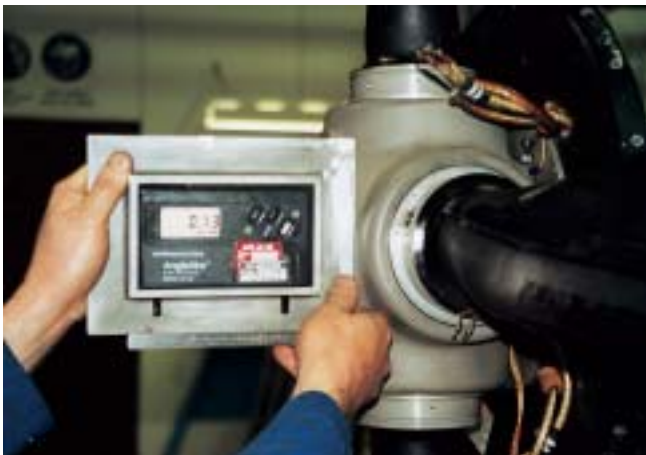
Obtaining the propeller reference plane before measuring the blade angle.

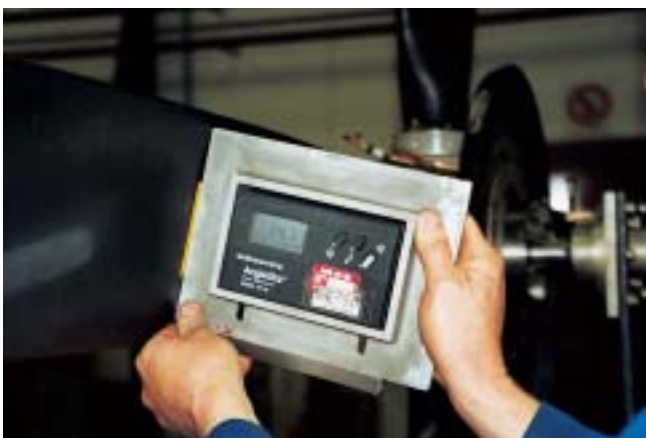
The blade angle being measured at the manufacturer's reference station, which is normally a specified distance from the propeller hub centreline.

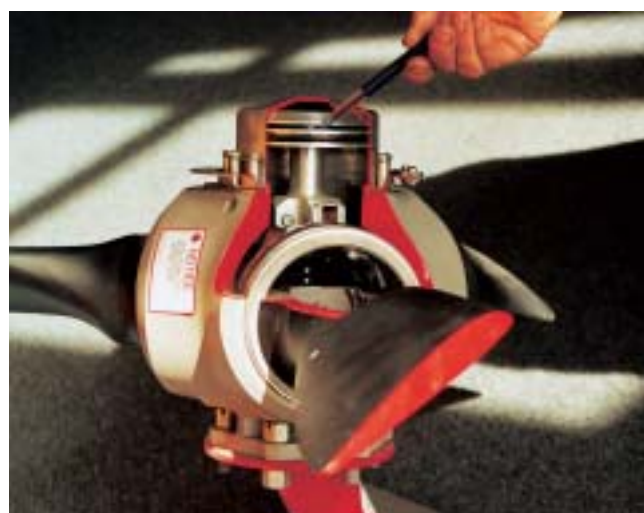
A cut-away of a McCauley C200-C400 threadless propeller showing the fine-pitch stop. Adjustment requires specialised tools and oil draining and is normally an overhaul shop task.

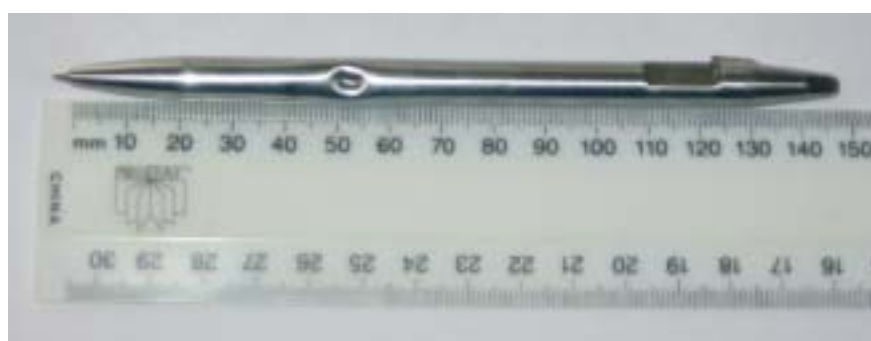
*The damage caused by a sprocket tooth.*

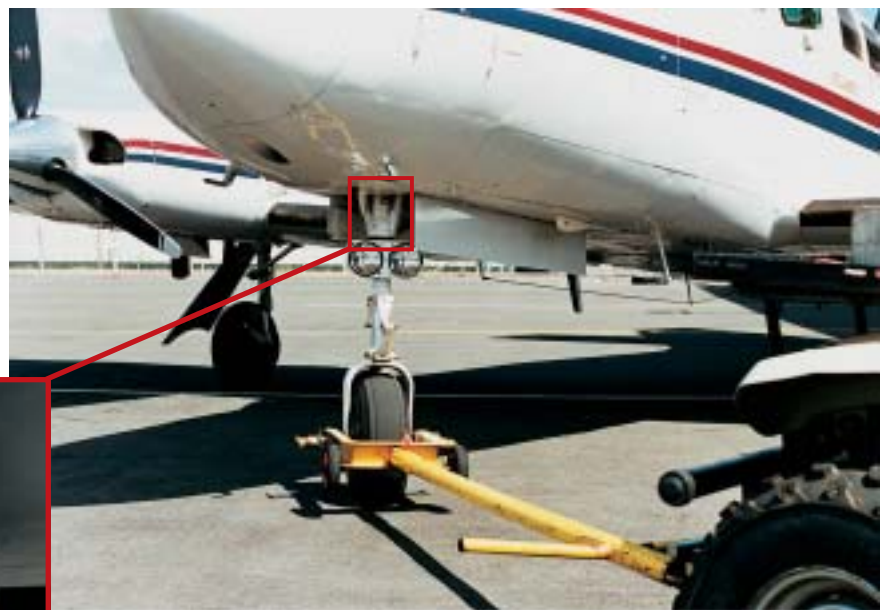
◀ The vertical red turning angle limitation lines and stopper are clearly visible on this Cessna 402 nosegear leg.
