# VECTOR

*Pointing to Safer Aviation*

May / June 2003

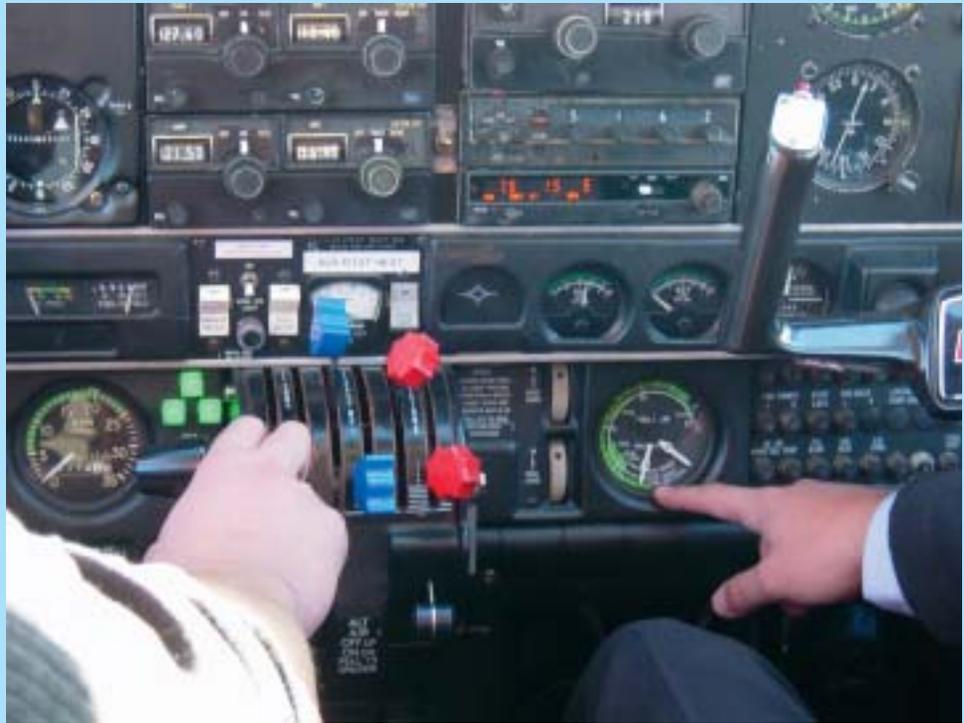
The student, when reaching 'fuel pumps OFF' in the checklist, mentally reverted to flying the other aircraft type and turned both fuel selectors (located between the two front seats) off

thinking that they were in fact the fuel pumps, the consequences of which did not become apparent until the loss of manifold pressure was noted. In the meantime, the student had also turned the lefthand engine magneto switches off confusing them with the landing light switches as the last item on the checklist. (The magneto switches are located directly above the landing light switches and have a cover over them to prevent them being inadvertently selected, which the student lifted.)

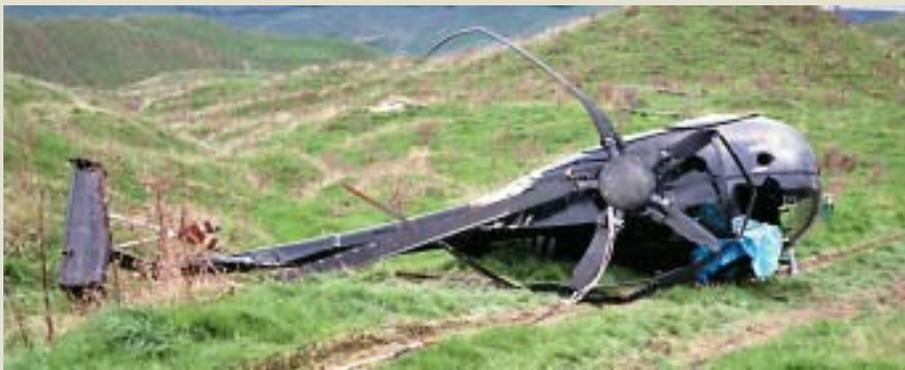
Photograph courtesy of TAIC.

During its investigation, TAIC found that experienced Hughes 369 pilots and instructors generally had a poor understanding of 'wet-line' instrument systems and, in particular, that a torque indication failure might be the first warning of engine oil loss. Because of this, the TAIC report recommended that there was

the need for pilots and operators to better understand this type of instrument system and know what the appropriate pilot response should be when erroneous engine instrument indications were observed.

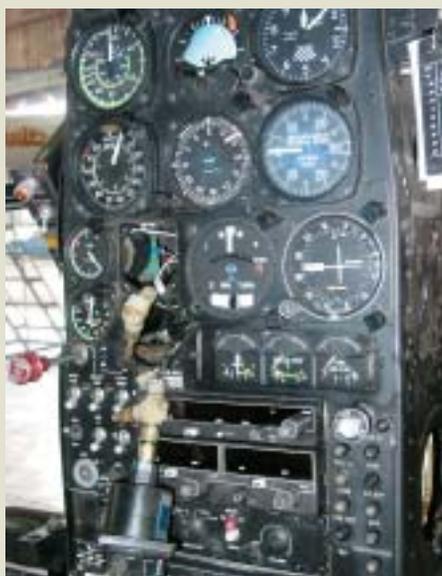
The accident helicopter's instrument panel, showing the broken torque and oil pressure gauge supply line fittings. Photograph courtesy of TAIC.

The pilot of the accident Hughes 369D had not been in the habit of monitoring engine torque gauge readings when making power changes, but instead referencing the TOT (turbine outlet temperature) gauge because it usually reached its limit first. This meant that he had little awareness of the torque gauge readings at any stage during the flight, and that the first warnings of an impending engine failure were lost.
