VECTOR

Pointing to Safer Aviation

Multi-Engine Turboprop EFATO Training

Even Worse than the Real Thing

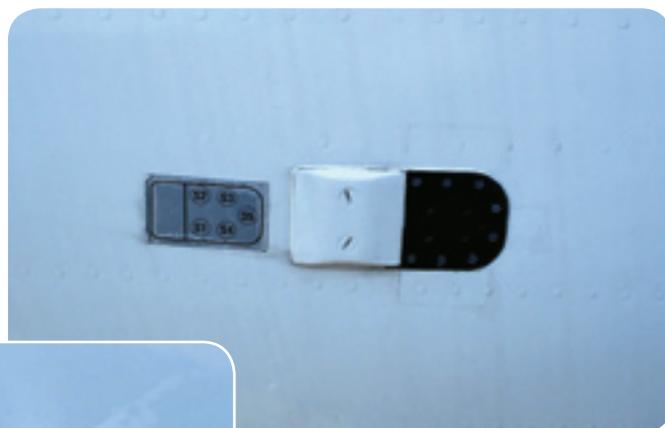
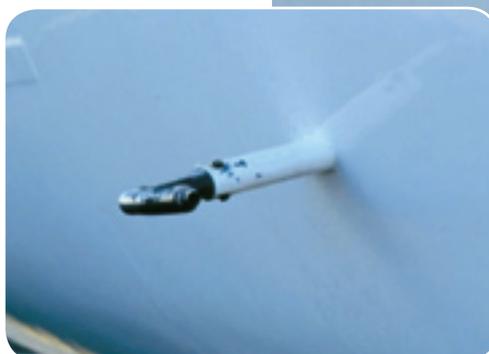
The lefthand instruments were thought to be most in error, because the indication of the righthand altimeter was closer to the Mode C indication. The crew thought that the transponder may have had an independent static source. The alternate static source was selected on the lefthand side. On doing this the lefthand altimeter rose a further 4000 feet, now making it 5000 feet higher than the righthand altimeter, and the fourth different indication of aircraft altitude – the present lefthand indication, the previous lefthand indication, the righthand indication and Mode C indications.

Because the alternate static source is considered unreliable on this aircraft type, and because the altitude indication was more extreme, the crew considered the indication from the alternate static to be less reliable and chose not to select alternate static on the righthand side.

Although not in the EAC procedure, the crew decided to depressurise the aircraft. The aircraft was depressurised in stages. After each step ATC reported a rise in the Mode C altitude. The indicated altitude on the righthand altimeter also rose, and the ASI indications increased. When completely depressurised the lefthand altimeter (still on alternate static) now agreed with the righthand altimeter, and also with Mode C. The ASIs indicated the approximate performance expected. Without further incident, the flight continued to Auckland, where a visual approach was made.

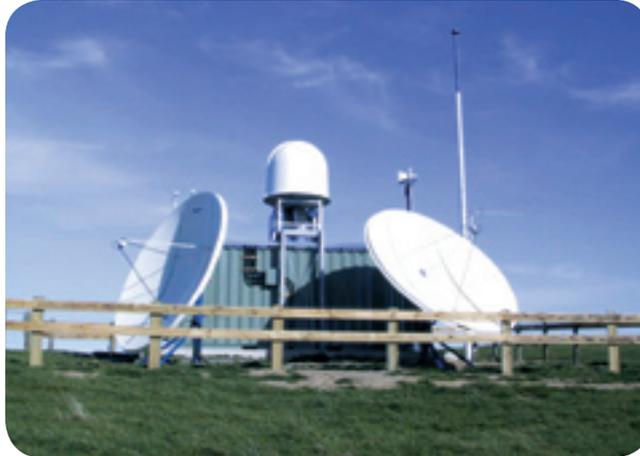
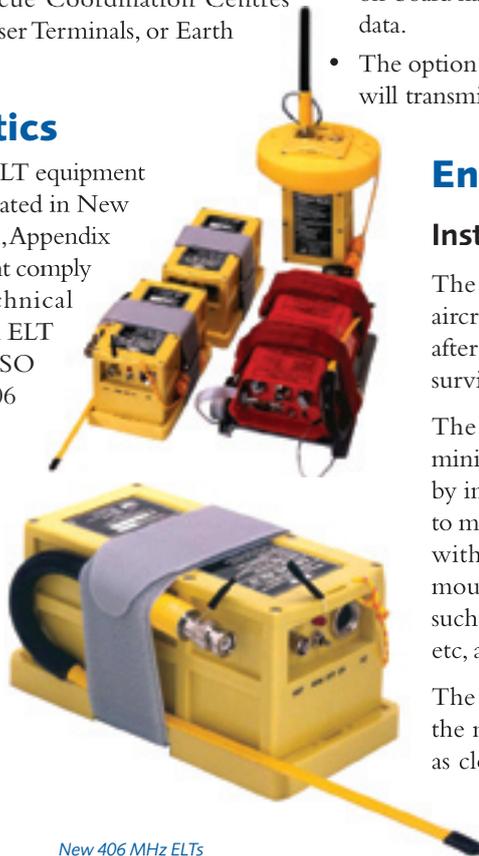
New 406 MHz ELTs

- Better positioning accuracy.
- A much lower false alert rate.
- The ability to incorporate a GPS module or interface with on-board navigation systems to provide highly accurate position data.
- The option of a self-contained GPS, which, after initialisation, will transmit the beacon location.

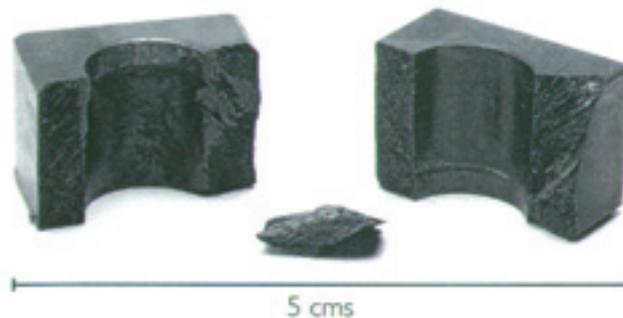
The New Zealand agents for the propeller, Aeromotive Ltd of Hamilton, quickly found the problem. A small plastic spacer in the hub had fractured, due, they believe, to a lack of grease. The problem of grease escaping from those hubs was well known. The manufacturer, MT Propeller of Germany, had previously issued two engineering changes to alleviate the problem, with little success. They have now

requested that the hub be sent back to their factory in order to make their third change. I really hope that it works this time. The initial minor vibration I felt after takeoff was probably due to the first piece of the spacer coming free and altering the balance.
