VECTOR

Pointing to Safer Aviation

VECTOR CAA NEWS

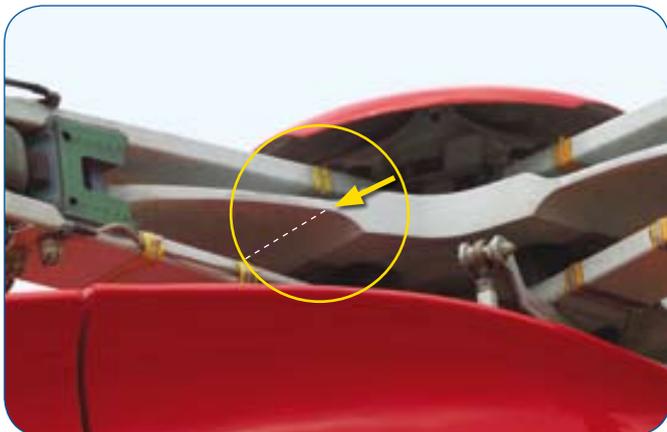
The line of cross-section change was the line of the impact failures.

The initial damage to the three helicopters was very similar – the shock of the strike (near the tip in each case) was transmitted to the Starflex™ head by a very long lever – the main rotor blade. The resulting moment was sufficient to tear the star arm completely through, along the line of the cross-section change (see picture). (A similar leverage mechanism caused the wing of the Cherokee to fail at the root, despite the strike in a relatively 'soft' area of the tip).

This gave one blade unlimited freedom in the plane of rotation – with a major shift in the centre of gravity of the rotor system. The forces resulting from the imbalance were immense, as in all three cases the entire main rotor system **and transmission** were torn bodily from the airframe. Freeze-frame the imagination there if you like.

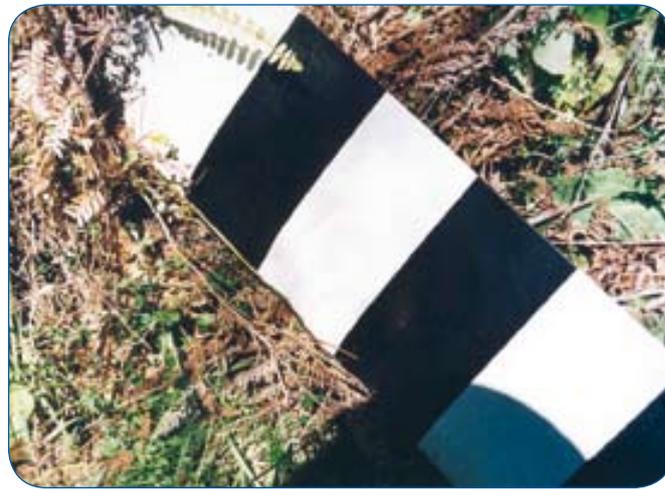
The seemingly minor dent on this Iroquois tail rotor blade was caused by a flailing longline that had been picked up by the main rotor.

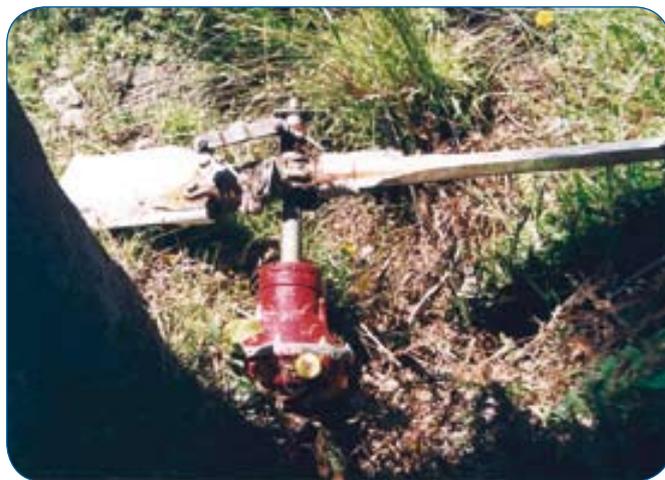
The result of the strike was the departure of the tail rotor and 90-degree gearbox from the airframe.

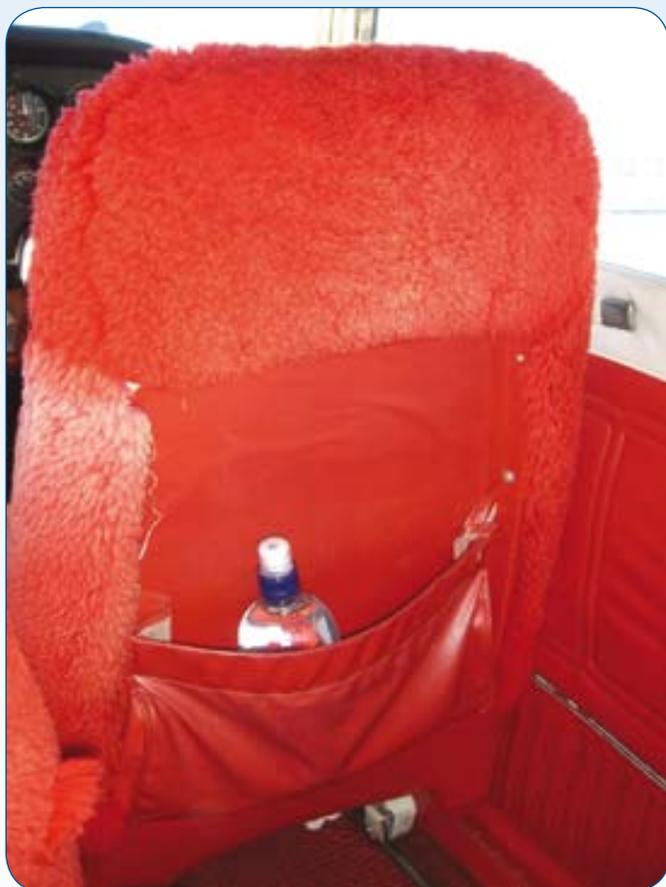
Ensure your water bottles are safely stowed so they don't fall onto the cockpit floor and possibly interfere with the rudder pedals.

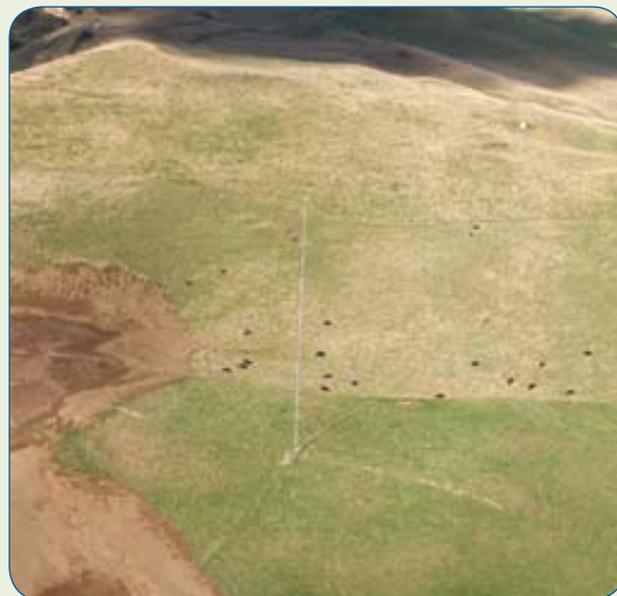
From the photograph, it can be seen that this mast is very hard to see even in good weather. The ground at the site is approximately 300 feet **amsl** (100 metres), and the mast height is just under 200 feet **agl** (60 metres). If the pilot had been at 500 feet **amsl** over the sea, then the turn inland would indeed have been a hazardous manoeuvre. Now there's a lesson.

One such mast is situated on the west coast of the North Island, just 13 NM north of Raglan aerodrome and about 6 NM south of Limestone Downs aerodrome. We believe this is a corridor that many use for VFR transiting to and from the Auckland area.

On a recent occasion in the vicinity of this mast, because of deteriorating weather, a pilot turned inland in order to preserve his horizon. Because the mast was on top of a hill right on the coast, and reportedly reaching about 600 feet above sea level, he nearly collided with it. The pilot acknowledged that he probably infringed the 500-foot-agl rule.

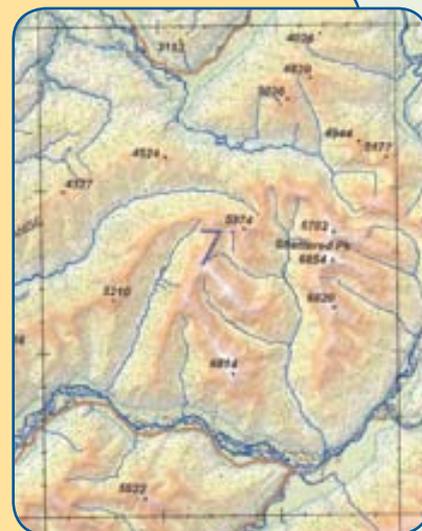
Have you ever wondered what are those 2-figure (sometimes 3) numbers that appear in each grid rectangle on Visual Navigation Charts? They are called Maximum Elevation Figures, MEFs. The large figure(s) are thousands of feet of altitude, the smaller figure hundreds. For example, **12⁵** means 12,500 feet amsl, and **9⁴** means 9400 and **0⁹** means 900.

Have you ever wondered how are they arrived at? For each rectangle, the altitude of the highest contour and the highest spot height are determined. To each of these is added 50 metres (164 feet) of allowances for mapping inaccuracies. The altitude of the top of the highest mast-like obstacle is also determined, but no allowances are added to this. The highest of these three altitudes is taken as the ruling altitude. This is converted from metres to feet, then rounded up to the nearest 100 feet to arrive at the MEF.

Have you ever wondered how to use them? Simple! If you flew at the MEF your clearance from the highest obstacle in the rectangle would be anything between 1 foot and 264 feet – not good. **Treat MEFs as representing solid obstacles. Add your 500-foot (or 1000) safety margin to the MEF to determine a minimum safe altitude in the rectangle.**

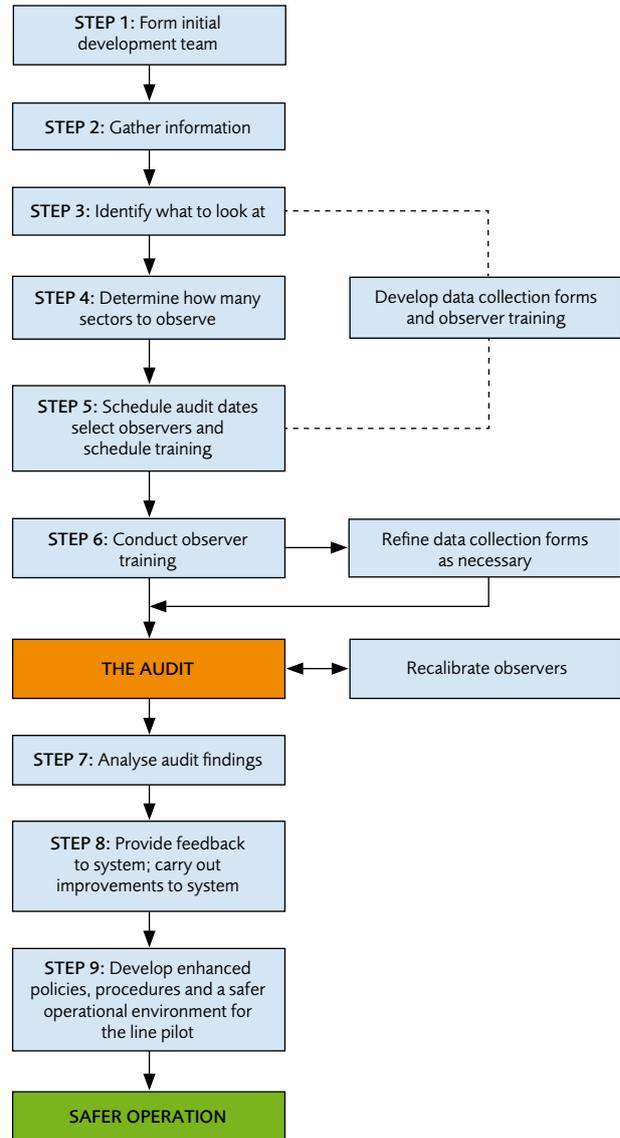
Figure 1: The key steps to LOSA

Figure 1 shows a flow chart of the key steps to LOSA.
