VECTOR

POINTING TO SAFER AVIATION

CIVIL AVIATION AUTHORITY
OF NEW ZEALAND

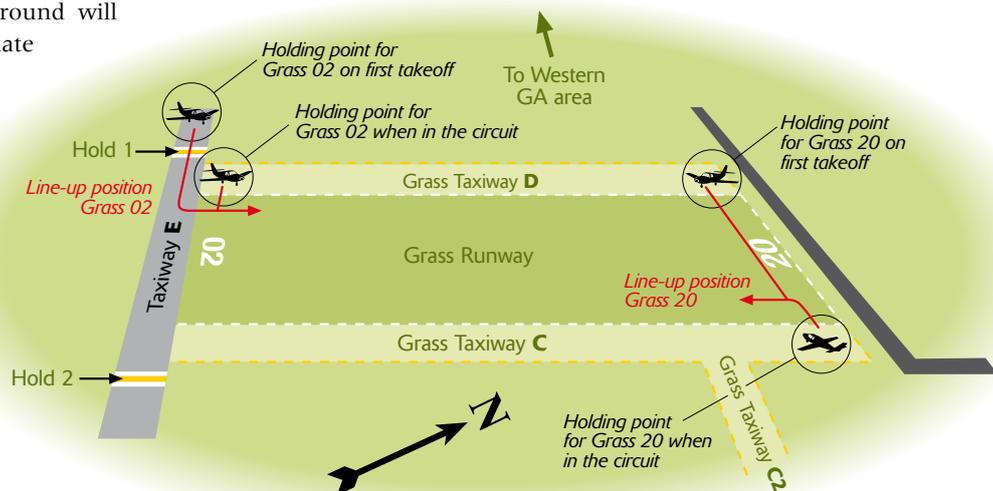
Grass Runway Line-Up Positions

When ready at the holding point, contact Christchurch Tower (118.3 MHz). If wake turbulence has been generated by sealed runway traffic, you may be kept at the holding point in order to keep the grass runway clear for landings. Christchurch Tower will give a line-up or takeoff clearance. Unless instructed otherwise, line up on the lefthand side of the grass runway, allowing reasonable space on your right for other aircraft to land or take off. When holding on Taxiway D for Grass 20 you should taxi across the full width of the grass runway to line up on the lefthand side, as shown in the diagram.

the sealed runway for departure, or if you would like a particular departure procedure. If using the grass, Christchurch Ground will issue a taxi clearance to the appropriate holding point. If you are departing from the western GA area and Grass 02 is in use, you will be cleared to Hold 1, located on Taxiway E, and if Grass 20 is in use you will be cleared to Grass Taxiway D. This clearance will normally include your VFR departure instructions as well.

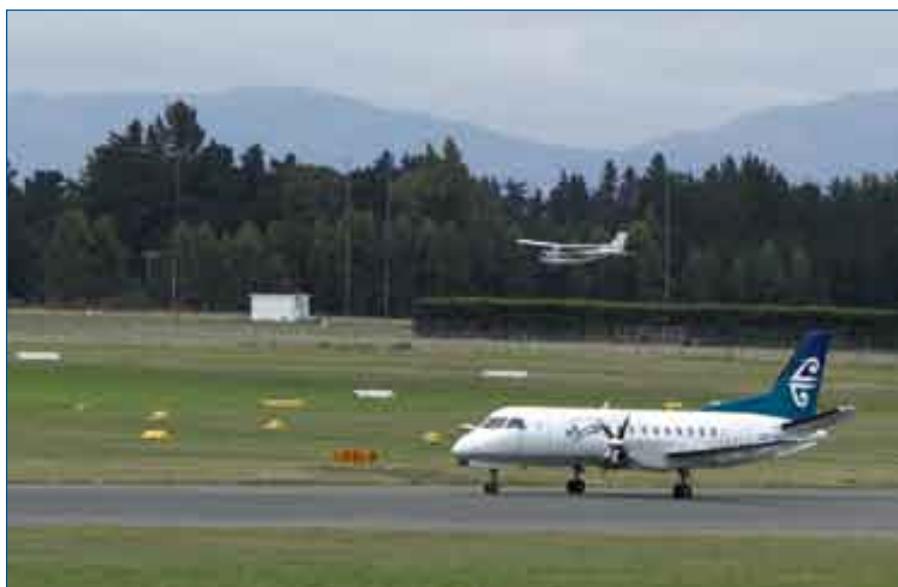
Simultaneous operations on the parallel grass and sealed runways at Christchurch.

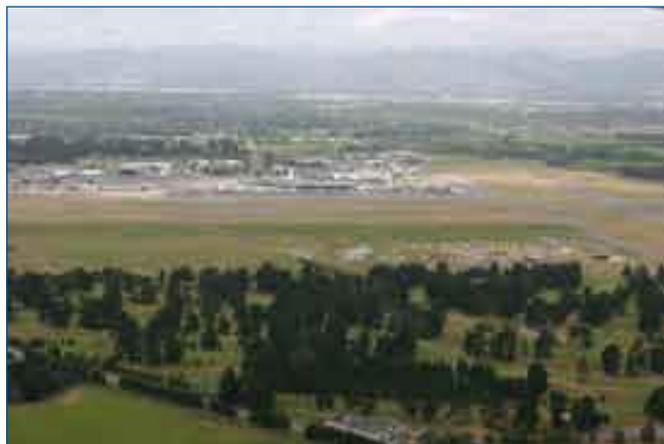
Downwind for the grass runway abeam the Grass 20 threshold.

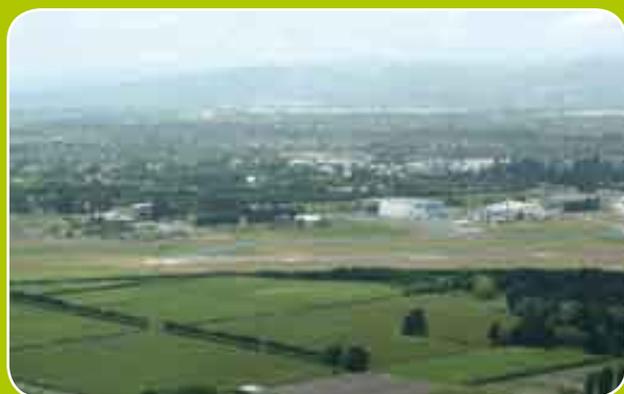
Base for Grass 20. Do not go any further north than the sealed runway threshold shown.

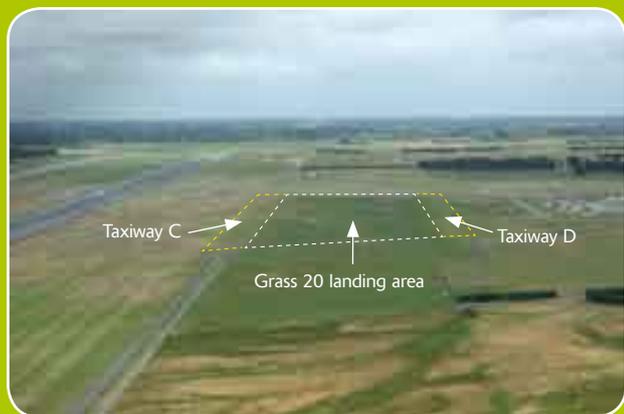
Final for Grass 20. Note the traffic landing ahead on the grass runway and departing from the sealed runway.

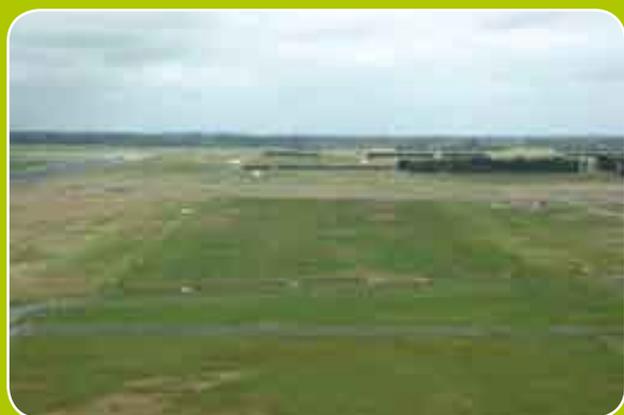
Short final for Grass 20. Note how difficult it is to see the white marker boards. There is an aircraft on Grass Taxiway C.

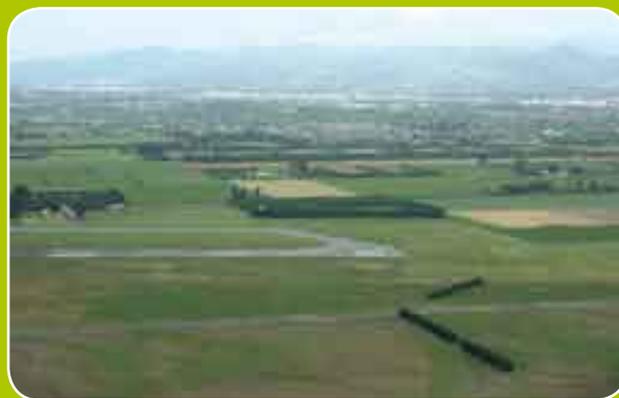
Base for Grass 02. Do not go further south than the sealed runway threshold shown.

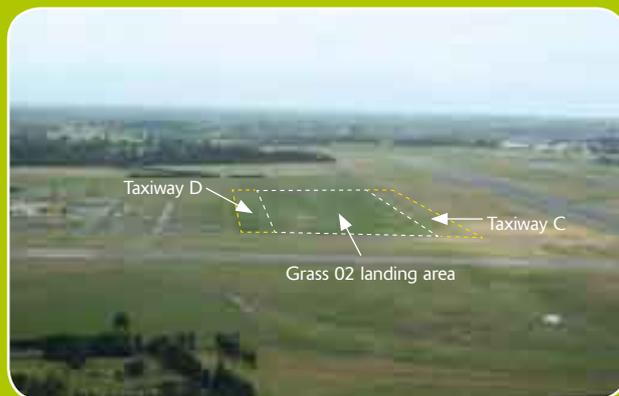
Turning final for Grass 02.

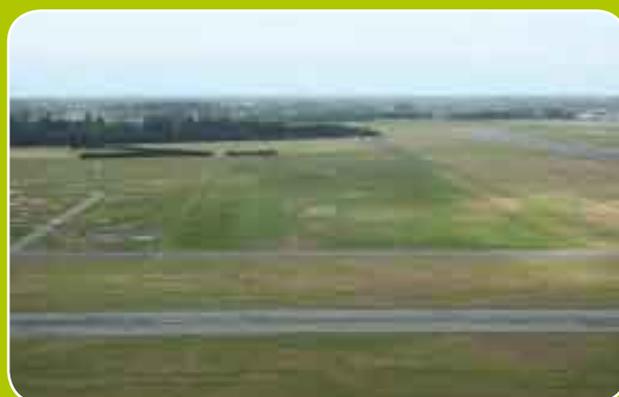
Short final for Grass 02, lined up on the left side of the runway. Note how difficult it is to see the white marker boards.

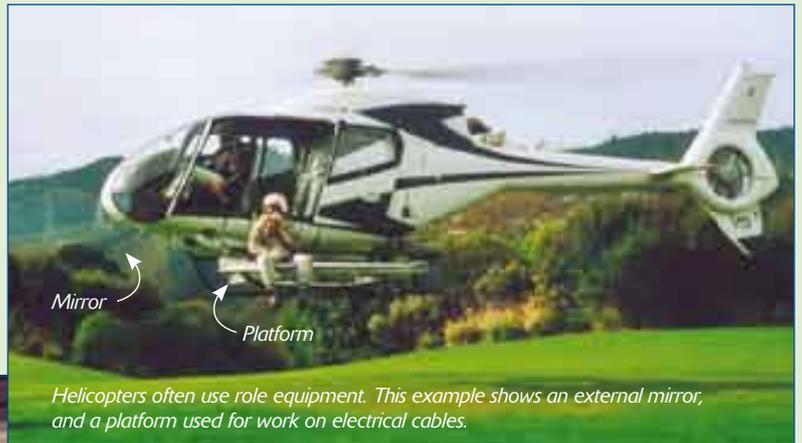
Mirror

Platform

Helicopters often use role equipment. This example shows an external mirror, and a platform used for work on electrical cables.

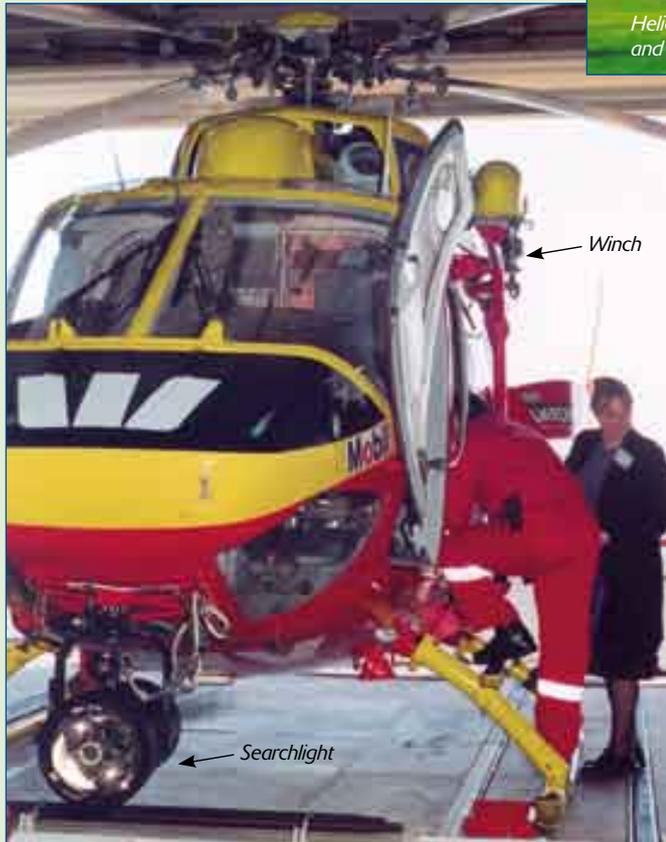
Winch

Searchlight

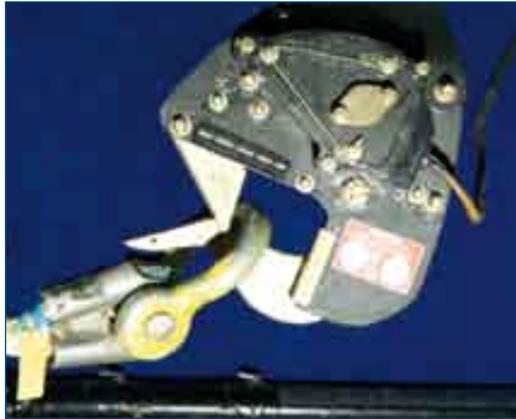
Since the publication of the last issue, two readers (both helicopter pilots) have been in touch regarding the article on sling loads. They point out that in the fourth photo the use of a small link or shackle can result in the shackle being caught on the hook tang on release, when the shackle is under

tension. This means that it may be difficult or impossible to jettison a load in an emergency, or the pilot may find that the load is still firmly attached to the hook even though the release mechanism has been operated.

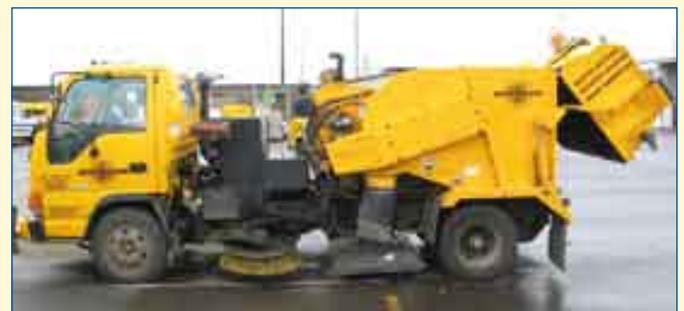
Nightly Apron Sweeping

A contracted company using a mechanical sweeper is available every night, 365 days per year. Prior to the inception of the new task force, the International Terminal

Building stands were swept on a random basis. Now every available stand, remote stand, and the inner pier road are swept every night, together with 'hotspots' identified by airfield staff on a daily basis. The driver holds a Stage 2 Airside Driving Permit meaning the vehicle can be driven on the movement area.

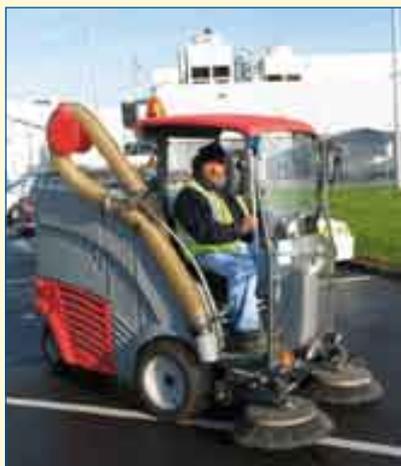
Mini Sweeper

Almost two years ago, AIAL contracted one of their most effective combatants of FOD, the new grounds overseer Peter Robinson. A horticulturist by trade, Peter has become a proactive member of the task force. He instituted the purchase of our own mini sweeper which is operated by the AIAL grounds people. He has set up an improved sweeping policy to supplement that of the contract sweeper. The unit is able to get right into those inaccessible areas as it is only just over a metre wide. The vehicle also has a vacuum arm that the driver can operate from his seat to get into awkward corners.

Mii Sadaraka operating the mini sweeper.

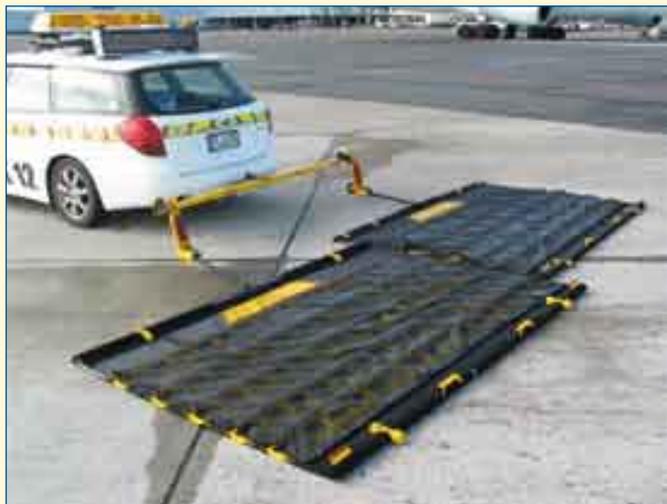
Soon after the task force began, a FOD 'Boss' was purchased. This tow-behind sweeping tool has proved to be a highly efficient means of removing FOD. Just point the vehicle, drive over the FOD and 'voila', the FOD is gone. The unit can be towed by all airfield operations vehicles and is regularly used by the team of airfield officers and part-time safety officers who oversee airfield projects.

The 'Boss' was used extensively in the final stage of the four-year runway rehabilitation. The outboard engines of large aircraft were blowing loose material onto the taxiways, but two or three runs with the 'Boss' picked everything up.

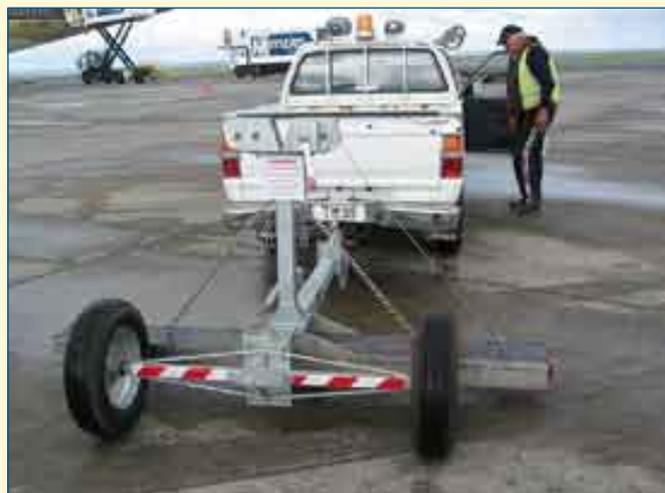
Magnetic Sweeper

In consultation with a local supplier, Cliff Jones has designed a magnetic sweeper that can be used by apron staff.

It is a permanent magnetic system with a life of 10,000 years. Due to its power, special rules have been introduced. For example, watches, mobile phones, credit-type cards with a

magnetic strip, and Airport IDs have to be kept half a metre away. The unit is not parked where it could affect magnetic equipment in aircraft.

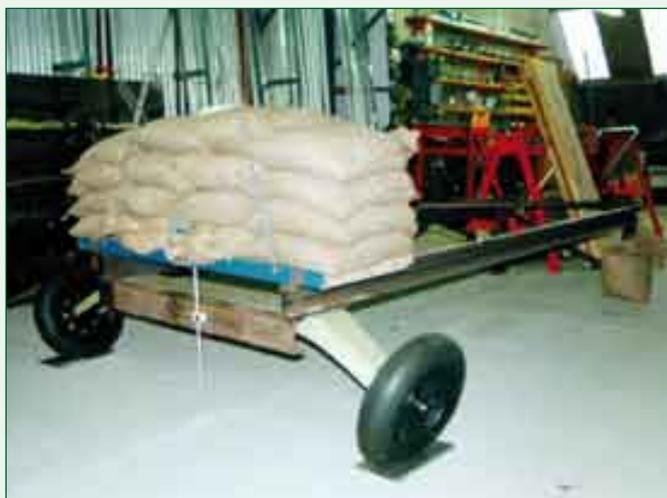
Undercarriage 'drop testing' is part of the certification process. The undercarriage of the Bantam B22J is constructed of fibreglass.

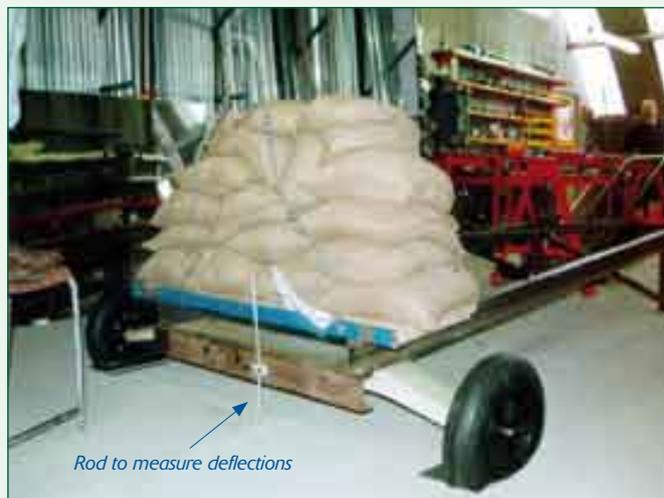
A test weight of 450 kg is dropped from a height of 224 mm to simulate load forces on the undercarriage.

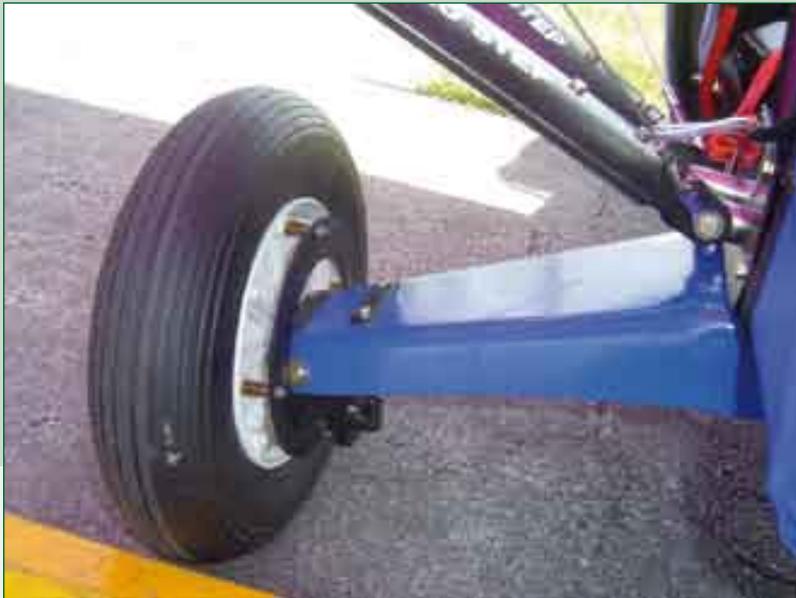
The Bantam B22J undercarriage.
