VECTOR

POINTING TO SAFER AVIATION

CIVIL AVIATION AUTHORITY
OF NEW ZEALAND

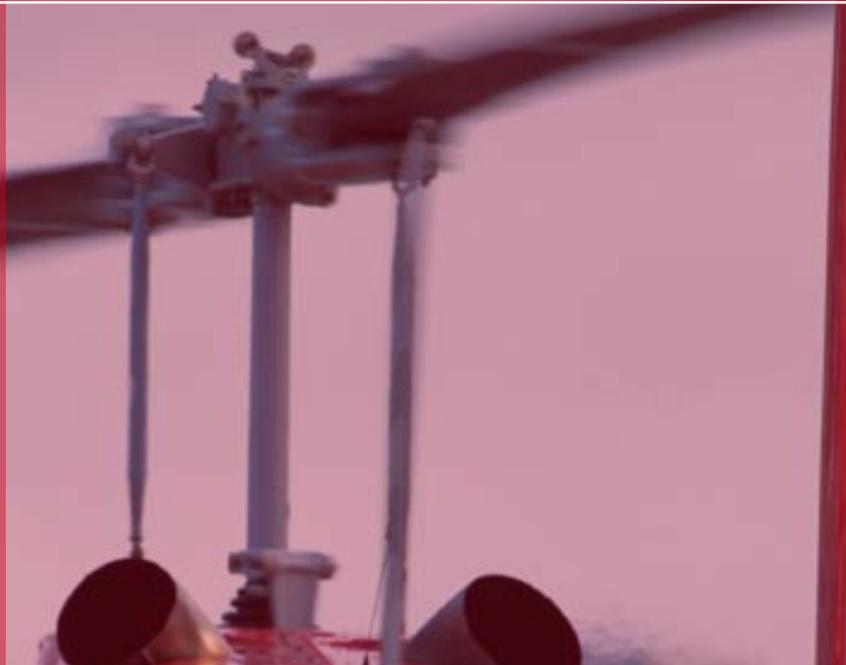
The above is part of the abstract of TAIC report 04-003. It states that the accident resulted from fatigue failure of a tension-torsion (TT) strap, a critical rotor hub component.

The TT strap bears the centrifugal loads of its associated main rotor blade, transferring them to the hub assembly, while still permitting movement of the blade about its feathering axis. On this particular helicopter, the TT strap assemblies comprised a one-inch (25.4 mm) stack of 50 stainless steel laminates each 0.020 inches (0.50 mm) thick. The laminates were 16 inches (406 mm) long, measured between the retaining pin holes at each end. The centre 30 laminates were 1.6 inches (40.7 mm) wide, with 10 laminates, half that width on either side.

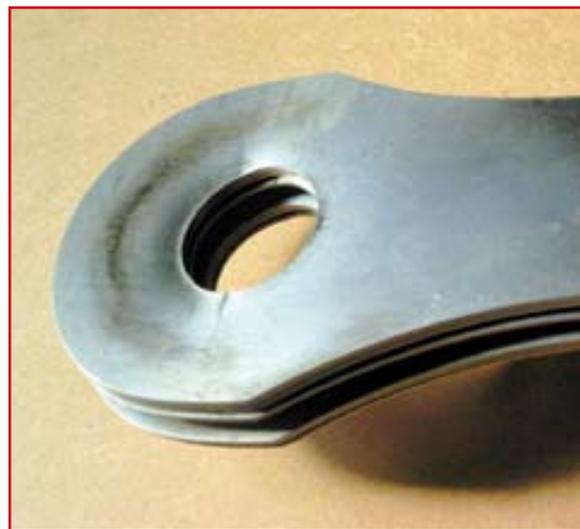
Damage at the TT strap retention pin hole.

Metallurgical examination of the failed TT strap found that the majority of the laminates showed low-cycle, high-load fatigue cracking initiating at the anchor pin holes and spreading across the strap. A few of the narrow laminates had failed in overload about mid span, stretching

up to 40 mm before failure. All laminates showed buckling of varying severity due to overload at the anchor pin holes – those with less buckling also had about 80 percent of fatigue striations across the fracture surface, indicating that their failure had occurred before the final overload event.

The other strap had not failed but had two laminates that had, and several with visible cracks. The fracture surfaces showed fatigue patterns similar to the failed strap. All laminates had overload-related buckling at the anchor pin holes. Fretting on the tensile load bearing surfaces of the anchor pins and the

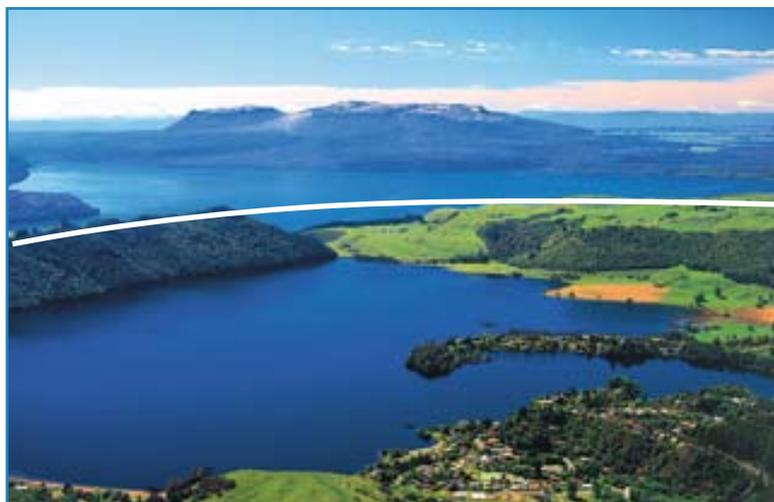
Lake Okataina (foreground) looking southeast across Lake Tarawera towards Mount Tarawera. The line marks approximately the boundary between the Rotorua CTR/D and the Mount Tarawera MBZ.

Caution is required when operating over Mount Tarawera (elevation 3644 feet), as controlled airspace starts at 4500 feet. Flying wide allows more terrain clearance. During windy conditions considerable updraughts and downdraughts occur in the area, and it may be prudent to obtain a clearance from Christchurch Control (119.5 MHz) to fly in controlled airspace above the MBZ.
