VECTOR

POINTING TO SAFER AVIATION

Forced-Landing Practice

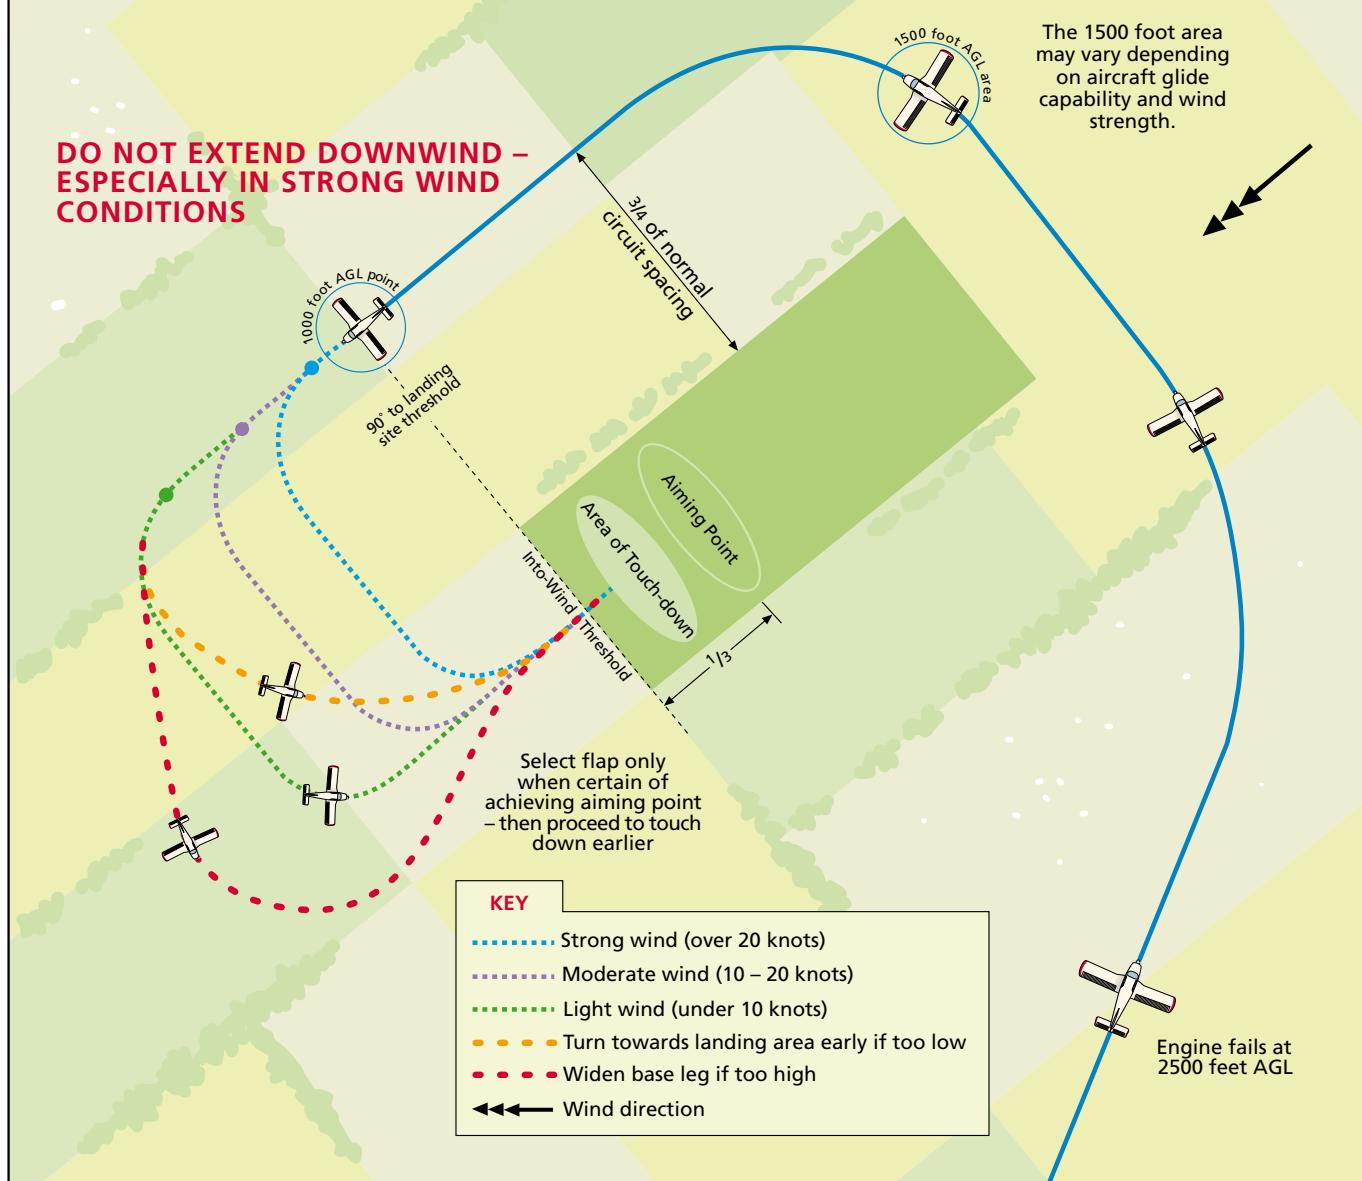
Planning an Approach to a Landing Site

Now that you have selected the most suitable into-wind landing site, you must plan your approach to it. This is one of the most important phases of the FLWOP process. A well planned approach profile will put you into a position from which you can turn onto a base leg at the correct height, and continue with a landing approach which is likely to have a successful outcome. The approach should be planned from the ground up. The following sequence is suggested for planning an approach to a landing site:

The stronger the wind the earlier you will need to turn on to a curved base leg (see diagram). Extending downwind in windy conditions would mean a very slow groundspeed on final approach, possibly causing an undershoot.

Cover: Selecting your landing site and planning your approach are critical to a successful forced landing. The diagram on page 5 illustrates the critical points.

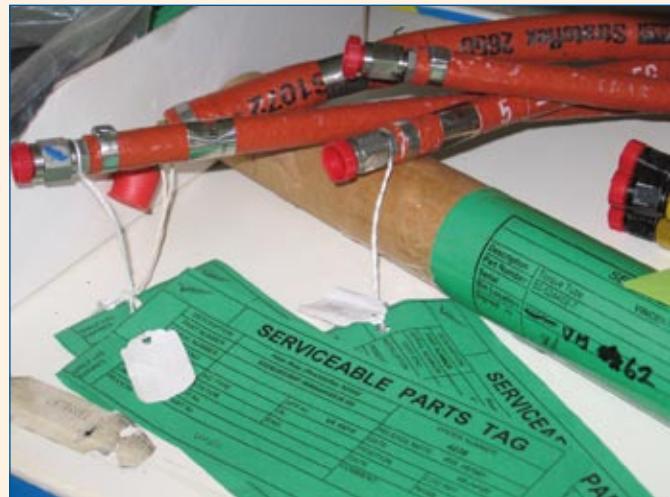
Advisory Circular (AC) 20-2A *Acceptability of parts* provides acceptable methods for showing compliance with Part 21, Subpart K and Part 43, Subpart B relating to the use of acceptable parts on type certificated aircraft. According to the AC, for this part to be acceptable, it should have been accompanied by at least an FAA Form 8130-3 *Airworthiness Approval Tag*, which is an "Authorized Release Certificate" under the FAA system. To be eligible for export from the USA, the part was required to be accompanied by a Form 8130-3. A specimen Form 8130-3 is shown opposite.

to export, and this form should have been forwarded on to the New Zealand purchaser. Any such part arriving from the USA and not accompanied by a Form 8130-3 should be regarded as not acceptable. The first step to rectify this situation should be to request the form from the supplier, and ask for an adequate explanation as to why none was provided. In the best case, it could have been a simple clerical error on dispatch; in the worst case, the part could be counterfeit, or 'bogus'.

12. Status/Work:					
13. Remarks:					
14. Certifies the items identified above were manufactured in conformity to: <input checked="" type="checkbox"/> Approved design data and are in a condition for safe operation. <input type="checkbox"/> Non-approved design data specified in Block 13.			19. <input type="checkbox"/> 14 CFR 43.9 Return to Service <input type="checkbox"/> Other regulation specified in Block 13 Certificates that unless otherwise specified in Block 13, the work identified in Block 12 and described in Block 13 was accomplished in accordance with Title 14, Code of Federal Regulations, part 43 and in respect to that work, the items are approved for return to service.

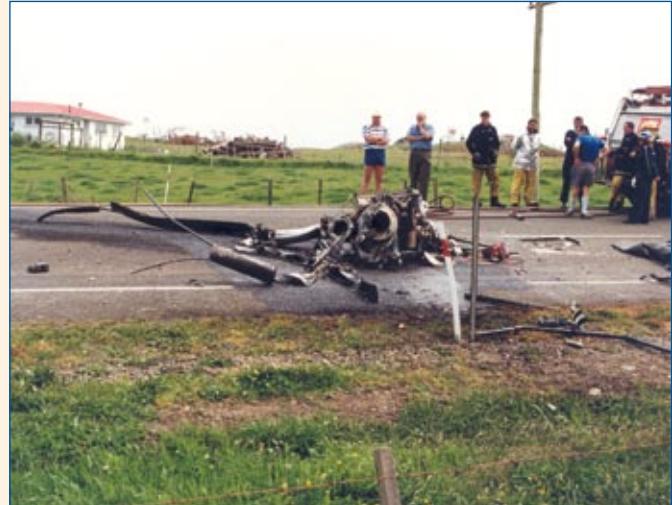
Worst case scenario: this fatal accident was a direct result of fitting bogus parts to the aircraft.

A classic case of 'bogus' parts was found during the investigation of a Robinson R22 helicopter accident some years ago. A tail rotor blade separated in flight, resulting in a loss of control and ensuing ground impact that killed both occupants. The tail rotor was found to be a non-standard part that had been fabricated from accident-damaged blades by an unauthorised person or organisation in the USA, and imported into New Zealand. To all appearances, the tail rotor blades were genuine, and this appeared to be backed up by the entries in the logbooks of the helicopter on which they had previously been fitted.

The workmanship and materials used in the remanufacture were well below standard, and readily detectable once the blades were opened up – but in their 'as presented' state, they were indistinguishable from genuine blades.

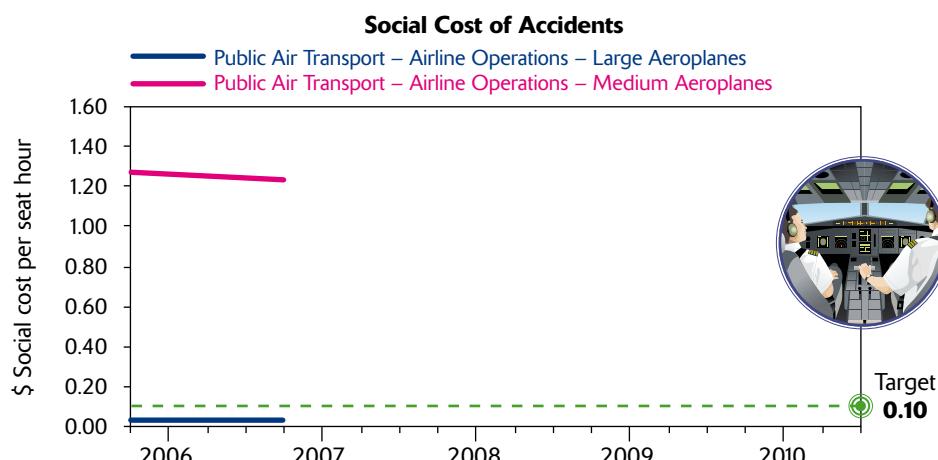
Results for the first 15 months (to 30 September 2006)

Large aeroplanes are already well below their target of \$0.10 per seat hour.

Medium aeroplanes are considerably above their target, although they are trending down. The target for this sector has been calculated over a 10-year average, and a single Metroliner crash two years ago has caused a serious spike in the trend line. It will not be possible for this sector to achieve its safety target until after 2010.

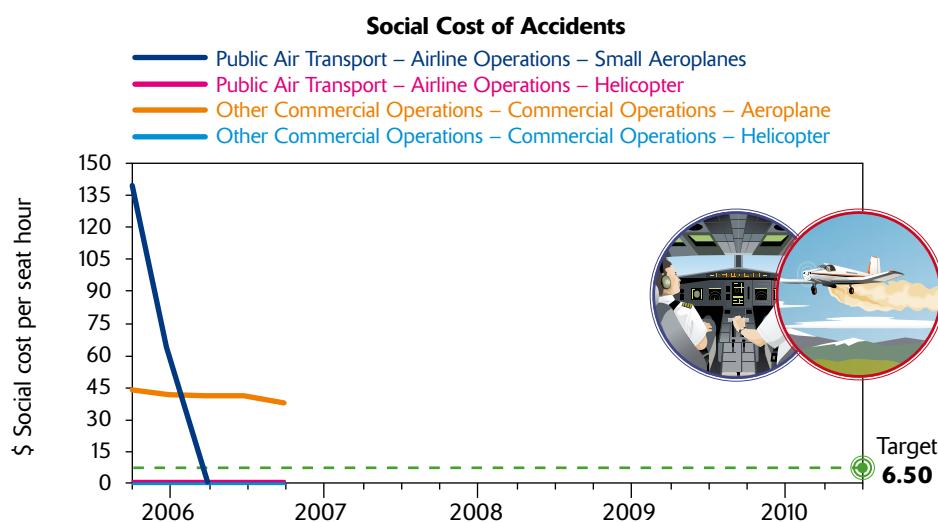
Airline operations – small aeroplanes is showing a significant downward trend from the high starting point created by six fatalities in late 2004 and early 2005. This group has been under its target level since April 2006.

Both helicopter airline operations and other helicopter commercial operations are well below their targets. There have been no fatal or serious injuries for these sectors since 2003.

However, the other commercial operations – aeroplane sector is well above its target, although trending down. If this trend continues, the sector could be on target by April this year.

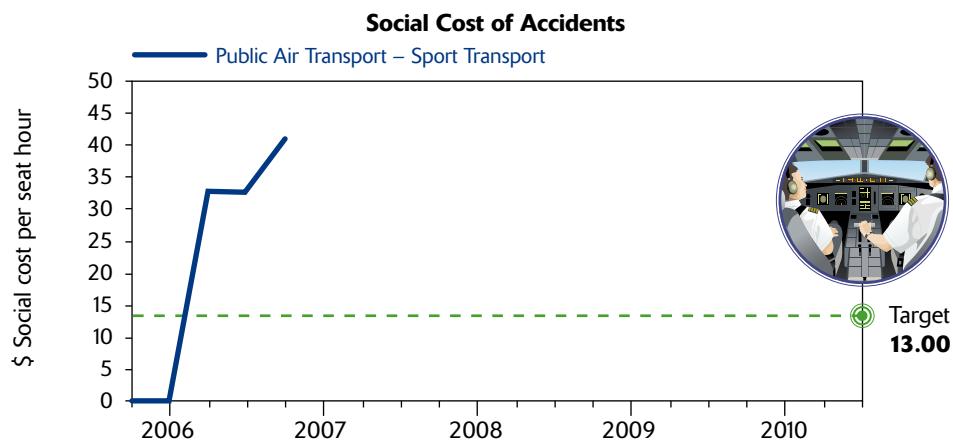
The sport transport sector is well above its target and is trending up. There have been five serious injuries in this group since the new target was set.

The activities in this group are currently commercial hang gliding, paragliding, ballooning, and parachuting.
