VECTOR

POINTING TO SAFER AVIATION

Syndicate Installs Traffic Advisory System

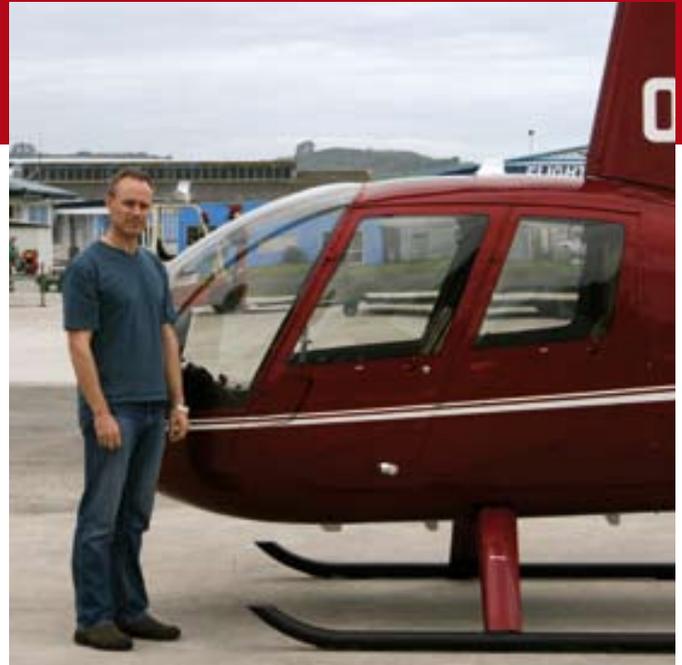
The author, Dave Saggs, and ZK-HOX. The upper aerial and front lower aerials (see left) are used by the TAS600 to give best coverage and aircraft detection.

South Pacific Avionics and Heliflite Pacific at Ardmore installed the box, wiring, two aerials, one above and one below the cockpit, and interface with the Garmin 420. We have an instant mute button on the cyclic that mutes an individual target, and a master mute on our intercom system so we can turn all the aural warnings off when in the circuit. If the instant mute button is pressed twice rapidly it will bring up all current aural warnings, even if you are sitting on the ground.

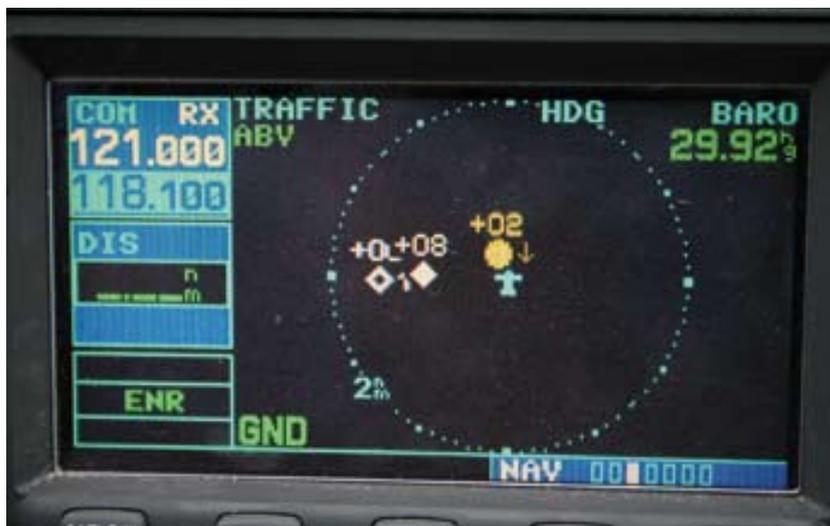
Not a sight you ever want to see. This is another aircraft a very short distance away, 200 feet above, but descending.

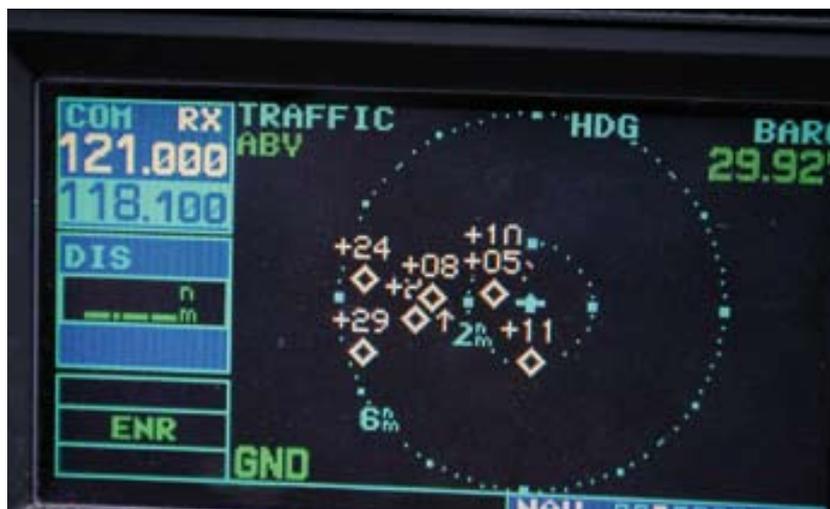
Just another busy day at Ardmore. The two aircraft on the left showing +24 (2400 feet above) and +29 are departing from Runway 05 at Auckland International Airport.

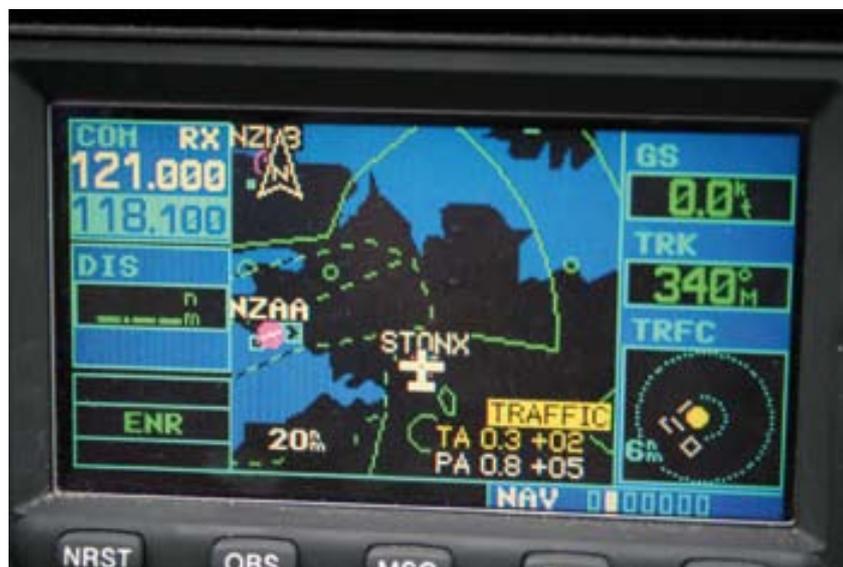
The Map page, showing a Traffic Advisory (TA), which is traffic within 500 feet altitude and not diverging. The Proximity Advisory (PA) is traffic within 500 feet altitude but not as high a risk as a TA. On the bottom right is a thumbnail of the traffic's position.

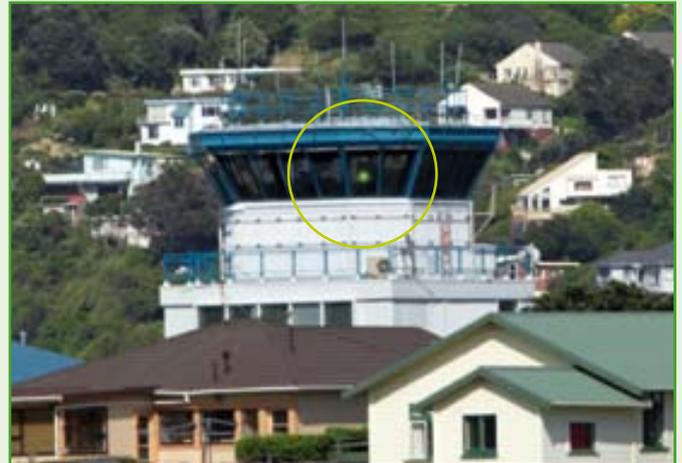
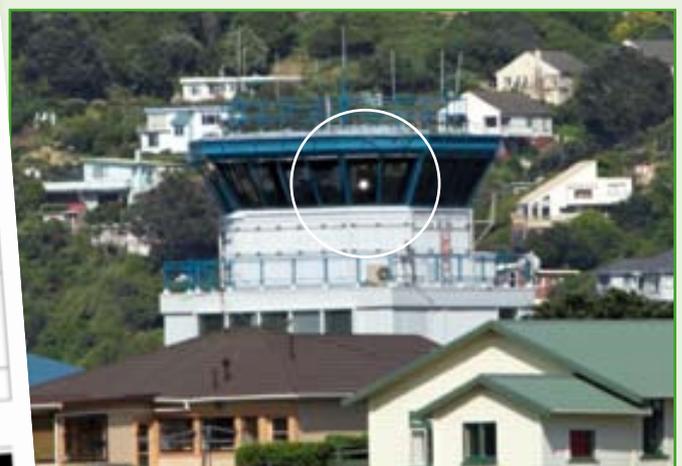
A tower signalling an aircraft. This is what a pilot will see. (Note that towers and lights vary.)

Visual signals from a tower are used to communicate an instruction to the pilot. The pilot is expected to comply, and acknowledge the instruction by rocking the wings of the aircraft.

Colour and Type of Signal	To Aircraft in Flight	To Aircraft on the Aerodrome
Steady green	Cleared to land	Cleared for take-off
Steady red	Give way to other aircraft and continue circling	Stop
Series of green flashes	Return for landing*	Cleared to taxi
Series of red flashes	Aerodrome unsafe — do not land	Taxi clear of landing area in use
Series of white flashes	Land at this aerodrome and proceed to apron*	Return to starting point on aerodrome
Series of alternate red and green flashes	Danger — be on the alert	Danger — be on the alert
Red pyrotechnic	Notwithstanding any previous instructions do not land for the time being

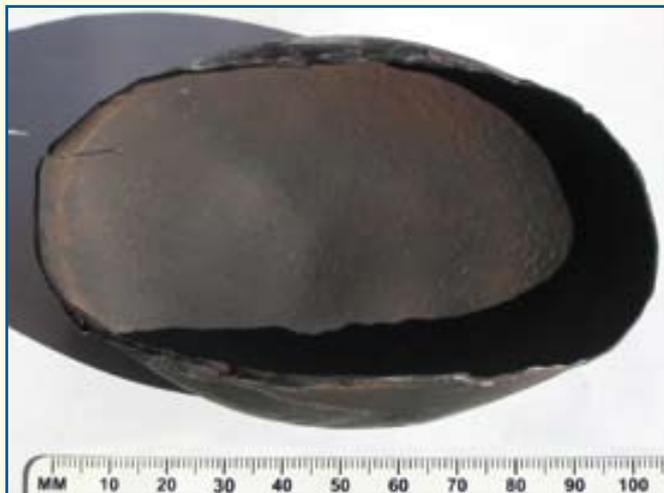
In the absence of an aircraft turning up with a piece of its exhaust obviously missing, theories about it being an internal component blown out had to be considered. The object is 6.5 cm wide at the widest point, which means that any exhaust outlet would need to be wider to eject the component.

likely from a piston powered aircraft. But which type, and whereabouts in the exhaust system had this piece of FOD come from? All the possibilities and suggestions were followed up but no one could identify a specific exhaust system, or identify the aircraft type.

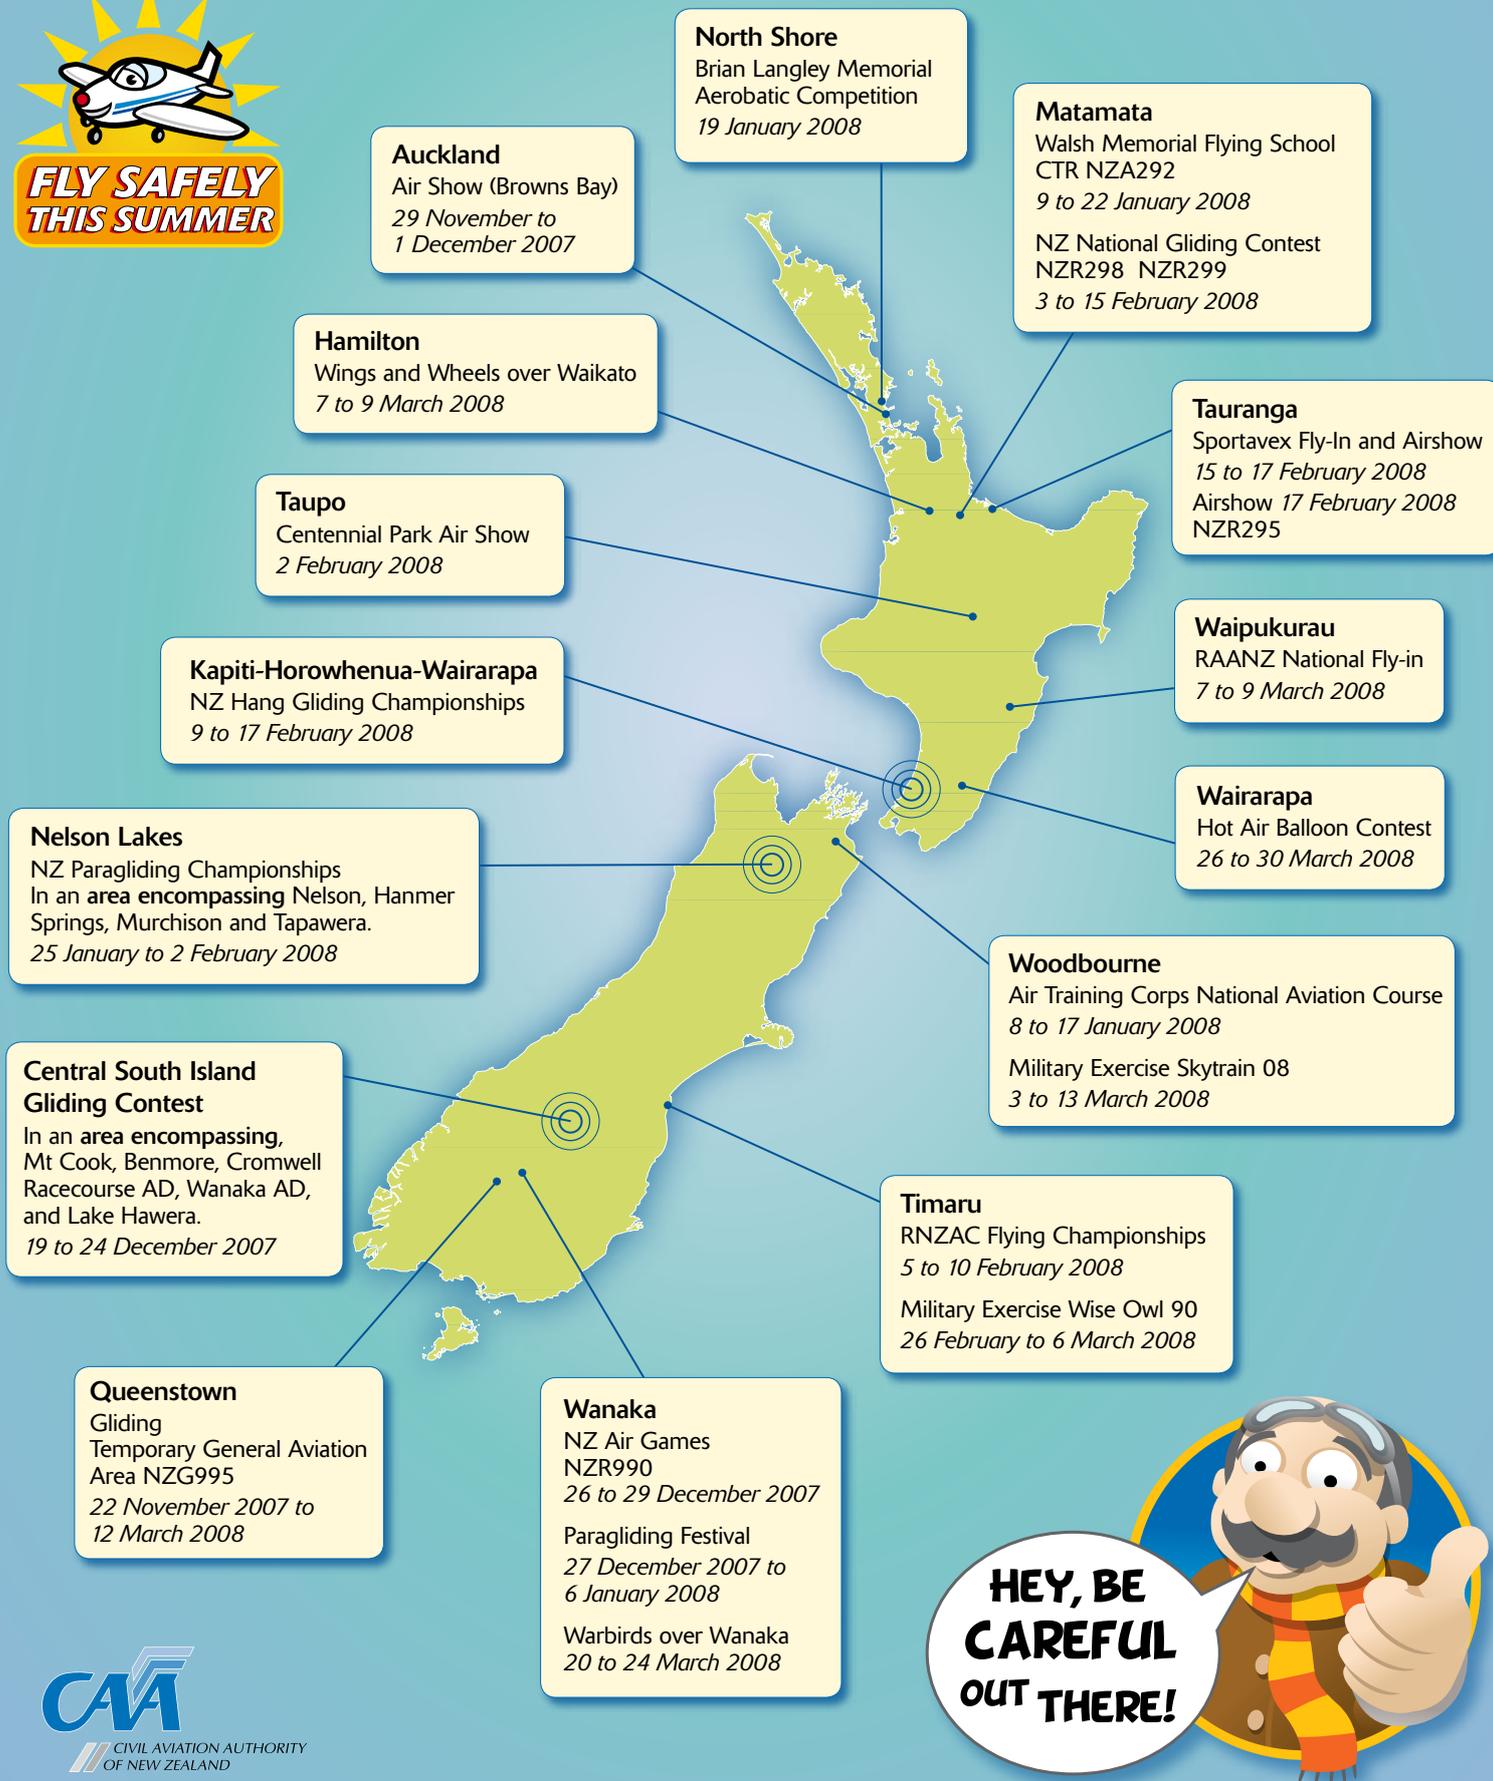
The map shows the known flying events between December 2007 and mid-March 2008.
