POINTING TO SAFER AVIATION

vector

May/June 2009

CIVIL AVIATION AUTHORITY
OF NEW ZEALAND

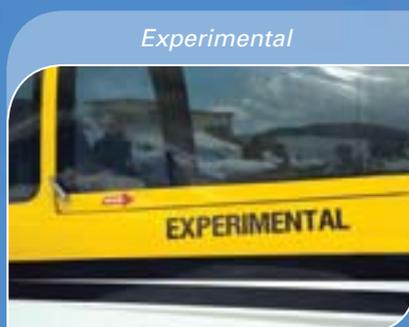
Under the proposed changes to Part 21, aircraft in the Experimental category will be carrying out flight evaluation or being used for research and development. The Falcomposite Furio is pictured.

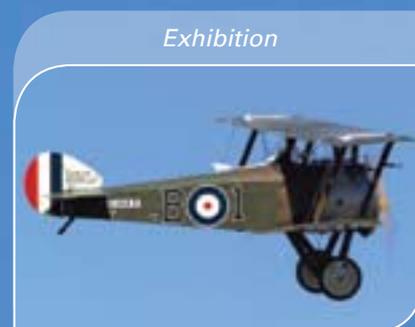
This rotary engine Sopwith Camel replica could be registered under the new Exhibition category.

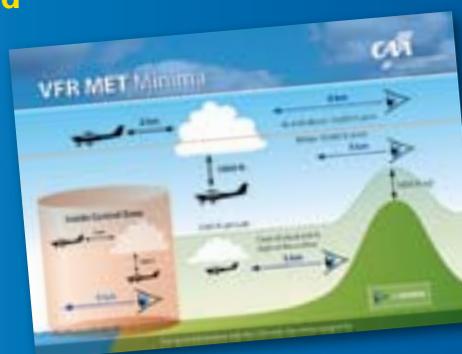
VFR Met Minima Card

In response to demand we have produced a simplified VFR met minima illustration, as a handy reminder of your visibility and distance from cloud requirements. On the back is a decision-making guide encouraging you to reassess your flight whenever any one of the indicators changes.
