POINTING TO SAFER AVIATION

July / August 2009

See and Avoid

Aircraft Have Limits

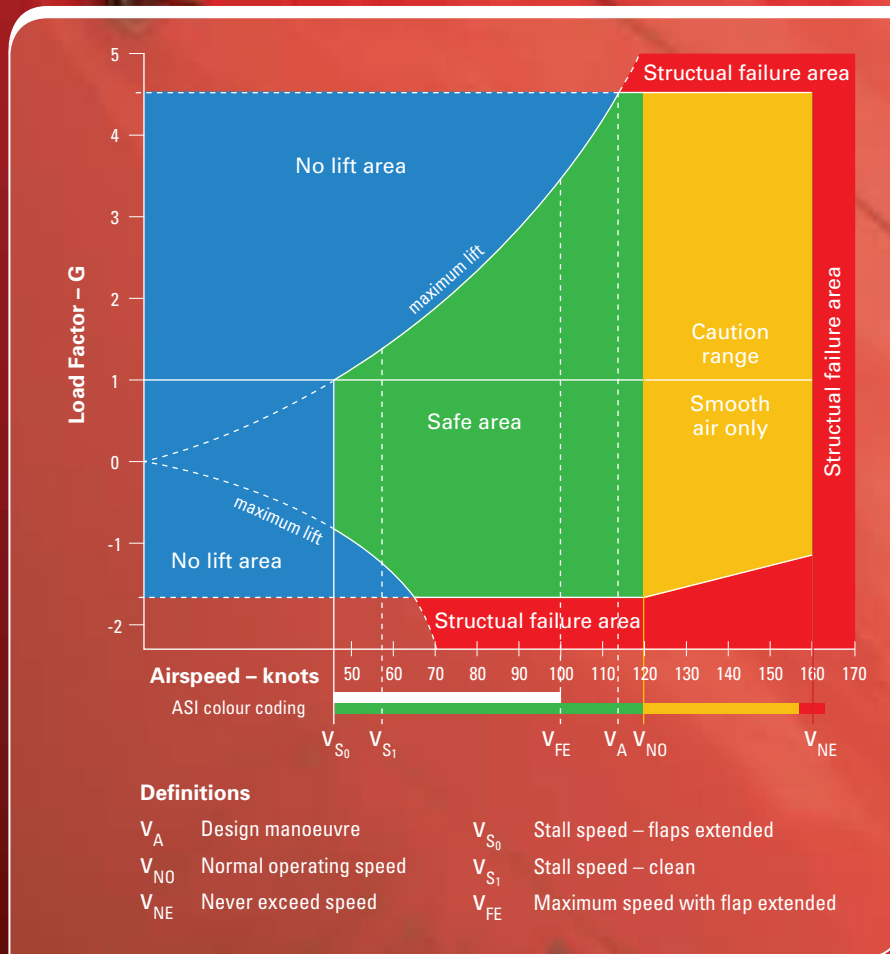
The Manoeuvre Envelope (V_N diagram)

A simple way of presenting this data is by using the V_N diagram. This is a graph of G against speed. Together, speed and G limits provide the 'flight envelope' of the aircraft: what it is allowed to do, what it cannot physically do, and what it should not do. Anything outside the envelope is beyond the limit load the airframe was designed for.

Blue Area

The blue area represents a combination of speed and G that the aircraft is physically incapable of reaching. The aircraft will stall before enough lift can be generated to produce the G force that can damage the airframe.

The red area is a no-go, in which you are likely to cause damage, either through too much G or from the drag forces produced at excessive speed.
