vector

In, Out and Around Hamilton

PBN Developments

Airworthiness Directive Changes

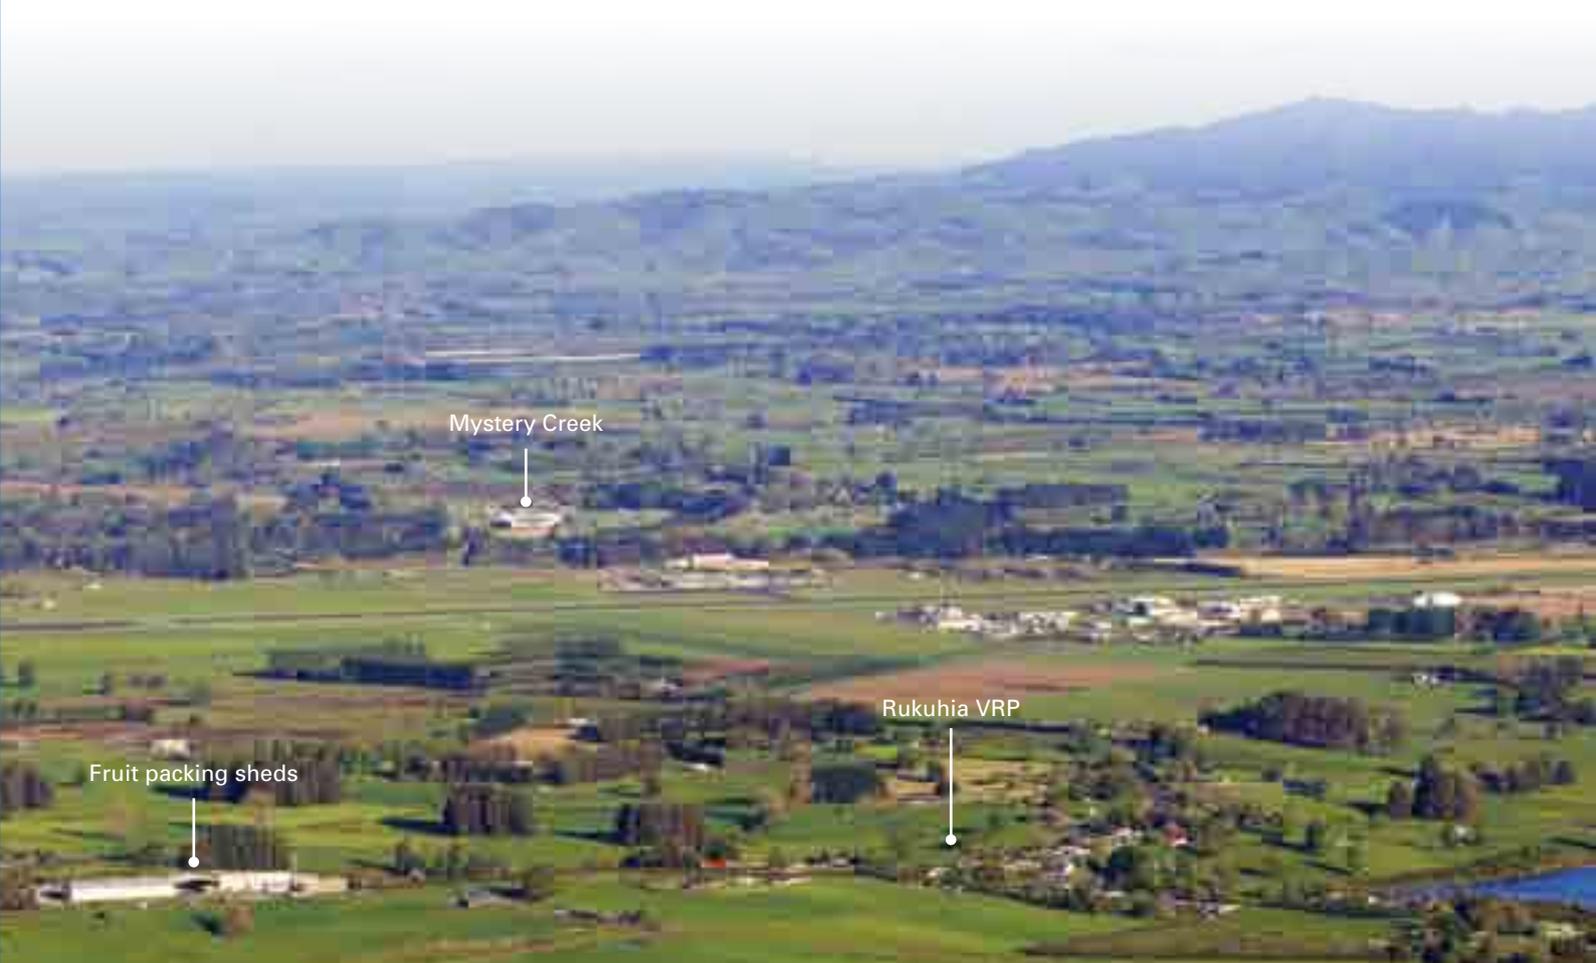
Hamilton aerodrome, with Rukuhia in the foreground and Mystery Creek just beyond.
Photo courtesy of Gordon Malcolm/Waikato Aero Club

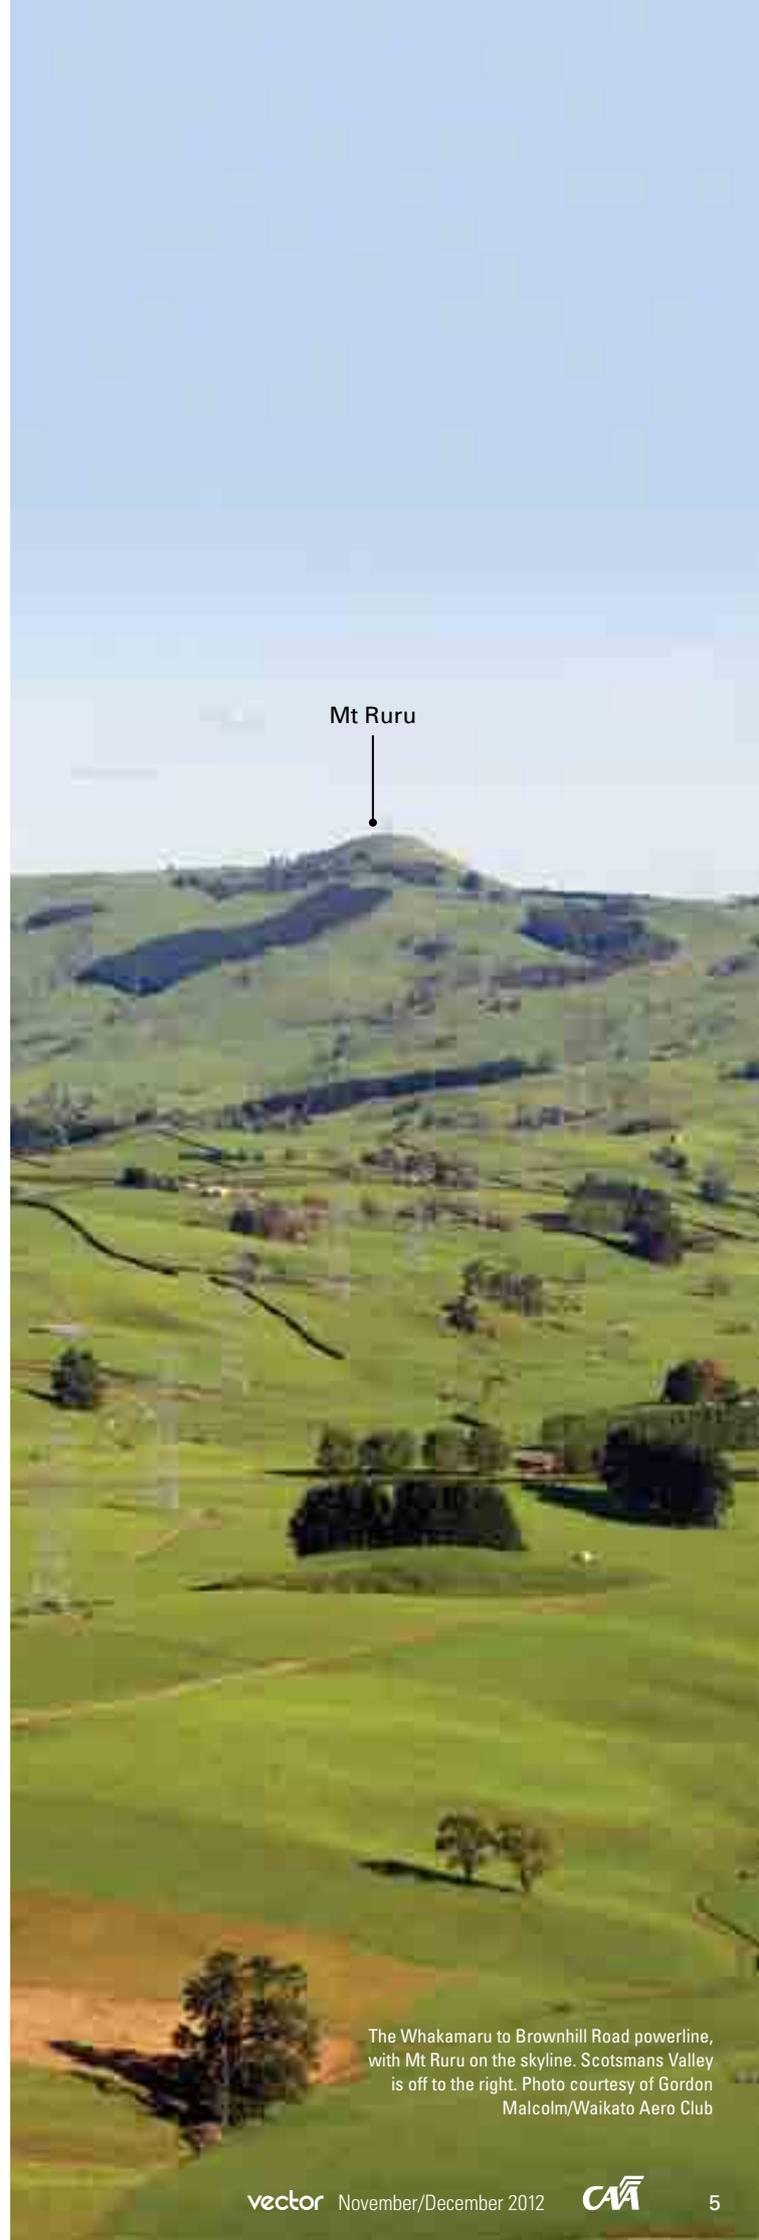
The Whakamaru to Brownhill Road powerline, with Mt Ruru on the skyline. Scotsmans Valley is off to the right. Photo courtesy of Gordon Malcolm/Waikato Aero Club

The powerline mentioned is distinctive, with towers much larger than those on the lines that it parallels as far south as Orini before diverging to the east. It crosses another line about two miles south of Morrinsville, and the differences are readily apparent at that point. The line can also be a useful reference for transiting traffic wanting to remain clear of the CTR.

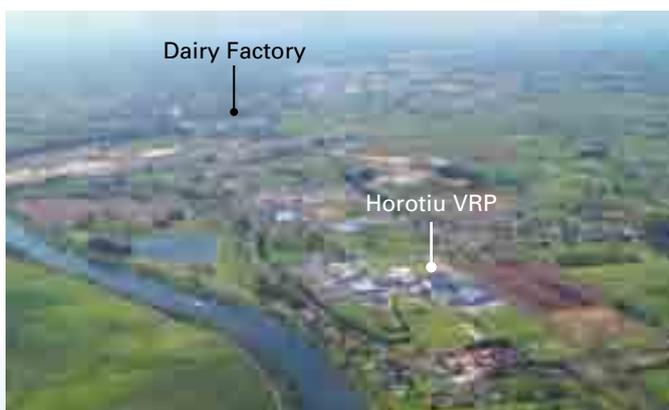
Horotiu (meat works) in foreground, not to be confused with the Te Rapa dairy factory (arrowed). The road under construction is the new Auckland expressway extension.

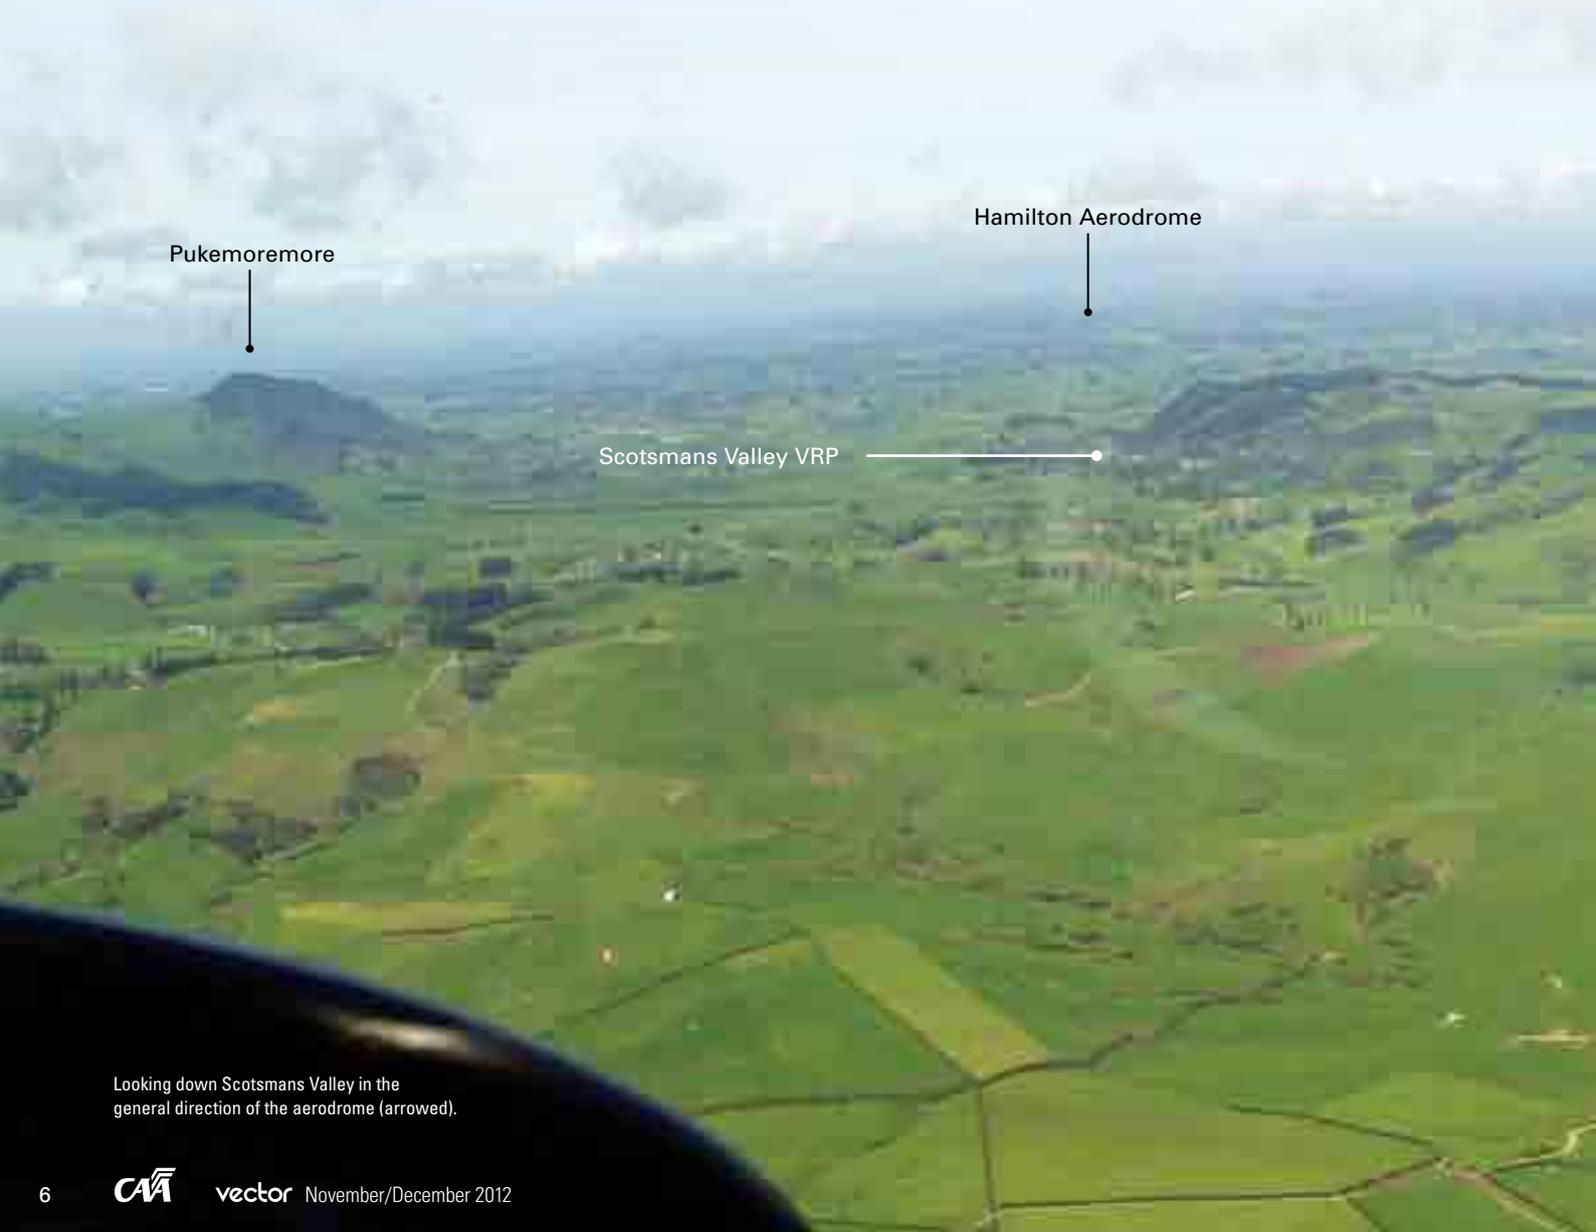
Looking down Scotsmans Valley in the general direction of the aerodrome (arrowed).

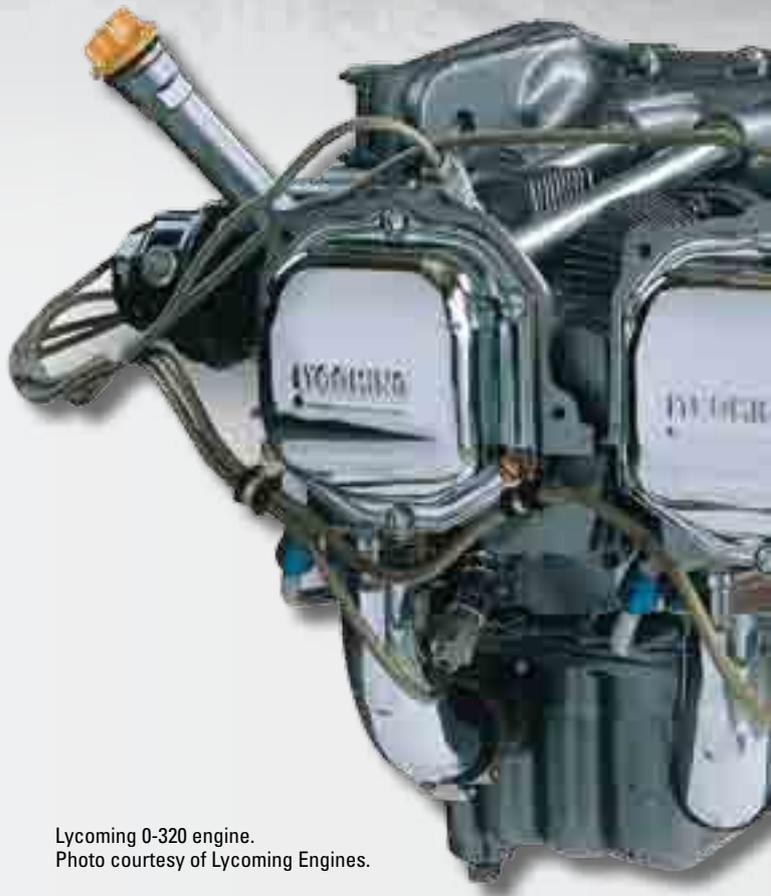
Lycoming O-320 engine.
Photo courtesy of Lycoming Engines.

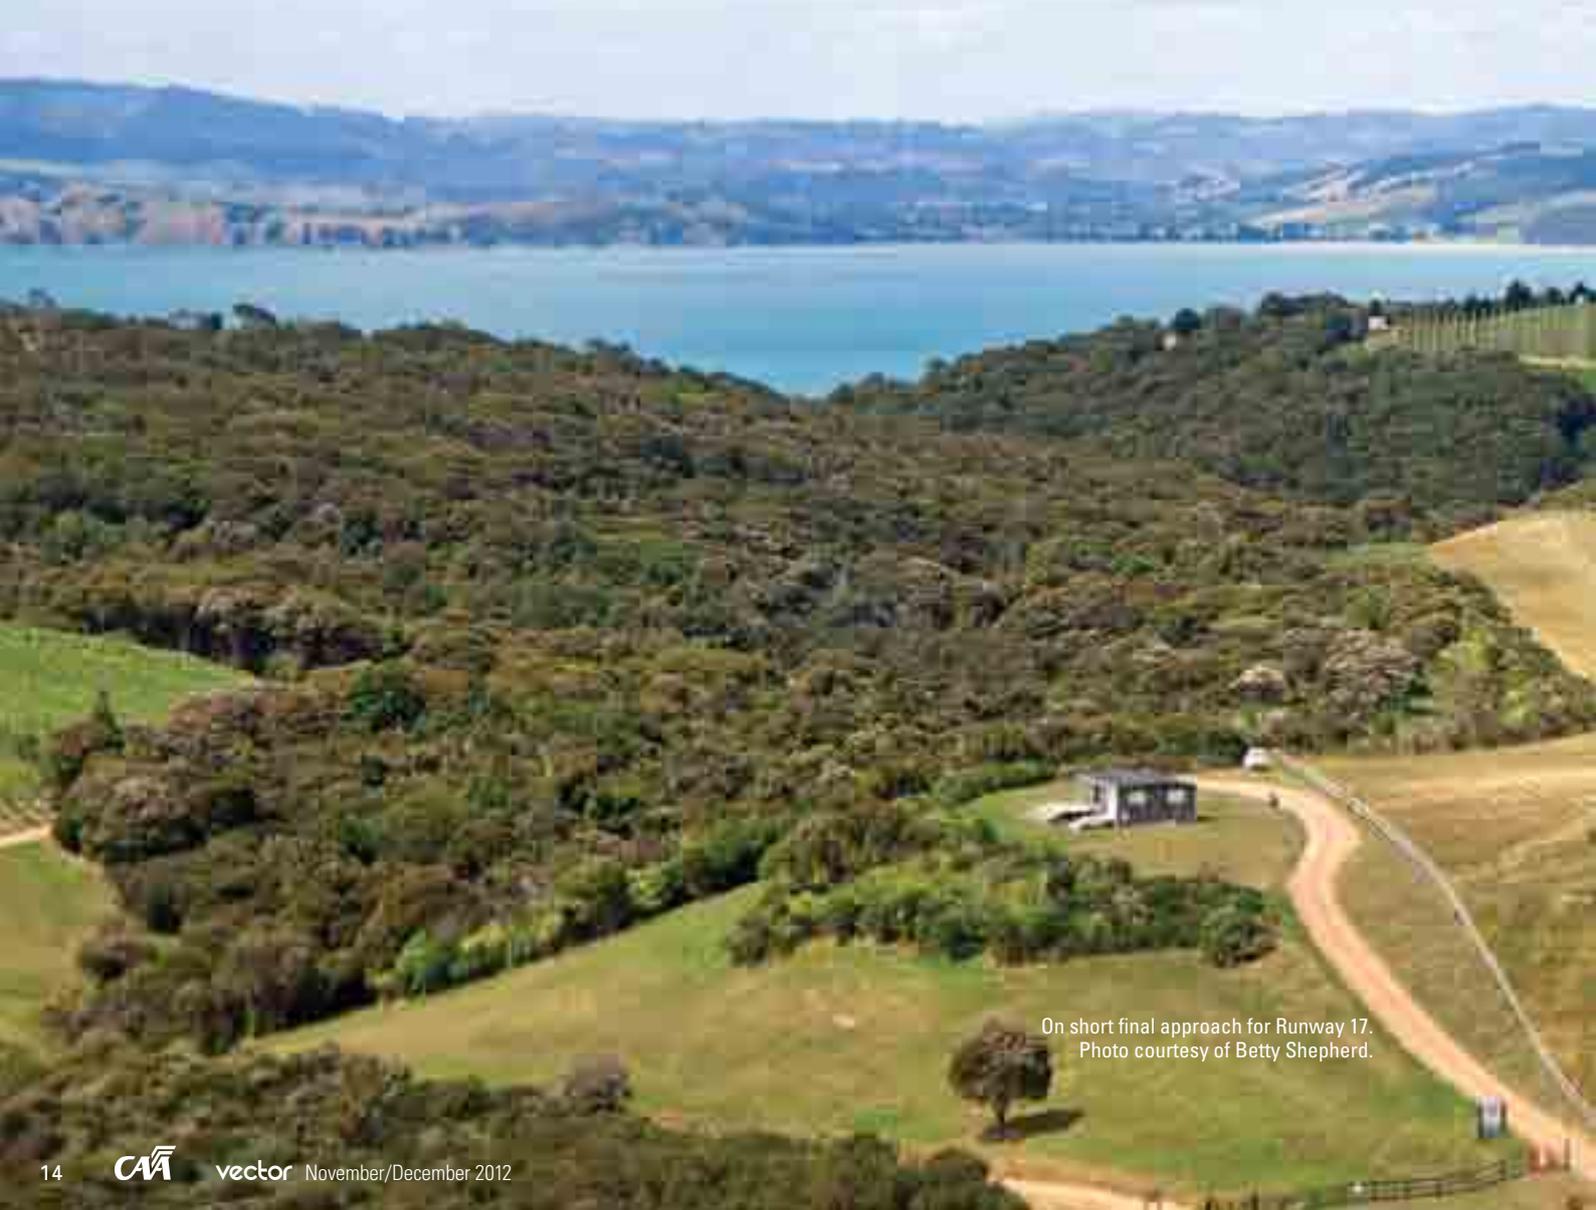
On short final approach for Runway 17.
Photo courtesy of Betty Shepherd.

Jolon cautions, "The south-west winds can cause significant windshear on short final for Runway 17, and can even catch out the most experienced pilots. Pilots need to set their own personal limits given their experience, the aircraft performance, and their recent experience into the airfield.

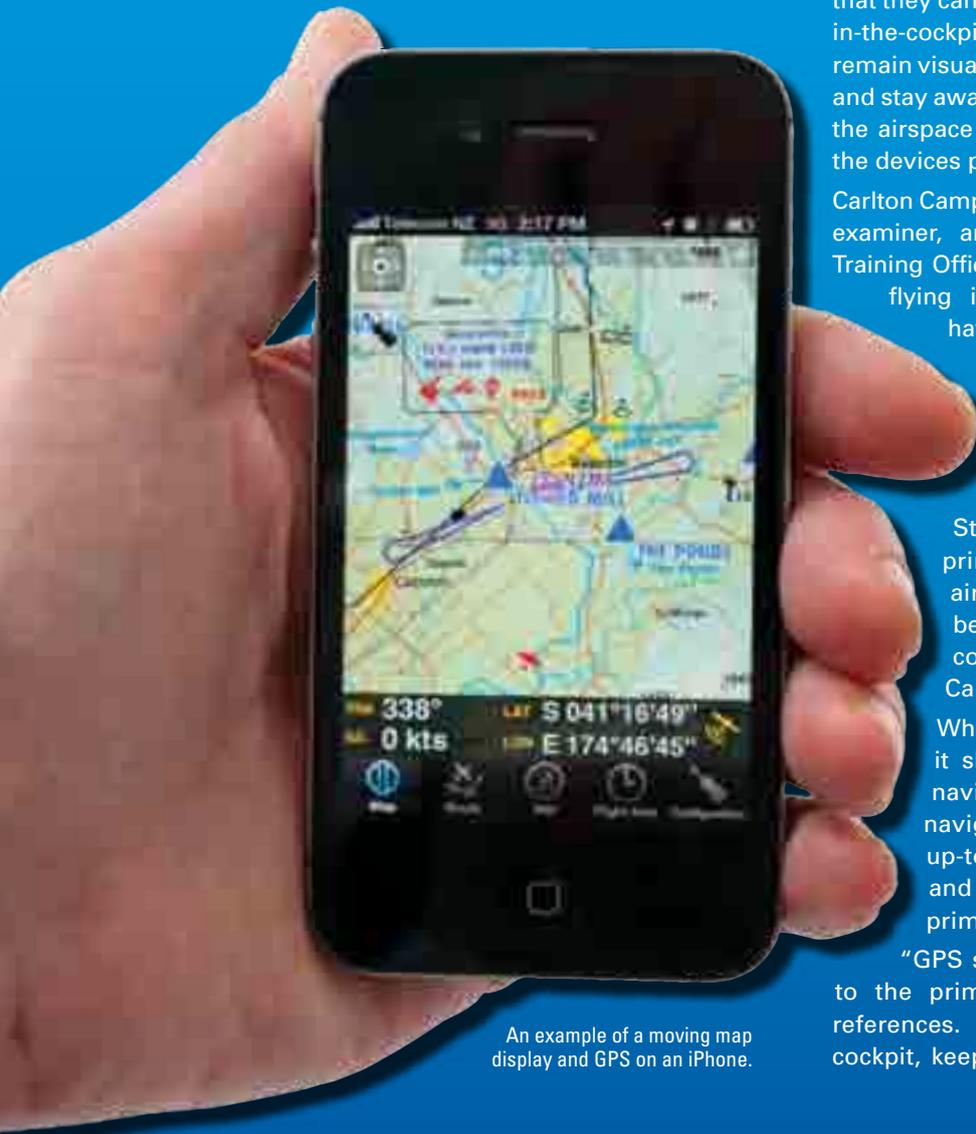
An example of a moving map display and GPS on an iPhone.

An example of an iPad display.

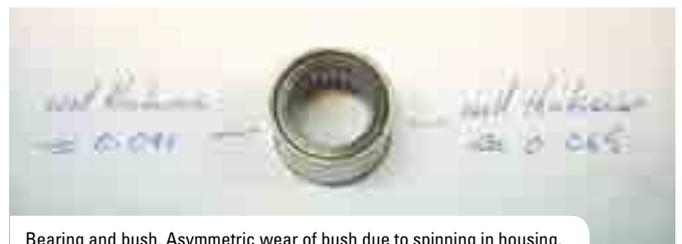
Bush

Part Model:	IO-520A
Part Manufacturer:	Teledyne Continental
ATA Chapter:	8520

During engine operation, the alternator drive belt was being repeatedly thrown from the pulleys.

Maintenance investigation found that the starter adapter spigot bearing located in the crankcase had been previously bushed. The bush retaining pin had failed, allowing the bush to spin, resulting in chattering of the gear drive train in the engine accessory case.

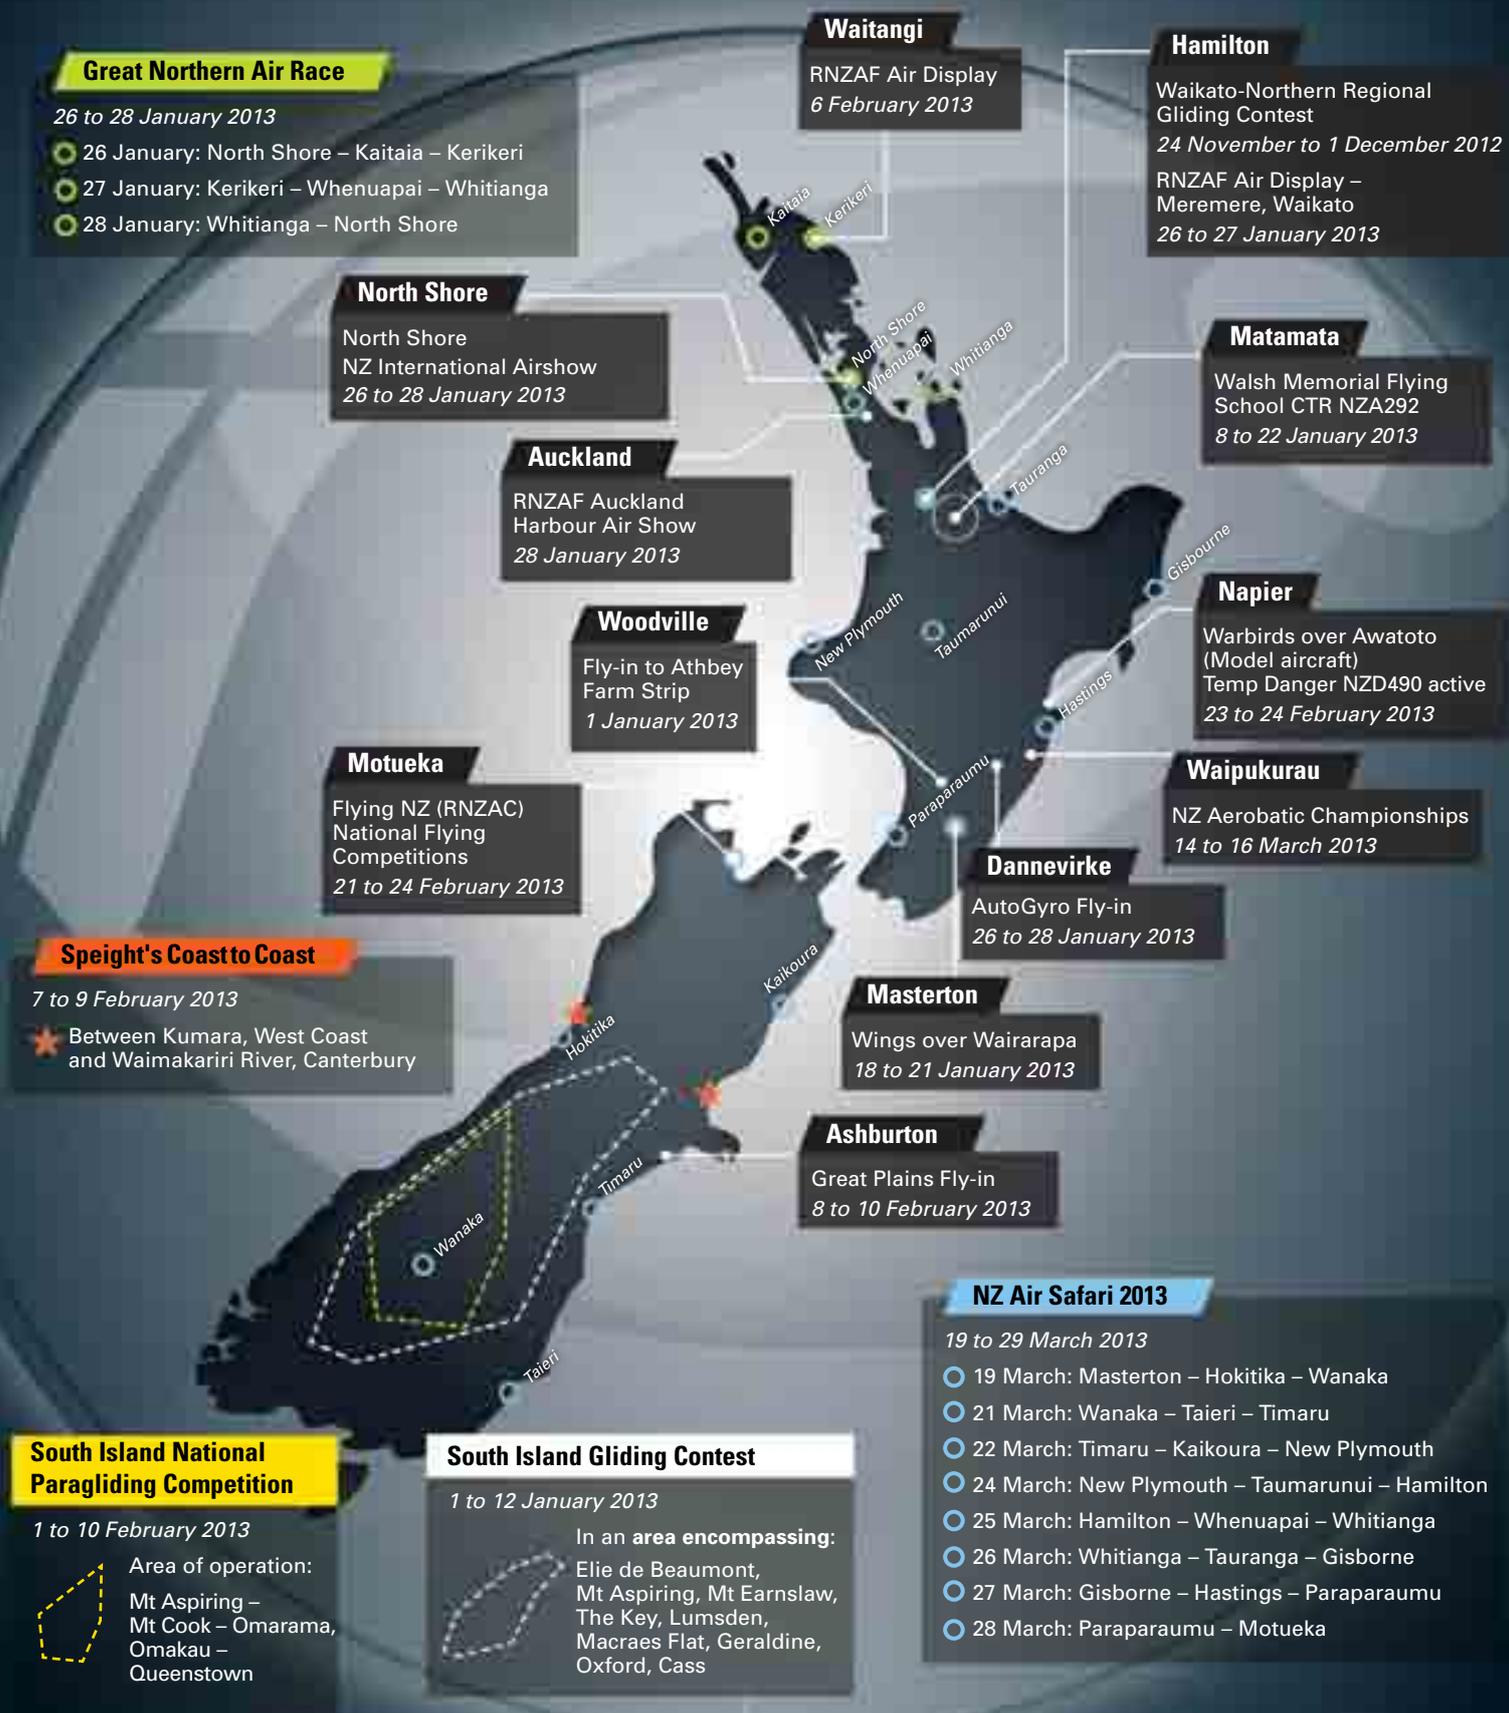
This map shows the known flying events between late November 2012 and mid-March 2013.
