vector

Taking Off in a Microlight

VFR Transit Lanes – Avoid the Traps

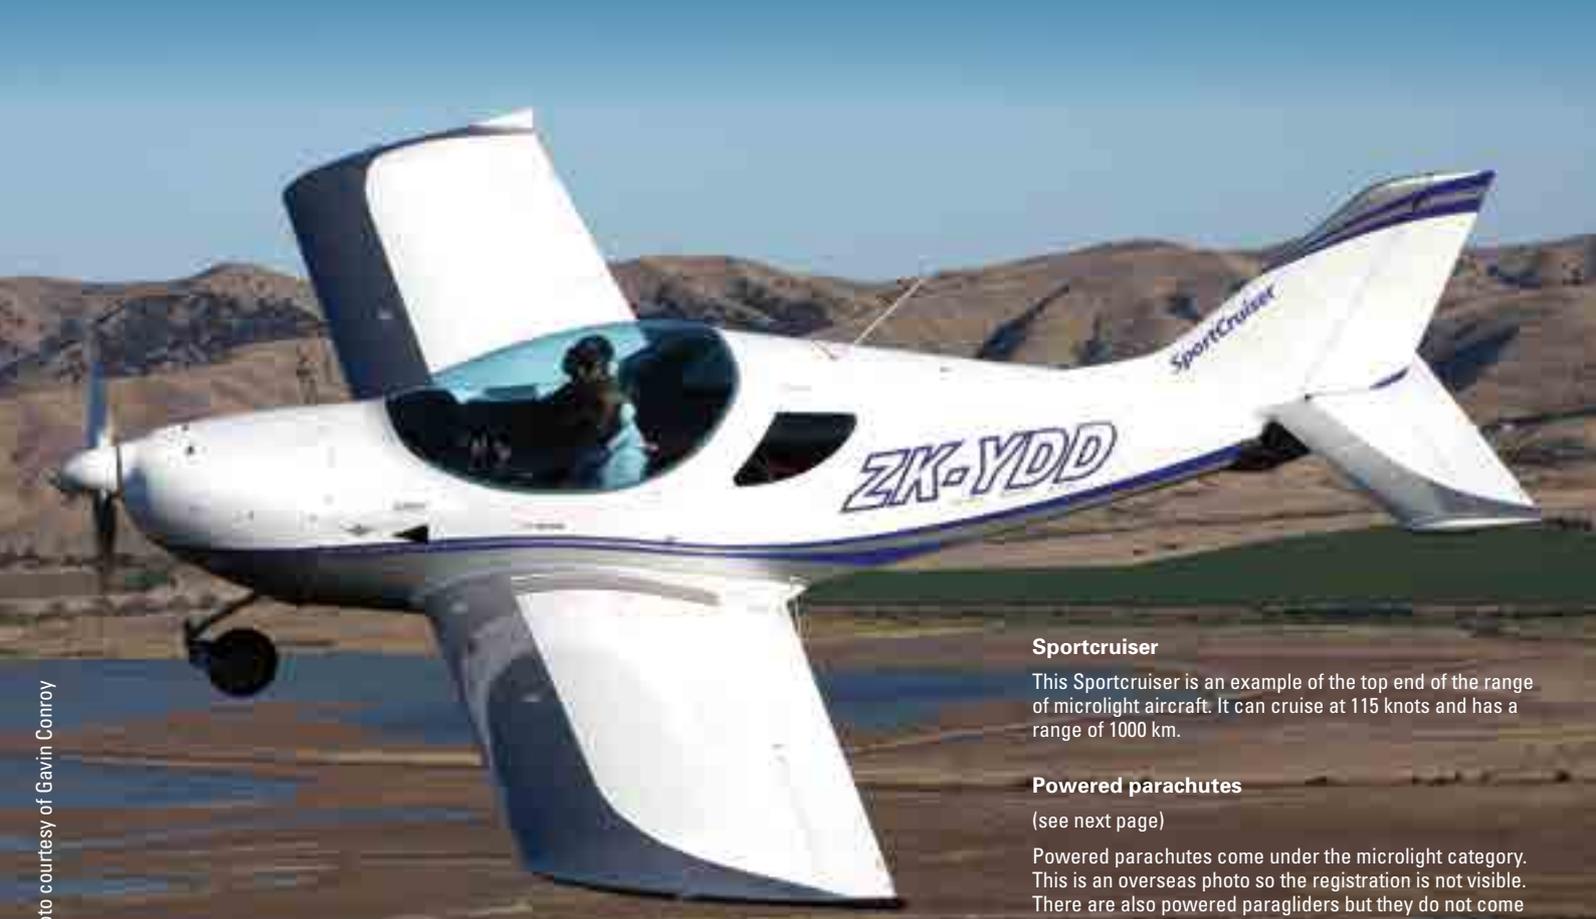
This Sportcruiser is an example of the top end of the range of microlight aircraft. It can cruise at 115 knots and has a range of 1000 km.

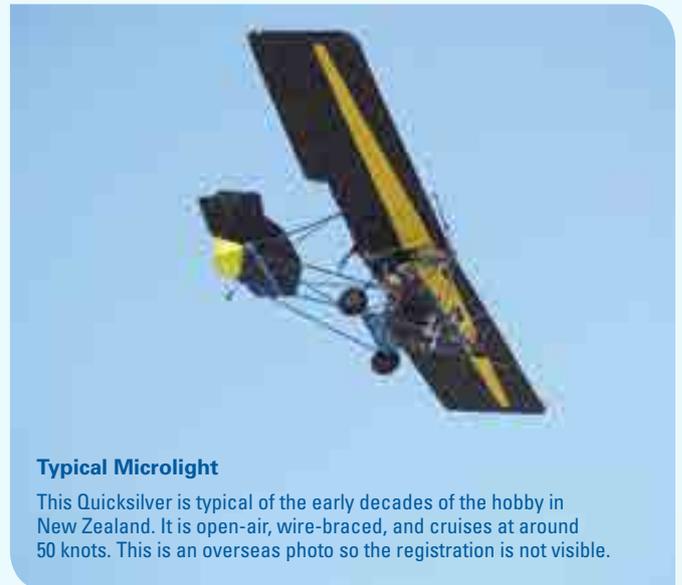
Typical Microlight

This Quicksilver is typical of the early decades of the hobby in New Zealand. It is open-air, wire-braced, and cruises at around 50 knots. This is an overseas photo so the registration is not visible.

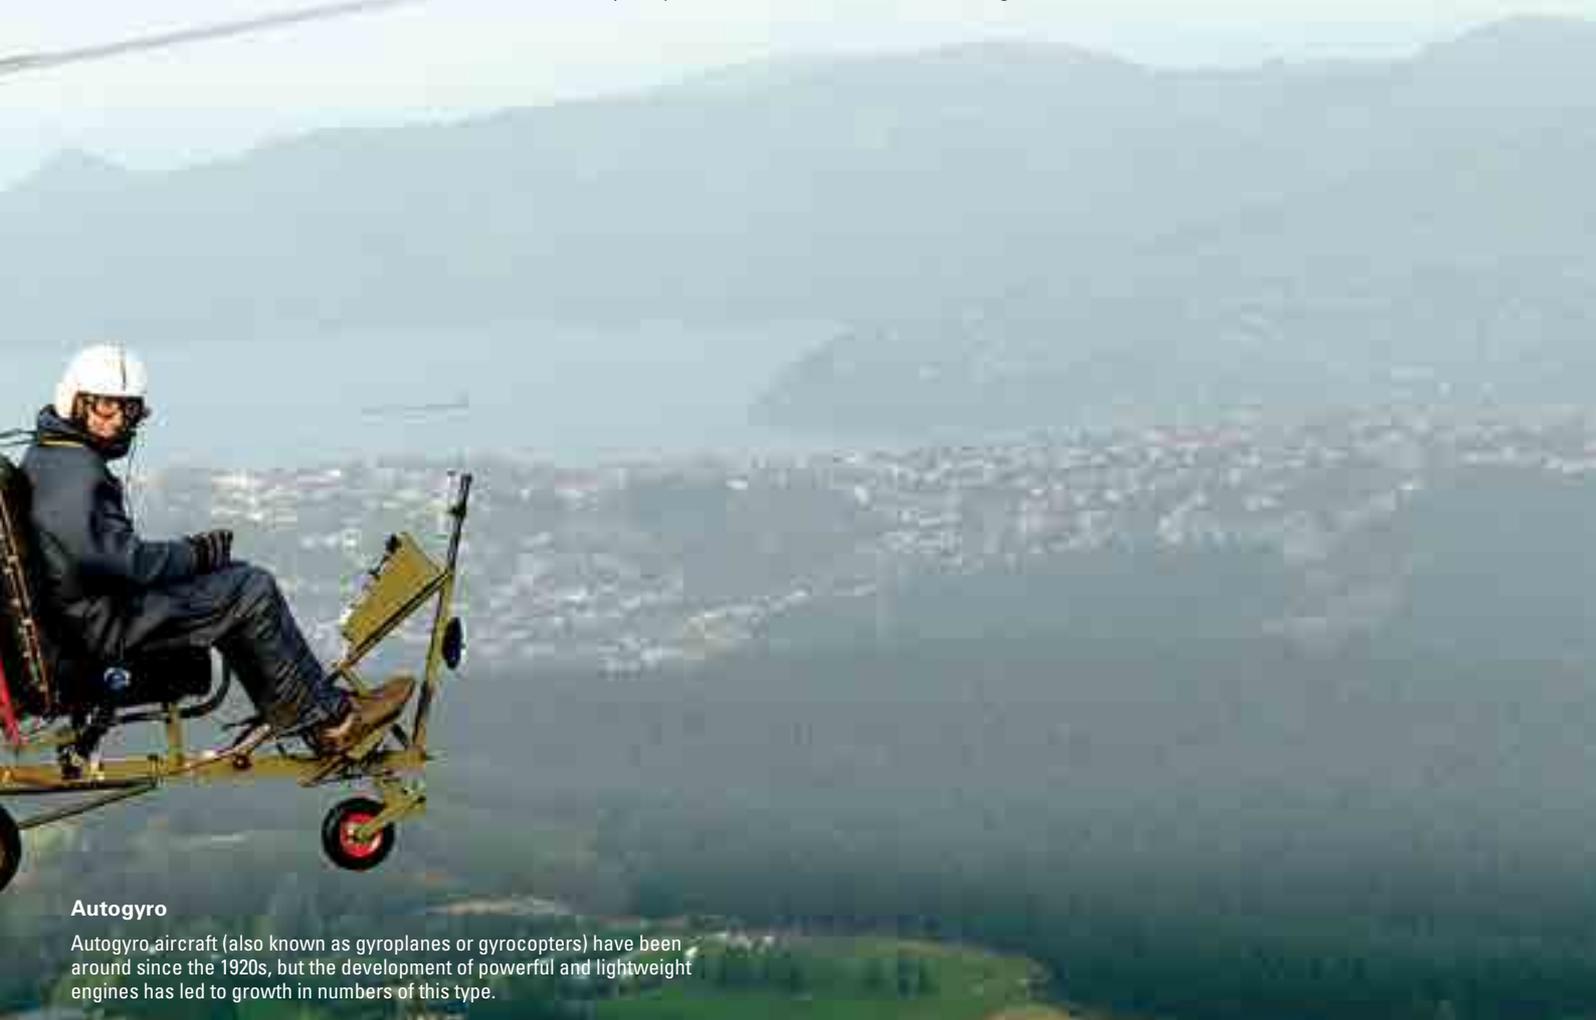
Autogyro aircraft (also known as gyroplanes or gyrocopters) have been around since the 1920s, but the development of powerful and lightweight engines has led to growth in numbers of this type.

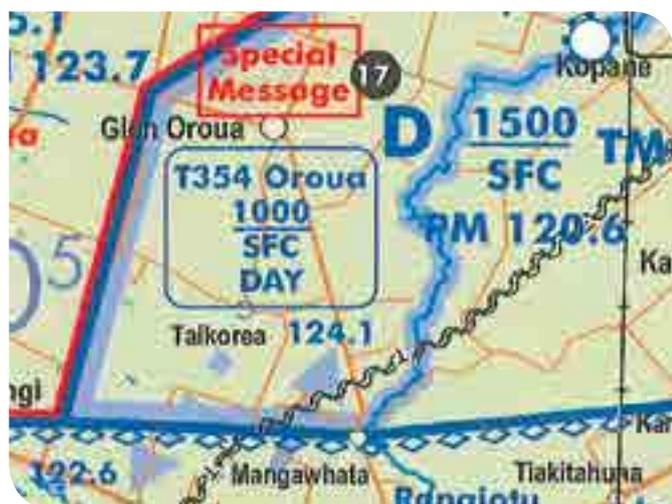
This example from VNC C2 shows the recommended T354 frequency 124.1 MHz (this is the Feilding aerodrome and CFZ frequency). Note the change to 122.6 MHz in the Manawatu CFZ to the south of T354.

Where there is a recommended transit lane frequency, this will be shown on the VNCs (see example below).

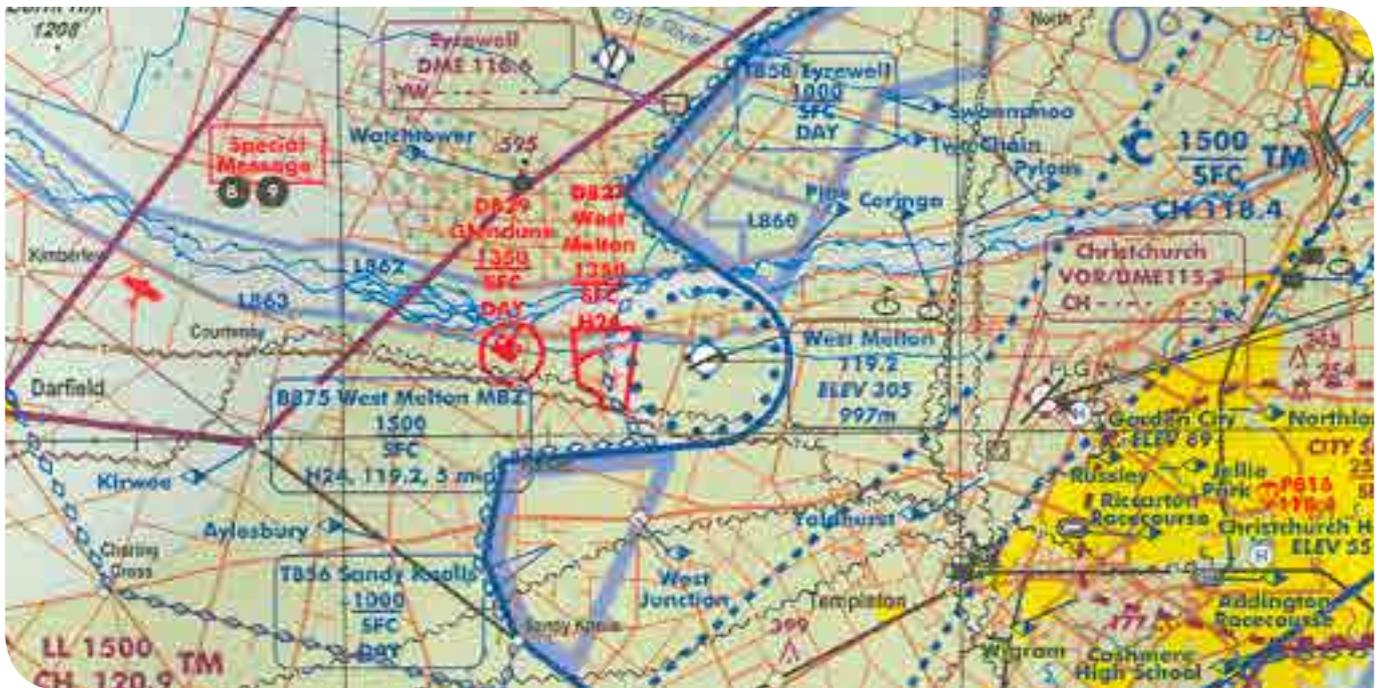
This section of VNC C13 shows the West Melton MBZ and the two transit lanes either side. There is a tendency for pilots to fly through the circuit at West Melton - see the article for advice.

When planning, make sure you identify the hazards associated with entering and leaving a transit lane (see the West Melton example).

"West Melton has a 1100-foot circuit altitude (795 feet above ground level). The transit lanes and danger areas that surround it tend to funnel traffic right through the circuit. Pilots come charging through the downwind and base leg," says Jay.

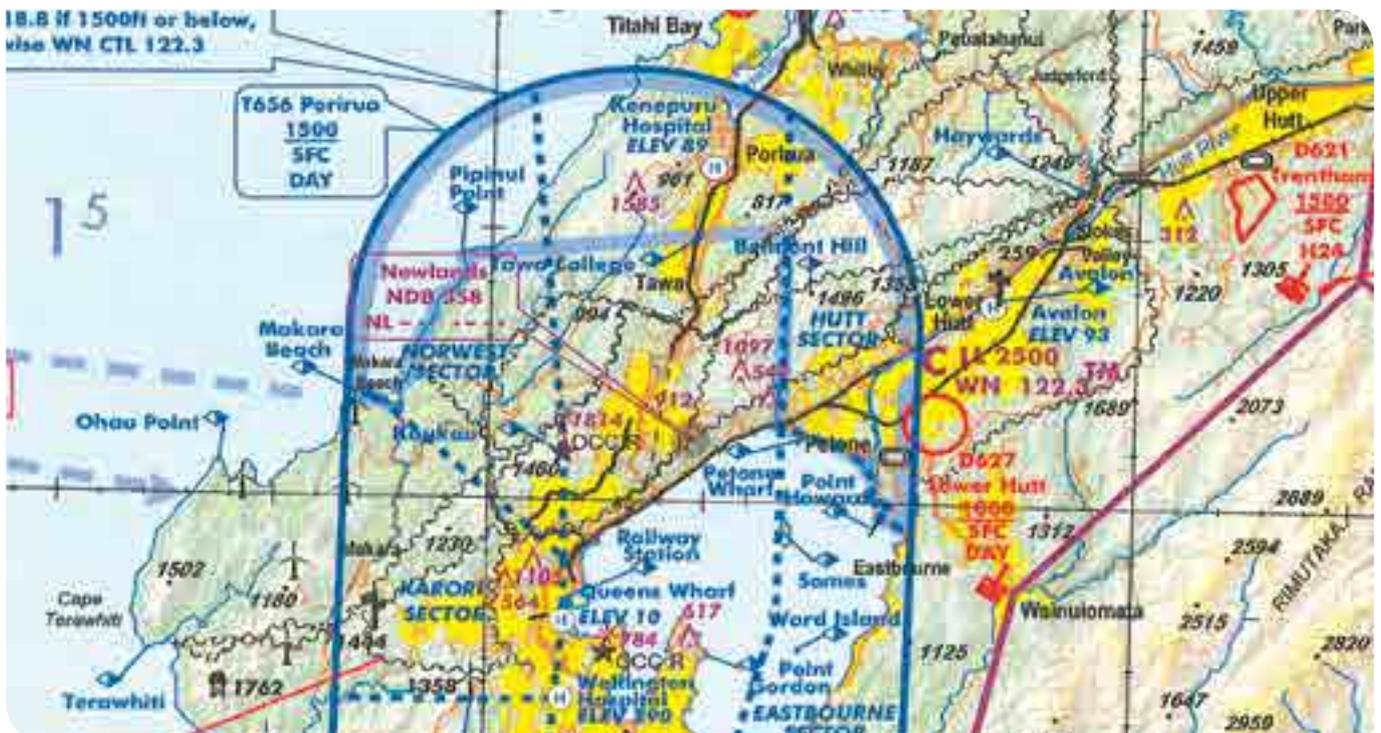
This section of VNC C2 shows the transit lane in the Wellington CTR. T656 is surface to 1500 feet and pilots often fly above that without clearance.

An aircraft entered controlled airspace without a clearance, tracking above transit lane T656 at 2500 feet.

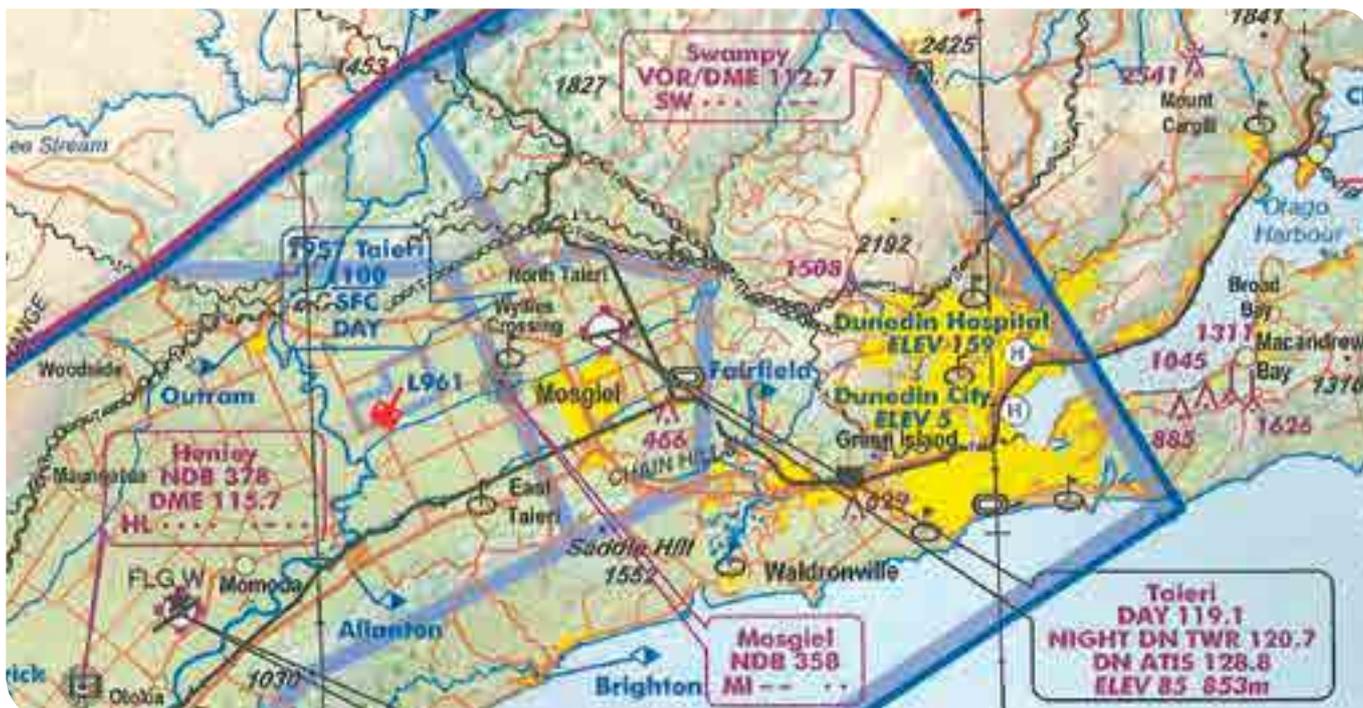
This section of VNC C8 shows the new boundaries for the T957 transit lane. The new charts were effective 14 November 2013.

"This extension widens the corridor around Mount Hyde. It also gives Taieri circuit traffic more space," says Paula. ■

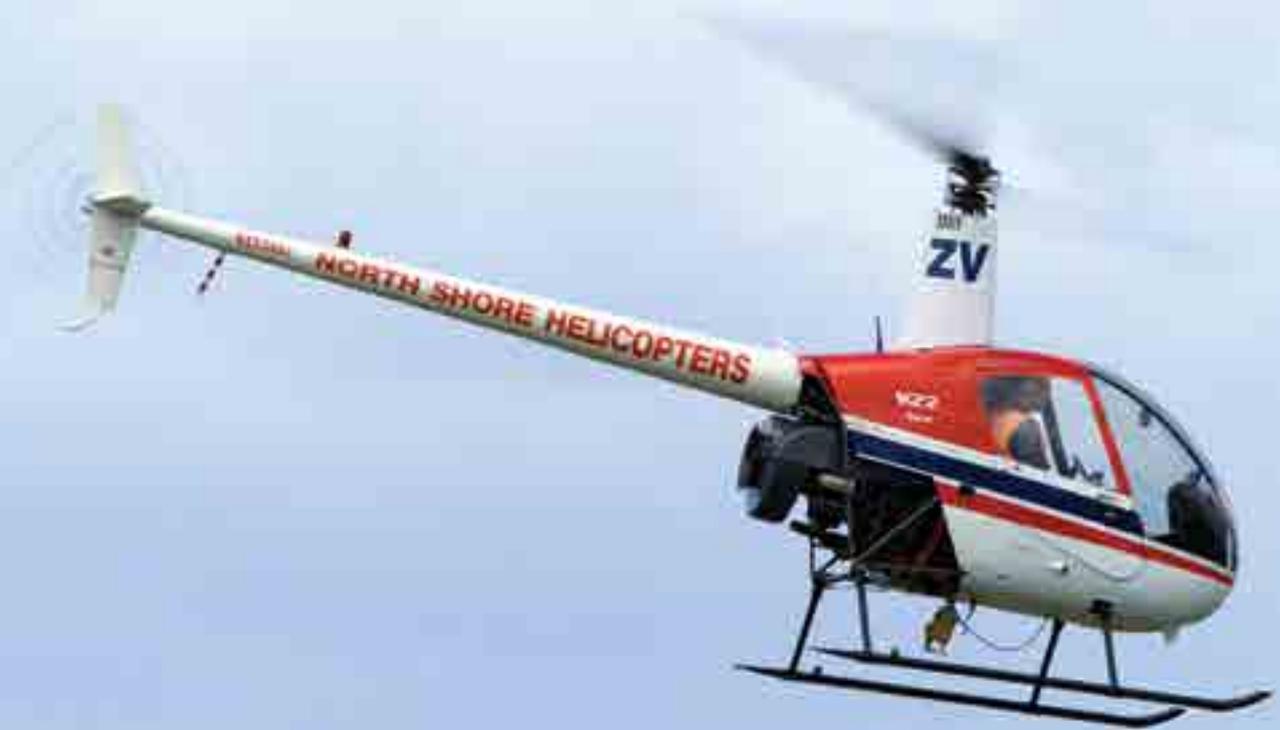
A Robinson R22 helicopter in normal flight.

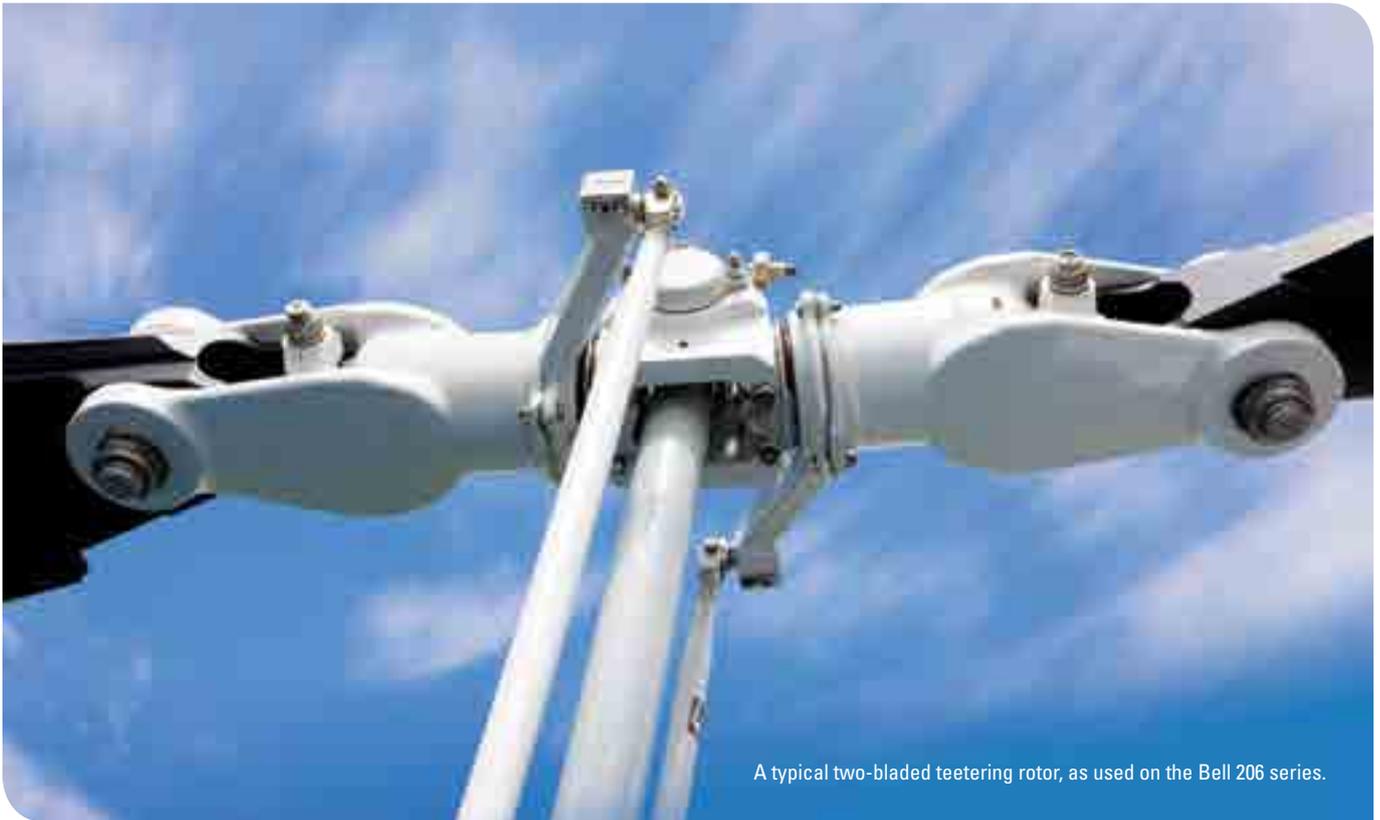
A typical two-bladed teetering rotor, as used on the Bell 206 series.
