vector

The Impossible Turn

Since 2001, there have been 18 accidents, eight of them fatal, following some kind of power loss after takeoff. The worst year for such occurrences was 2014. But a thorough preflight, fuel system check, and resisting the siren call of the runway behind you, could well save your life.

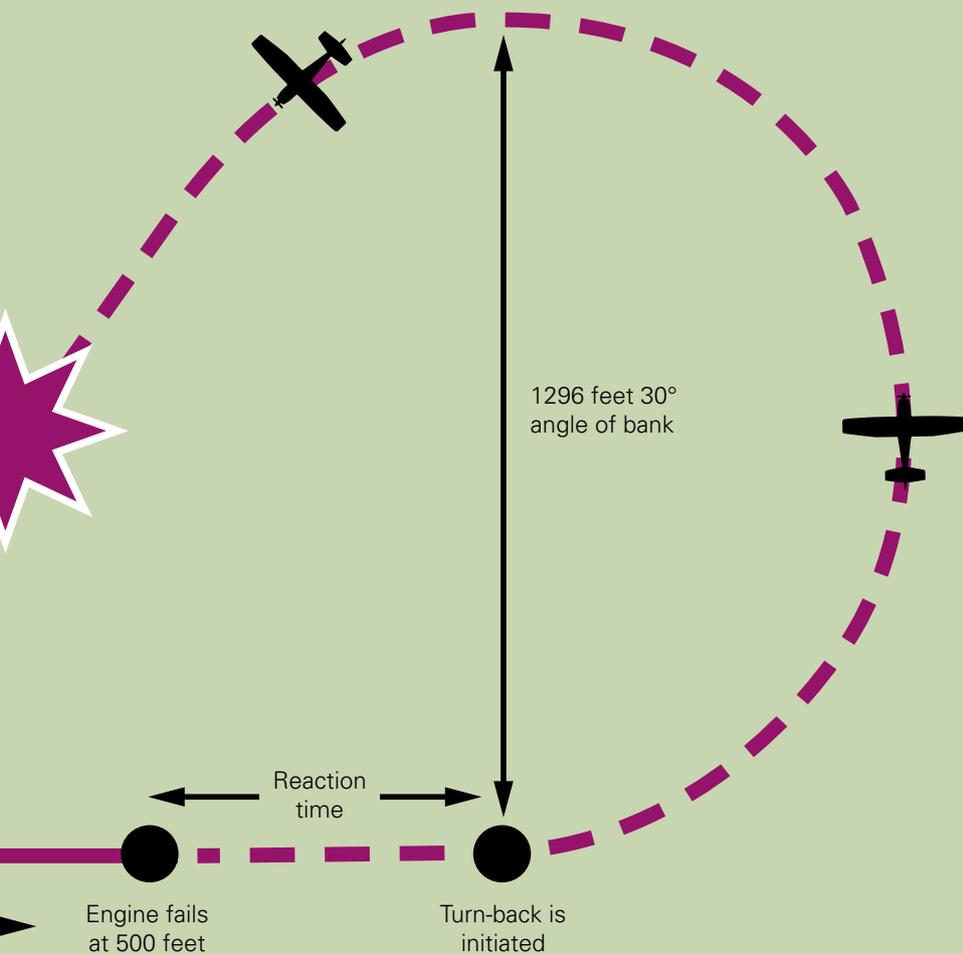
Data for a Cessna 172 turning back after an engine failure at 500 feet agl

Conditions and Assumptions

Note that total distance back to the runway from failure point is 7711 feet whereas the aircraft glide capability is only 4560 feet. This means you would land 3150 feet short of the runway.

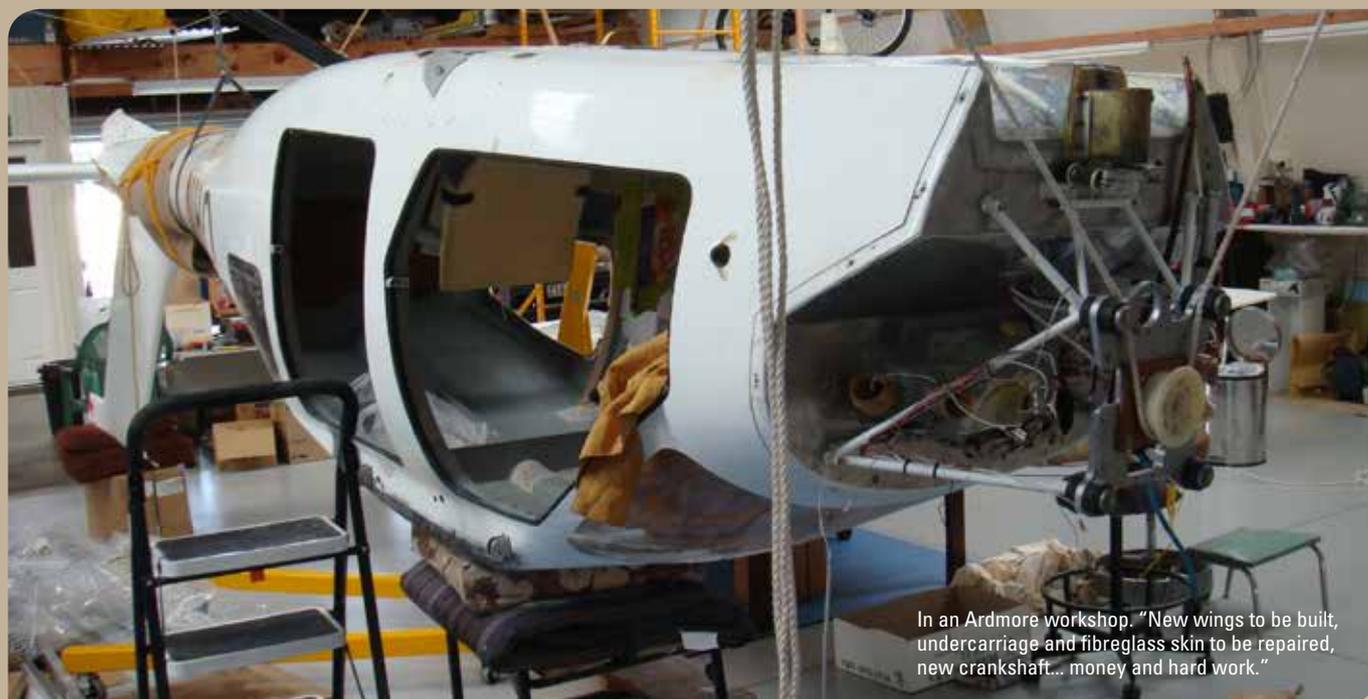
In an Ardmore workshop. "New wings to be built, undercarriage and fibreglass skin to be repaired, new crankshaft... money and hard work."

The Bad: New wings to be built, undercarriage and fibreglass skin to be repaired, new crankshaft... money and hard work.

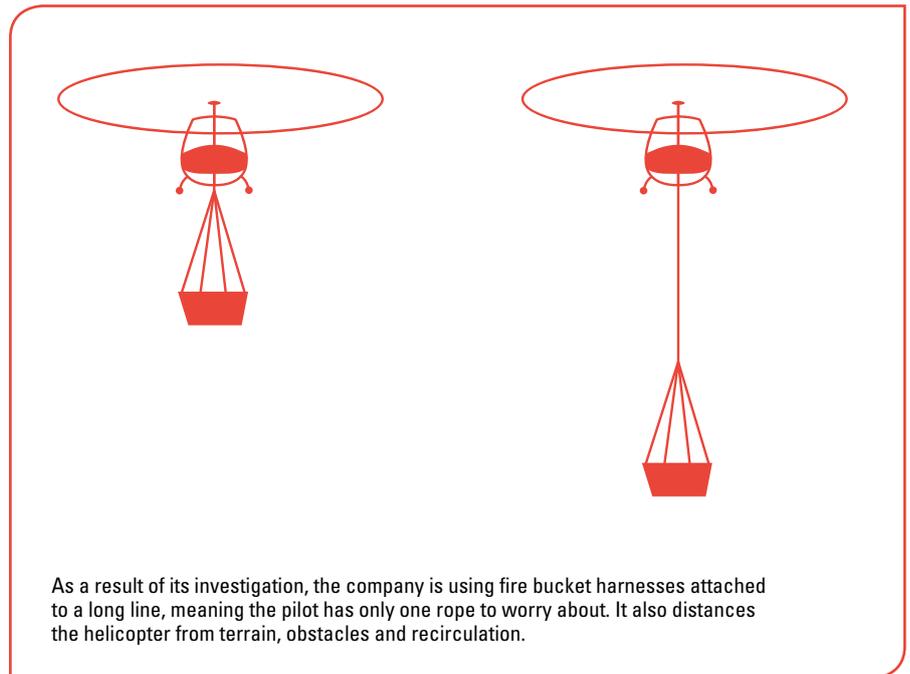
Diagram supplied by operator.

When that positioning caused the tension to reduce on two of the four Dynex strops slinging the bucket beneath the helicopter, one strop became caught over the left skid.

The company's subsequent investigation found the accident risk would have been reduced if the bucket had been rigged with a single strop (see diagram).

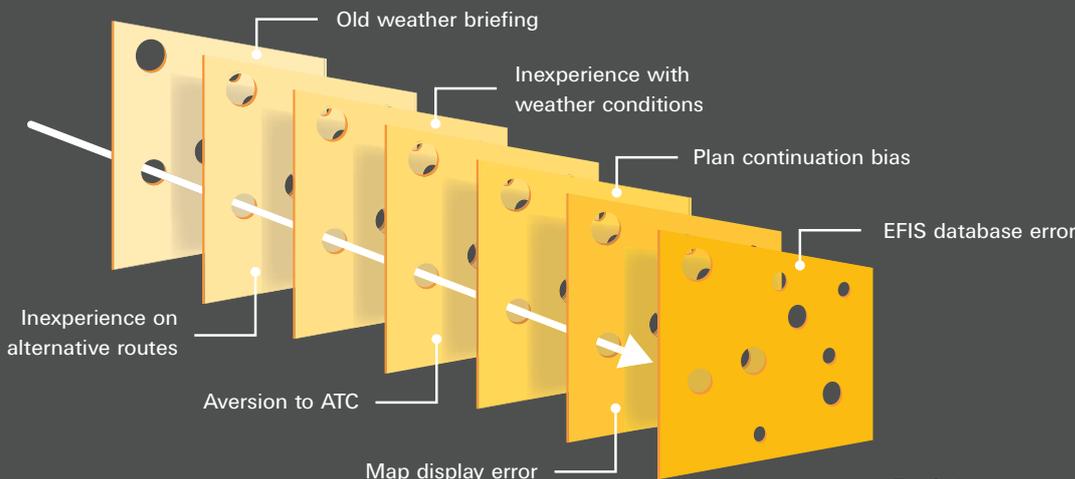
The Swiss cheese model of safety incidents, Prof James Reason, 2000.

SML's Swiss Cheese

The slices of cheese represent various factors that make up your safety framework. The holes represent the holes in that safety framework. In SML's case, those holes lined up, making the pilot defenceless.
