# vector

# In this issue...

**PUBLISHED BY THE** Engagement and Communications Unit of the Civil Aviation Authority of New Zealand, PO Box 3555, Wellington 6140.

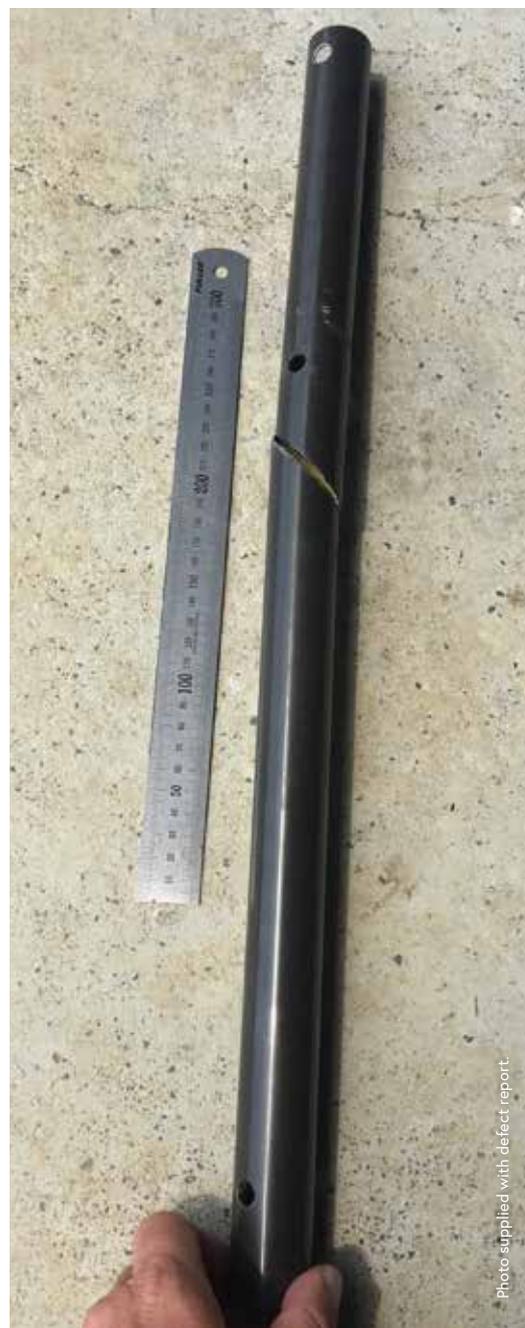
// Continuing airworthiness notice 27-014 was issued in February 2020 to "bring attention to a defect reported to the CAA of finding a severely cracked pilot to co-pilot tail rotor torque tube on a Hughes 369FF".

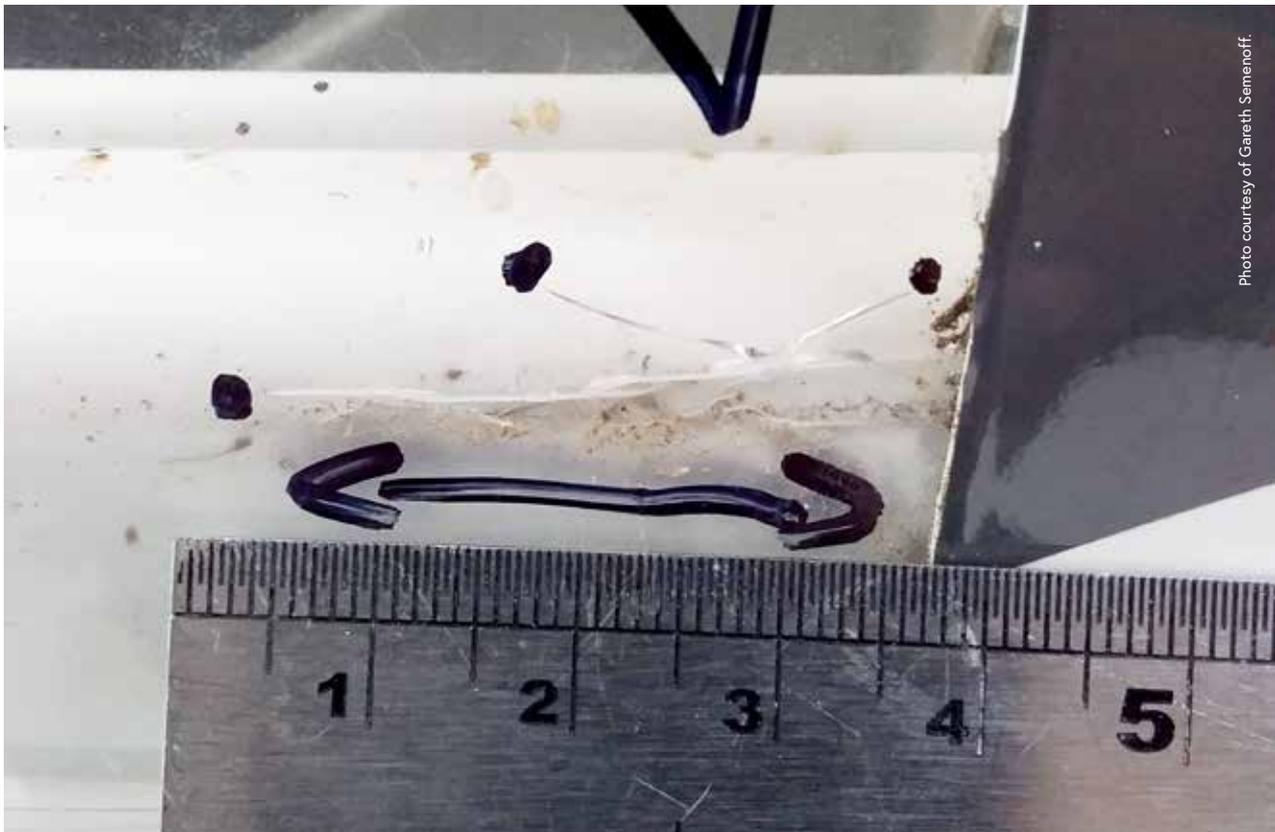
// A Taranaki engineer found this cracking in the Aeroprakt windscreen he was about to replace. The CAA was able to warn the rest of the Aeroprakt community with a continuing airworthiness notice, after the engineer reported it as a defect.

“Later in the year, an engineer in Taranaki was about to install a new windscreen – as a result of the service information from the manufacturer – when he noticed cracking in the original.

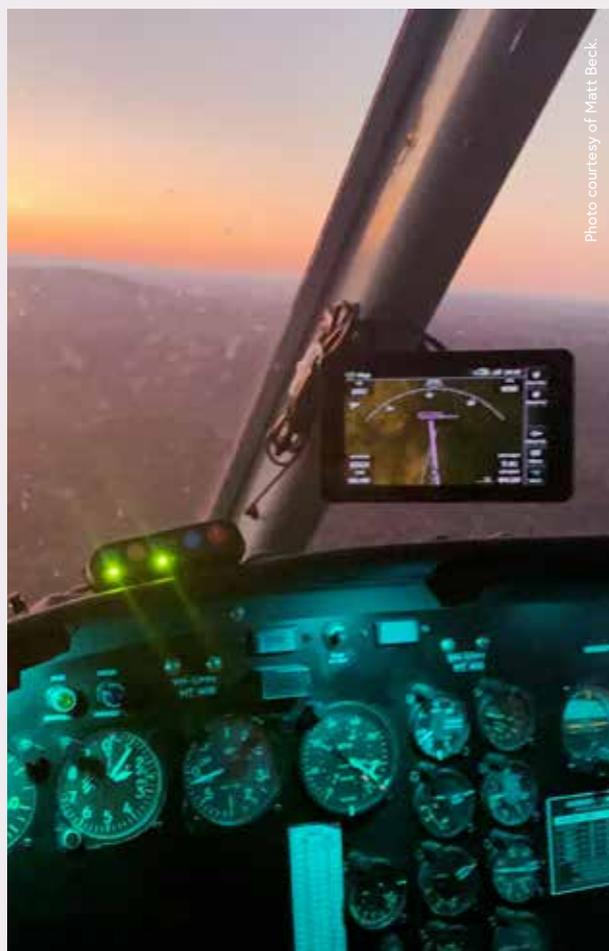
// A permanently mounted GPS – an example of a design change.

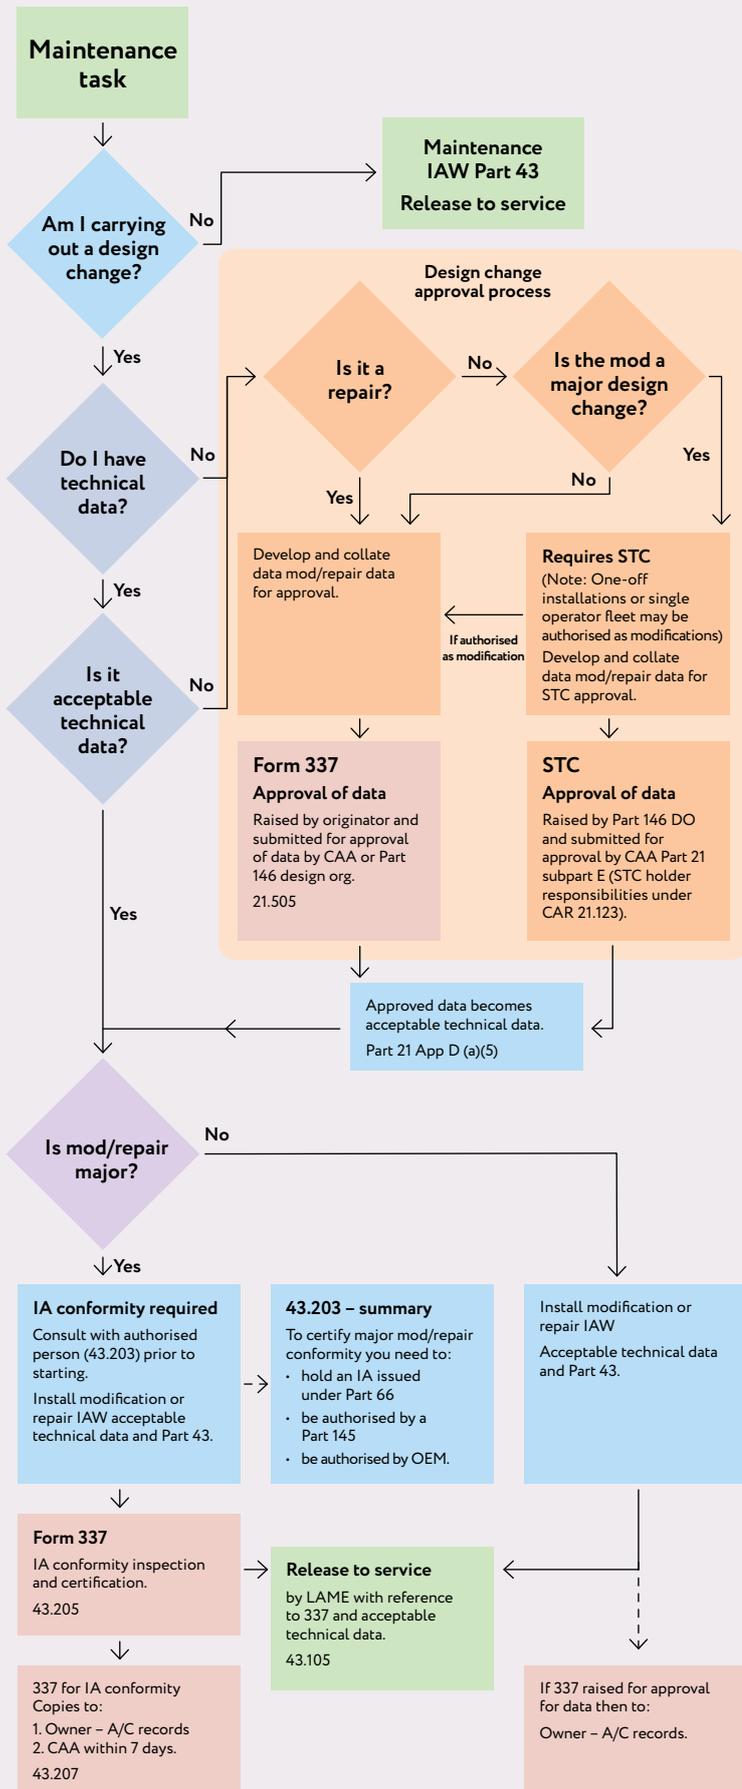
# MODIFICATION/REPAIR PROCESS

Am I carrying out a design change?

Is it a repair?

Is mod/repair major?

IA conformity required Consult with authorised person (43.203) prior to starting. Install modification or repair IAW acceptable technical data and Part 43.

43.203 – summary To certify major mod/repair conformity you need to: • hold an IA issued under Part 66 • be authorised by a Part 145 • be authorised by OEM.

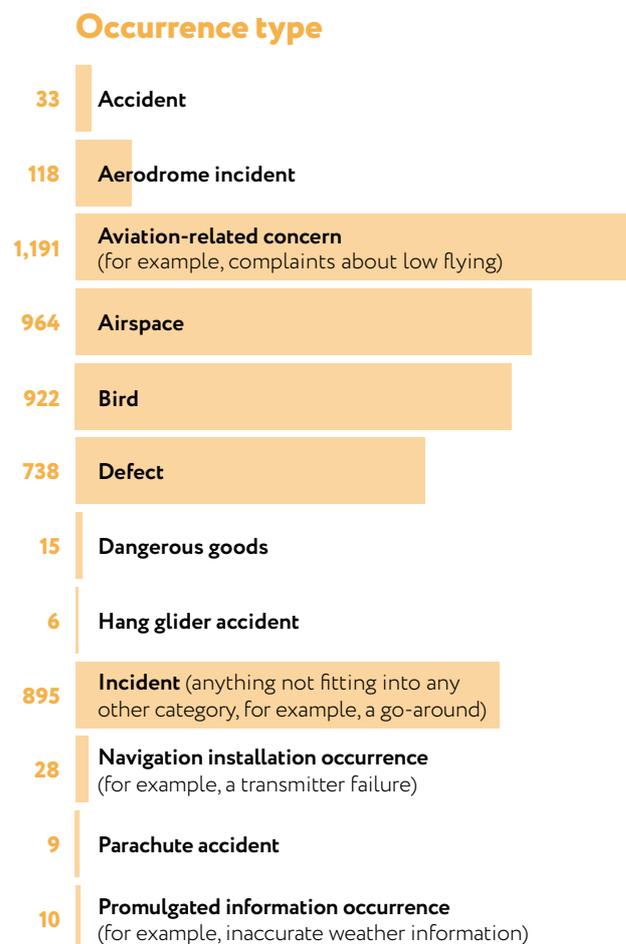
The CAA receives thousands of occurrence reports each year. To give you a picture of the number, and types, of occurrences reported, we've created the chart below.

These occurrences were reported to the CAA between 01 January 2020 and 30 September 2020.
