vector

VFR INTO IMC

Part One

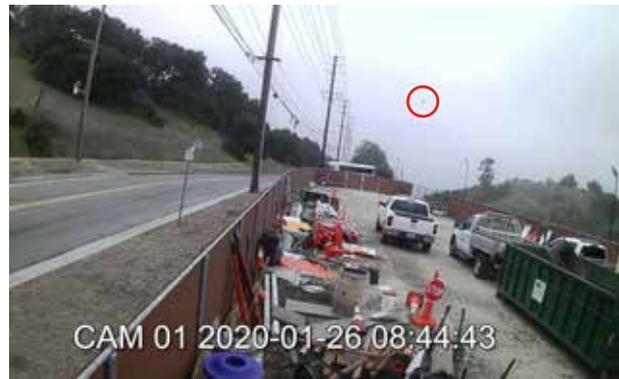
// State highway camera image of N72EX, carrying Kobe Bryant, pilot Ara Zobayan and seven others, as it disappeared into cloud, about two minutes before it impacted terrain.

But repeatedly during the accident flight, the 8600-hours pilot, Ara Zobayan, flew with less than regulation visibility, just under the clouds rather than 500 feet below them, at a lower altitude than his employer recommended, and at speeds far exceeding those recommended by the IIMC training he’d received seven months before.

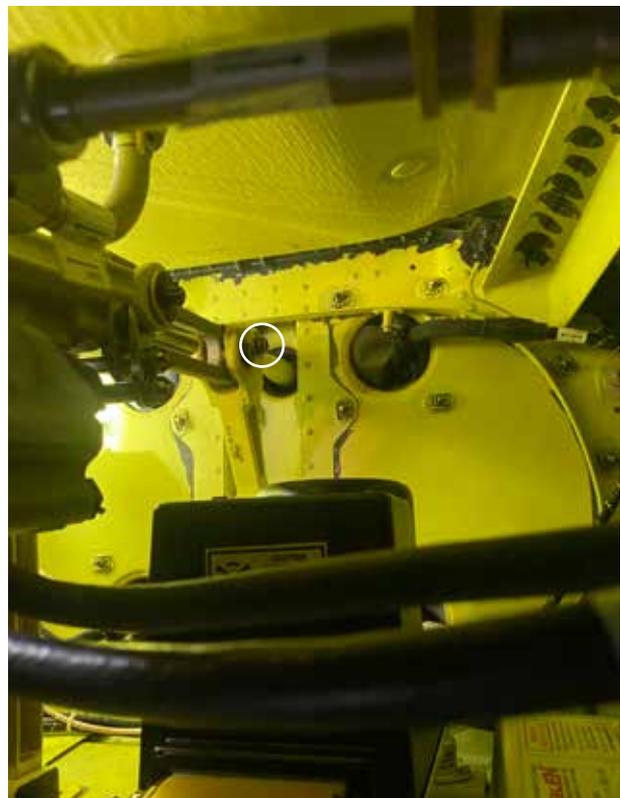
// Very hard to see. The bellcrank to rod end bolt is half a metre away from the engineer's head and 90° right to their field of vision.

The operator's investigation found that the maintenance and duplicate inspection were carried out in a very confined area, which led to the second engineer, according to the investigation report, not really being able to absolutely “confirm the bolt had gone through the rod end and that the nut was secure.

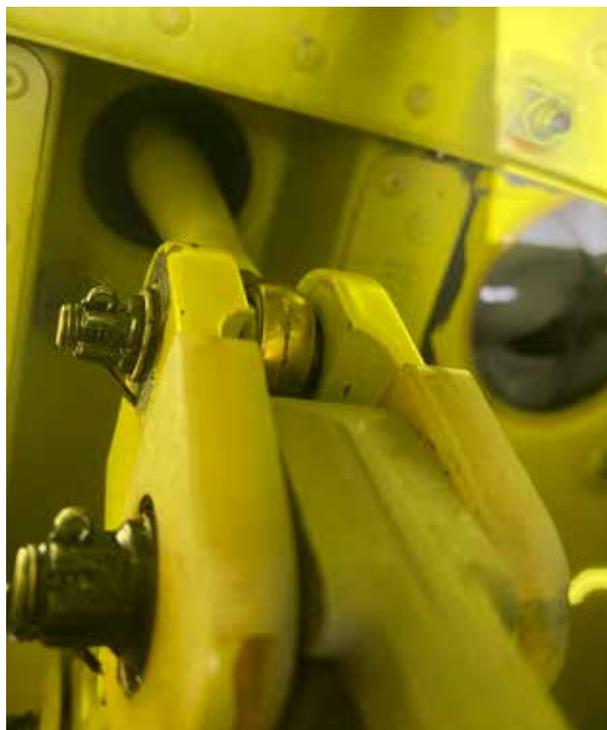
// The bolt and retaining nut correctly installed in the bellcrank and control rod end bearing.

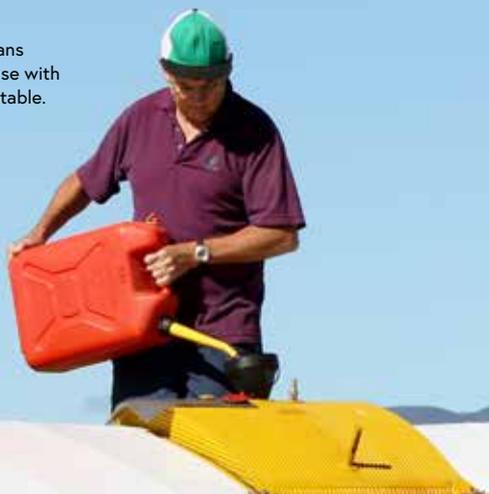
// Plastic jerry cans intended for use with fuel are acceptable.

If you use non-standard jerry cans, the fuel can degrade the gasket in the cap making it brittle to the point where it disintegrates.
